## **FEASIBILITY STUDY**

## **RAIL YARDS' BLACKSMITH SHOP**

**CITY OF ALBUQUERQUE**

**CHERRY/SEE/REAMES ARCHITECTS, LLP**  
September 12, 2012

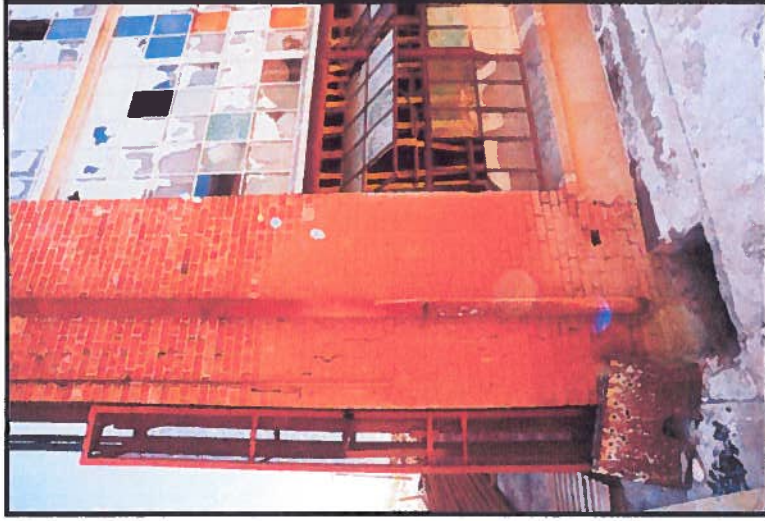
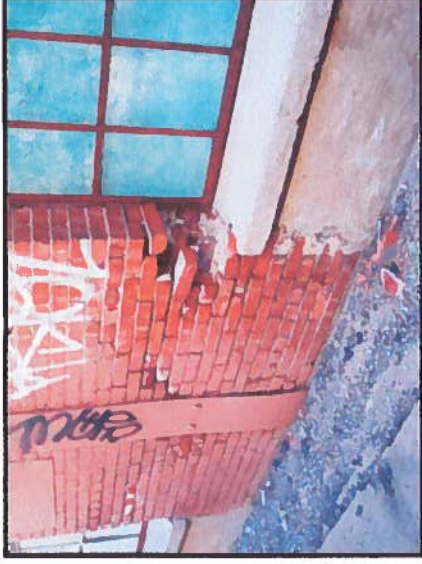
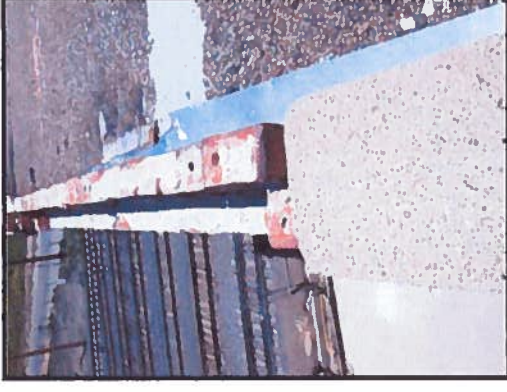
The northwest corner of the building has been damaged by the drain at that corner. Some brick on the west side has been damaged at the sill. Much of the brick throughout the building needs cleaning and repointing. The removal of the parapet caps on the north wall have left the brick cavity open to weather damage.

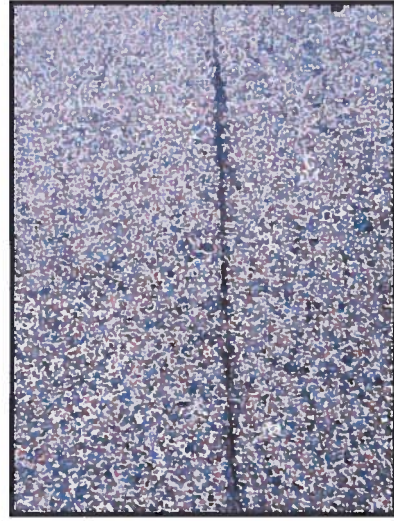
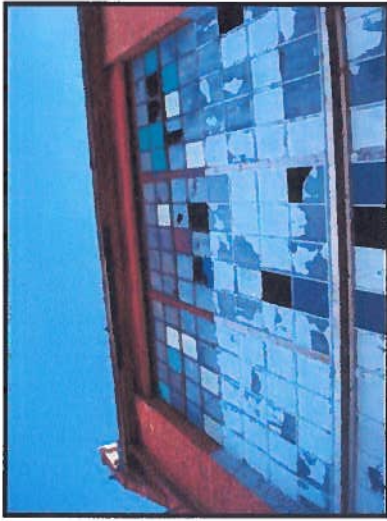
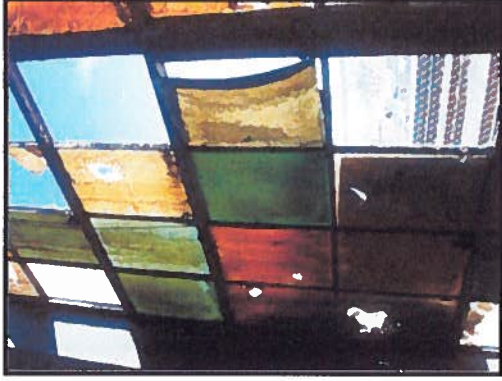
The window panes have been broken and replaced in some cases with plastic in a variety of colors. Some panes are missing completely. It has been reported that the window putty contains asbestos. If asbestos is confirmed, it will have to be mitigated.

The window frames are metal and need refurbishing. Some of the pivoting windows still operate. It is estimated that approximately 20 percent of the panes need to be replaced (assuming retention of intact plastic panes).

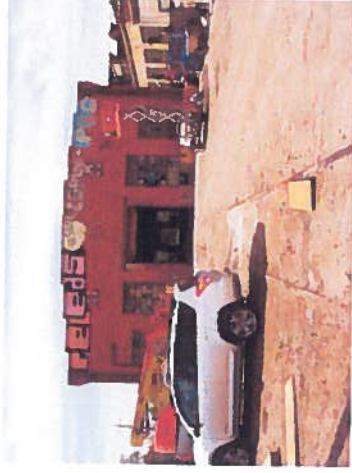
FIGURE 1: North entrance to the Blacksmith Shop as viewed from the north – existing tracks at center must remain thereby representing an important constraint with respect to future grading and drainage.

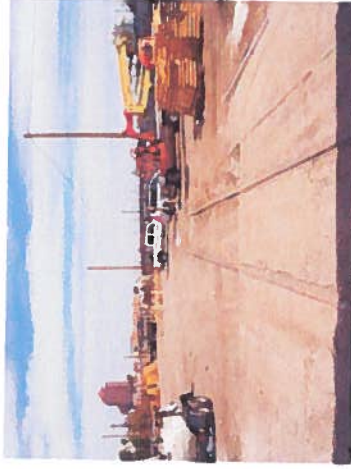
FIGURE 2: View of the area immediately north of the Blacksmith Shop as seen from the north entry to the building. Based upon visual site inspection, the existing land appears to gently slope toward the building entrance.

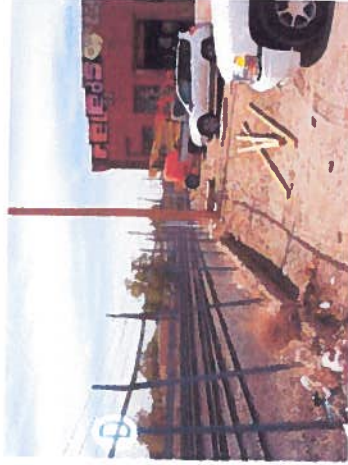
FIGURE 3: The existing railroad tracks and bed situated to the east of the Blacksmith Shop, left edge of photograph, are topographically higher thereby representing a de facto berm to block offsite flows from the upstream properties to the east of the site.

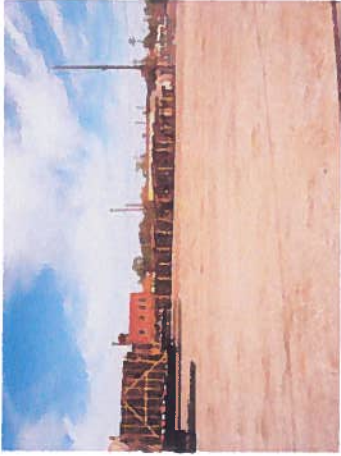
FIGURE 4: The yard north of the Blacksmith Shop and other buildings on the site is relatively flat with poorly defined drainage. This area is presently used for the fabrication and storage of movie props.

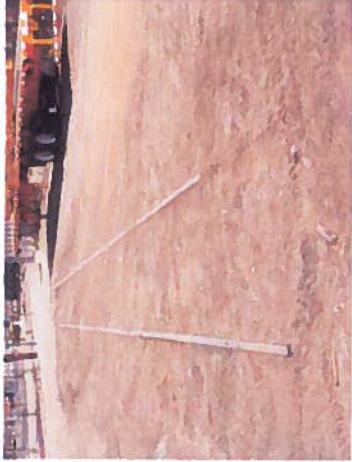
FIGURE 5: The grading and drainage of the northerly portion of the site is complicated by the existing railroad tracks that represent a significant constraint.

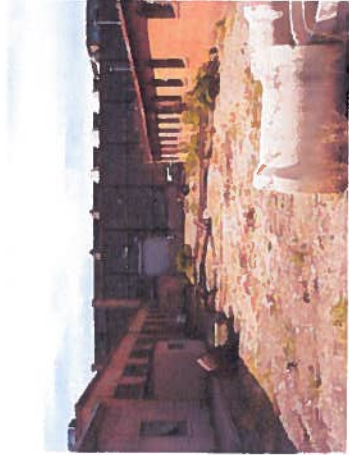
FIGURE 6: The area between the buildings also exhibits poorly defined drainage; the Boiler Shop appears in the background.

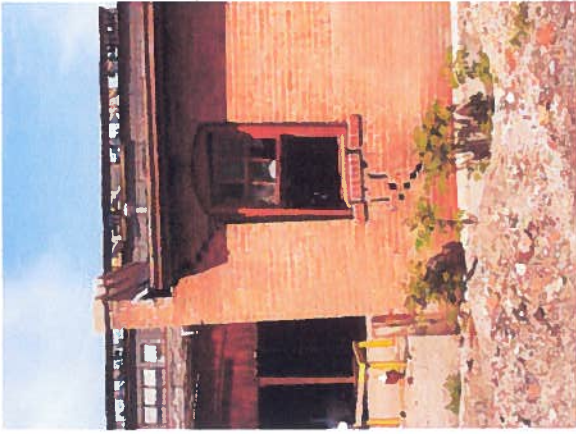
FIGURE 7: The brick outbuilding seen to the left of Figure 6 exhibits structural damage at its southeast corner, the apparent cause being lack of positive drainage away from the structure.

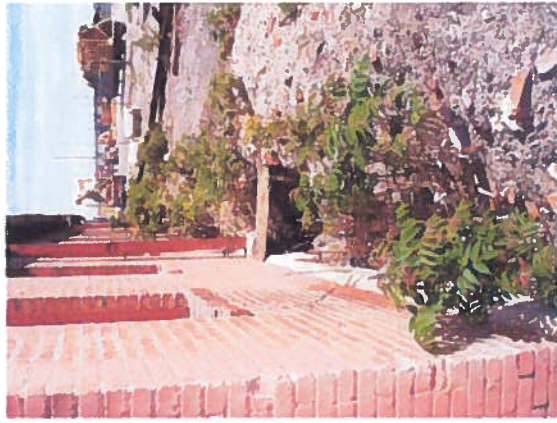
FIGURE 8: The southeast corner of the brick outbuilding shown in Figure 7 looking north. An existing roof drain leader appears to discharge underground into the soils immediately adjacent to the structure. This may have contributed to the damage observed in Figure 7.

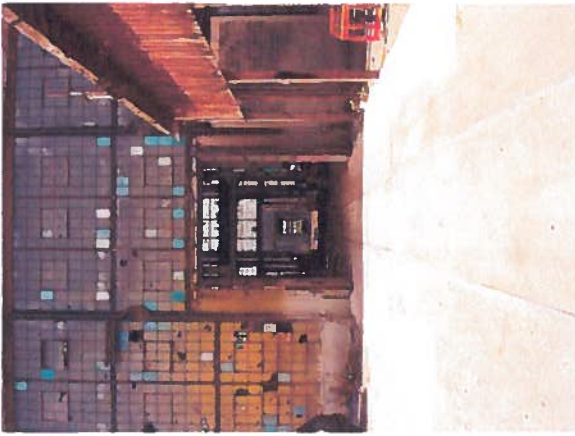
FIGURE 9: The north entry to the Boiler Shop also relies upon existing tracks. This area is also quite flat making future grading and development a challenge.

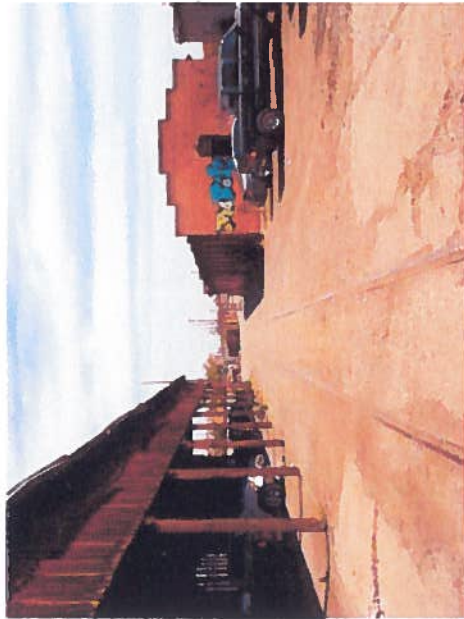
FIGURE 10: The existing tracks leading to the Boiler Shop are seen at the center of this photograph with the brick outbuilding of Figures 7 and 8 at the right and the Sheet Metal Shed to the left. Again, this area is flat with poorly defined drainage. Plans for future development should take into account the need to better drain developed runoff from this area.

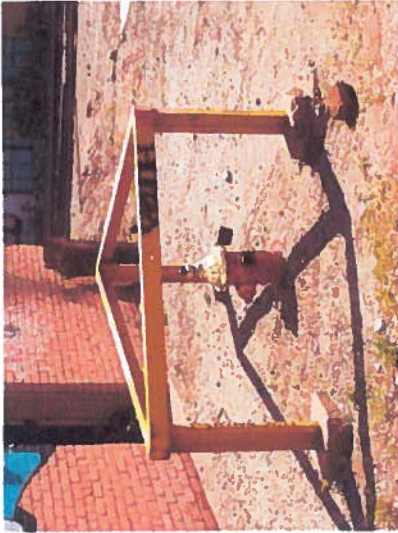
FIGURE 11: An existing fire hydrant, status unknown, located at the southwest corner of the brick outbuilding is partially buried, an apparent lack of adequate grade control.

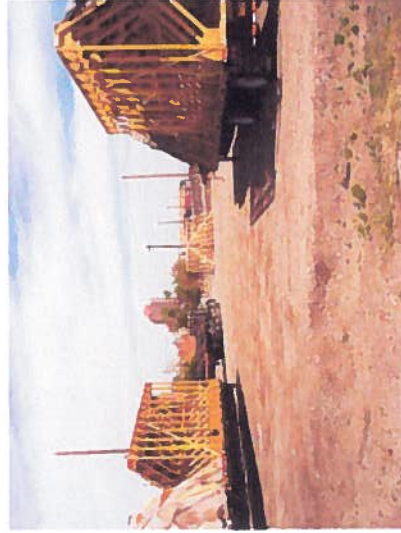
FIGURE 12: Another view of the yard north of the Blacksmith and Boiler Shops where the land is topographically flat with little to no apparent relief. The assumed trend in drainage is east to west (right to left) toward Second Street SW.

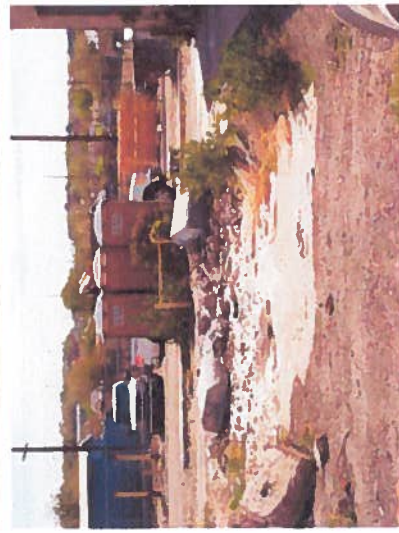
FIGURE 13: The manufacture of movie props onsite creates waste materials that are being discharged to an unlined pit near the northwest corner of the Blacksmith Shop. If the site is to continue to support the movie industry, these sorts of discharges must comply with the City of Albuquerque MS4 Permit prohibiting illicit discharges

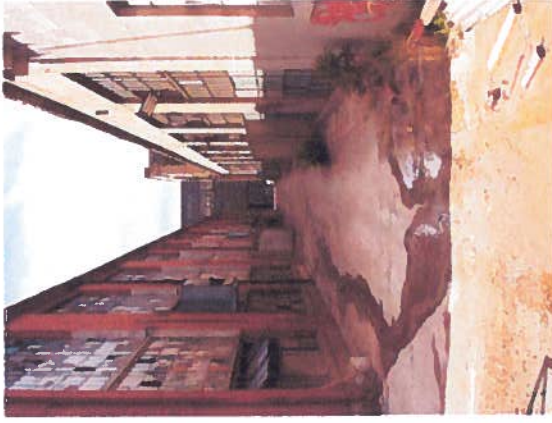
**FIGURE 14:** A narrow alley lies between the Blacksmith Shop and a CMU Warehouse to the west. This area lacks positive surface drainage. Surface drainage appears to discharge to an antiquated storm drain system and/or French drains. In either case, the existing facilities appear to be unmaintained and in disrepair. Replacement with a private storm drain connecting to Second Street SW is recommended.

The redevelopment of the Blacksmith Shop should address the drainage deficiencies of the South Basin. It is recommended to re-grade and repave the narrow alley for positive drainage. A series of storm inlets located at the low points, commonly referred to as sumps, and connected by private storm drain piping will work toward this goal. The private storm drain should drain to the south toward the south dock along the south face of the Blacksmith Shop and the Boiler Shop. From this point, the private storm drain should drain west beneath the south dock toward Second Street SW. Along this route, the roof drains from the Boiler Shop should be intercepted and connected. Prior to the design and construction of the private storm drain improvements, a comprehensive investigation of the

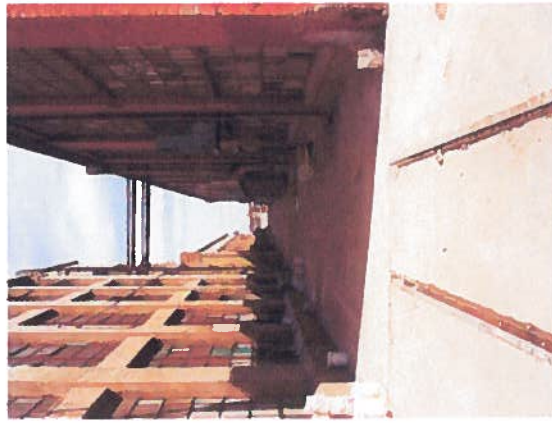
**FIGURE 15:** The narrow alley as viewed from the south continues to depict a condition absent of positive drainage. An outdoor urinal is located at the midpoint of the east (right) side of this space. It is unknown where this abandoned facility drained or drains.

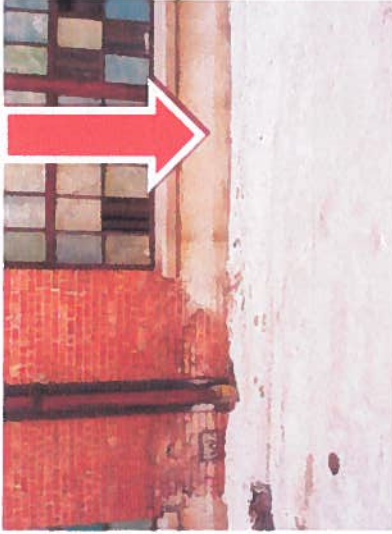
FIGURE 16: Existing roof drain near the northwest corner of the Blacksmith Shop appears to discharge below grade. This location is a de facto sump; the high water mark is observed on the face of the building. The white chalky residue is believed to be washout from the manufacture of movie props.

existing storm drainage system should be conducted. This effort would determine if the manholes, inlets and roof drain leaders documented by Figures 16 through 22 are connected to a viable existing system. If existing improvements are in adequate condition and sized appropriately, retrofitting into the redevelopment design may be feasible. Regardless, an effort should be made to collect the surface and roof runoff discharging into this area and safely conveying it to a public storm drainage outfall.

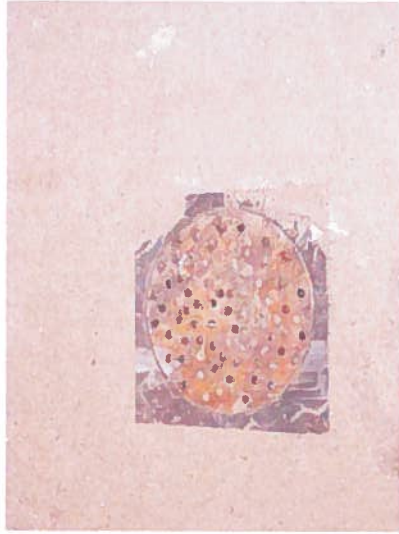
FIGURE 17: Several small diameter area drains are observed within the alley. These appear to be in poorly maintained condition with limited capacity.

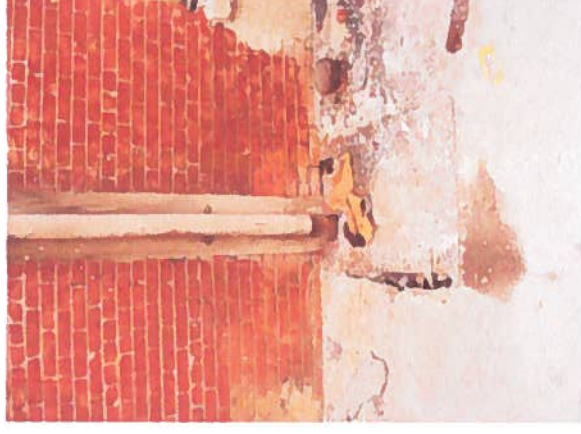
FIGURE 18: Existing roof drain near the southwest corner of the Blacksmith Shop also appears to discharge below grade. It is unknown if the roof drains connect to an underground storm drain system or simply discharge to a dry well or French drain.

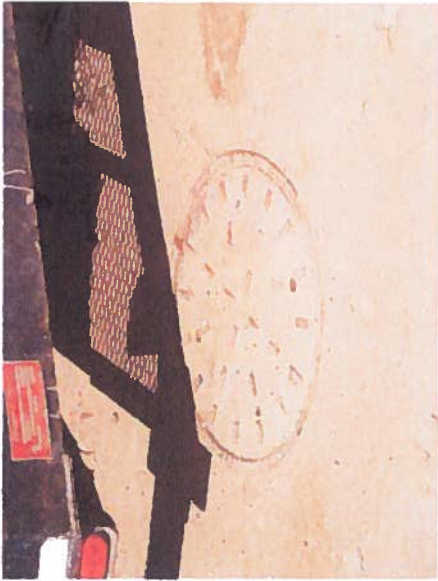
FIGURE 19: A series of manholes are located on the “dock” area south of the Blacksmith Shop and Boiler Shop. These manholes appear to be storm drain features that may drain west toward Second Street SW.

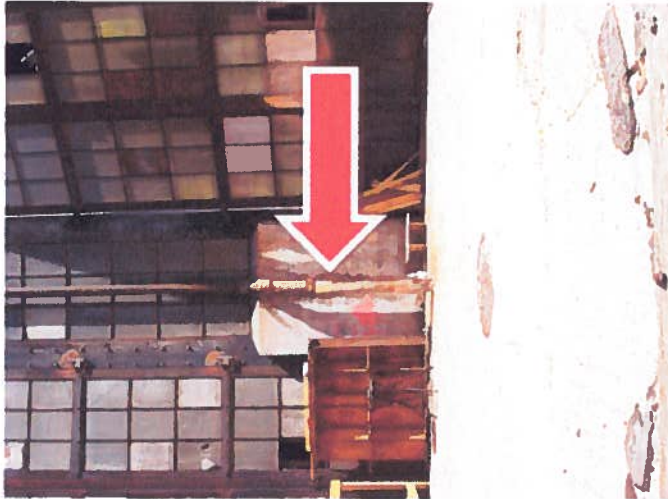
FIGURE 20: This manhole south of the Boiler Shop appears to align with a roof drain on the south face of the Boiler Shop.

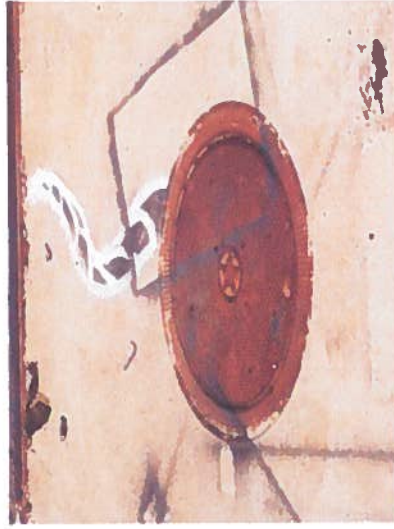
**FIGURE 21:** Several different styles of manhole cover are seen on the south side of the Boiler Shop. Further investigation is required to determine if these are interconnected or serve separate facilities such as sanitary sewer or industrial waste.

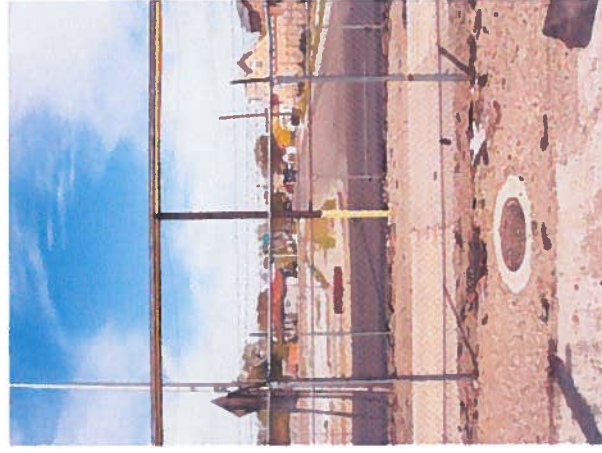
**FIGURE 22:** The westernmost manhole is located just east of Second Street SW where a 42-inch public storm drain is located. It is unknown if this is a storm drain manhole or if it is somehow connected to public storm drain facilities within Second Street SW.

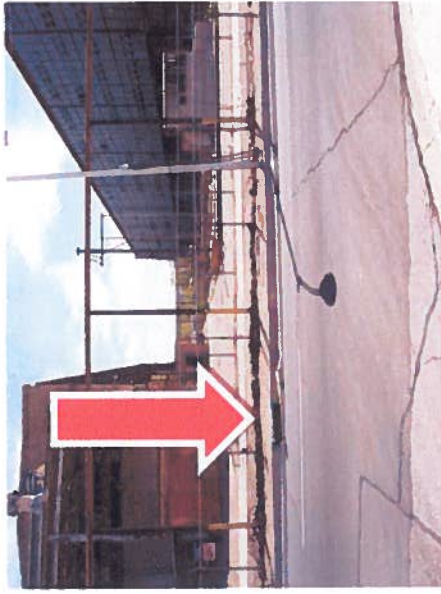
FIGURE 23: View of the south side of the Boiler Shop as seen from the intersection of Second Street SW and Santa Fe Avenue SW, looking east. A public storm inlet in the east curb line of Second Street SW is seen at center right

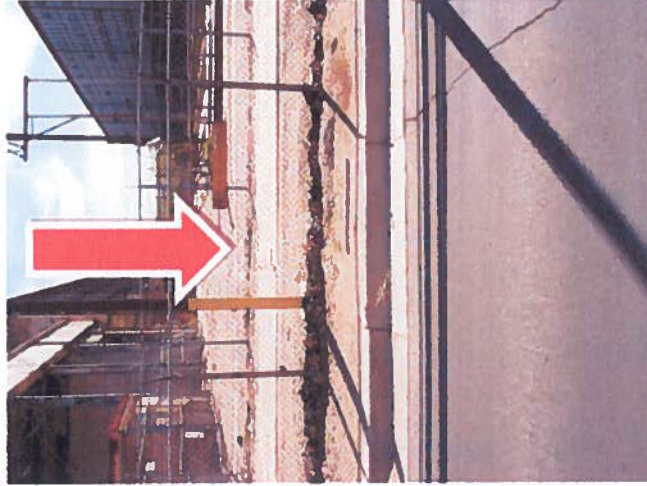
FIGURE 24: A closer view of the south side of the Boiler Shop with the manhole pictured in Figure 22 visible just beyond the second chain link fence. The storm inlet pictured in Figure 23 is located to the left, just beyond the frame. The debris in the gutter line, left edge of the frame, provides a reference point.

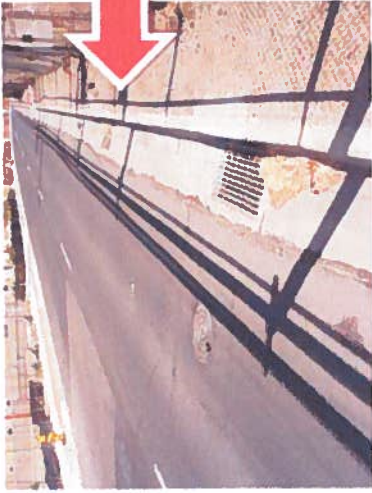
FIGURE 25: Another view of the public storm inlet in the east curb line of Second Street SW as viewed from the south looking north with a second inlet located upstream.

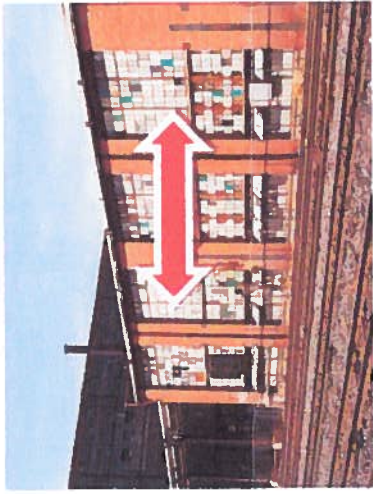
The East Basin consists of the east half of the Blacksmith Shop roof. As shown by Figures 26 and 27, the east half of the roof drains east and discharges via roof drain leaders to the east perimeter of the building. At this point, the roof drain leaders discharge below grade, probably to a dry well or similar feature. Figure 28 depicts this condition of discharge below grade.

FIGURE 26: The east face of the Blacksmith Shop abuts the railroad right-of-way. Several roof drains are seen on the east face discharging below grade. The roof drains appear to drain the east half of the roof area of the building. The west half discharges to the narrow alley seen in Figures 14 through 18.

The East Basin has limited opportunity for change as it consists of the east half of the Blacksmith Shop roof area. Presently, as illustrated by Figures 26 through 28, the east roof area drains via existing roof drain leaders to discharge below grade at the east face of the building. It is recommended that this existing condition not be changed unless there is a compelling structural reason. If changing the method of roof drain discharge is necessary, the drainage must be diverted to the North or South Basins; surface discharge per the Predesign Conference recap will not be allowed as it would result in discharging runoff onto an adjacent private property.

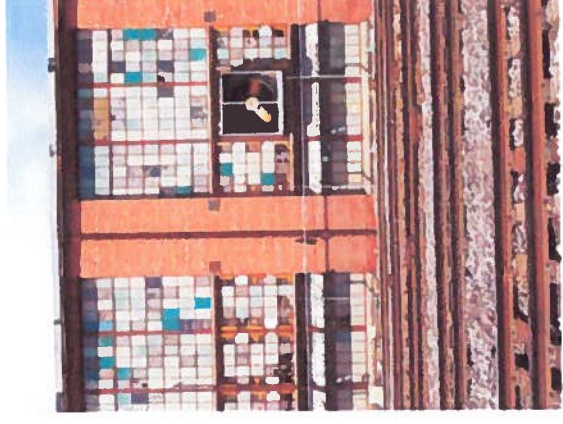
FIGURE 27: A closer view of the east face of the Blacksmith Shop more clearly illustrates the condition of a roof drain discharging to below grade.

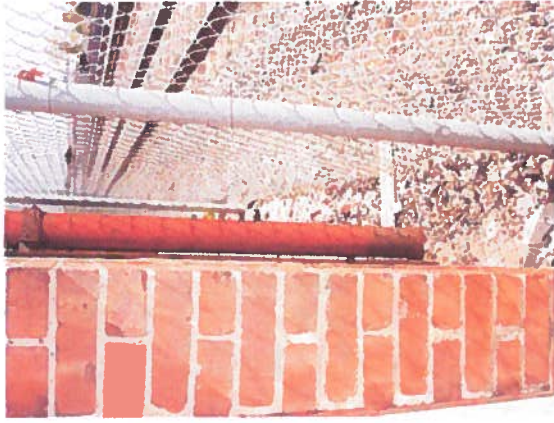
**FIGURE 28:** Another view of a roof drain on the east face of the Blacksmith Shop as seen through an existing window in the building. It is unknown if this pipe connects to an underground system or a simple dry well. Regardless, this is an existing condition that has likely been serving the site for many decades.
