# **SOIL MANAGEMENT PLAN**

## **City of Albuquerque Rail Yards**

### **Albuquerque, Bernalillo County, New Mexico**

**July 16, 2020**

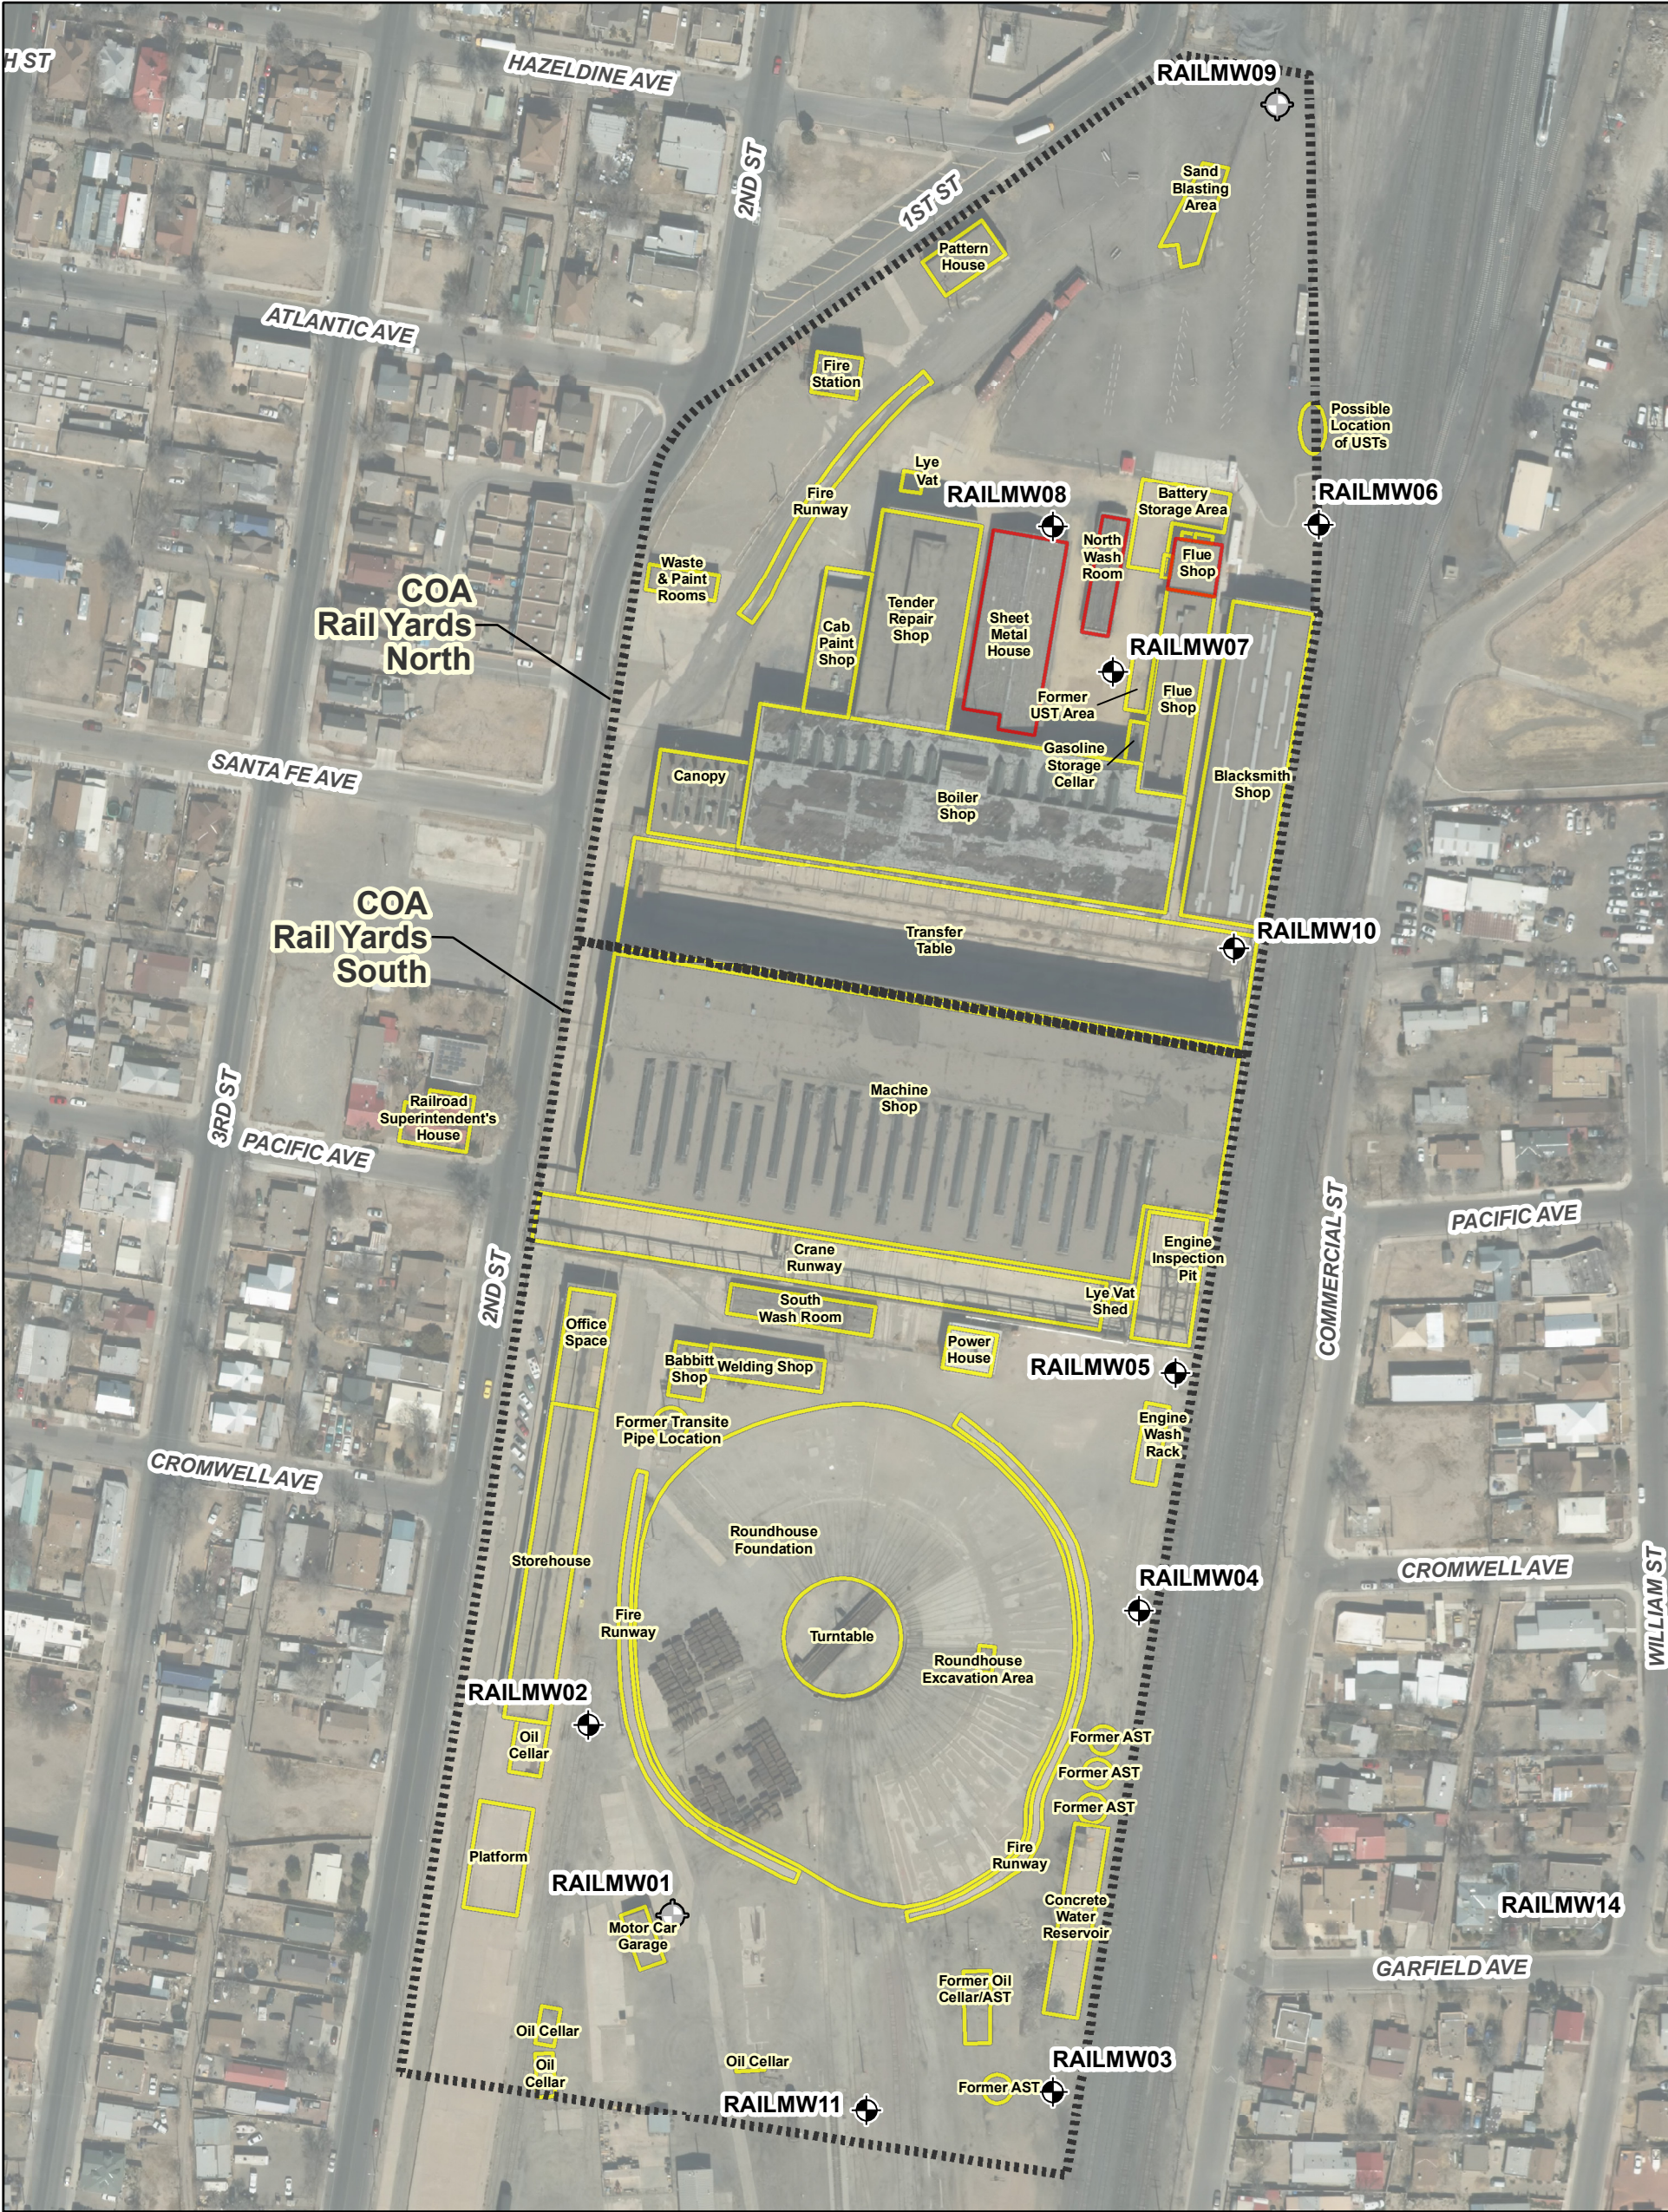
Figure 2  
Site Plan  
Soil Management Plan  
Albuquerque Rail Yards,  
Albuquerque, New Mexico

Note:  
RAILMW01 is damaged and currently  
being evaluated for possible repair.

Transite pipe (pipe made from an asbestos-cement material) was identified in the subsurface near transformers located south of the Babbitt Shop (**Figure 2**). Samples of the Transite pipe contained 25% to 30% asbestos (Terracon, 2005). The pipe appeared to be the remnant of piping used for hot/cold water used throughout the main buildings. It is unclear whether any Transite pipe has been removed from the COA Rail Yards and therefore any future excavation activities must proceed with caution and be aware that this material may be encountered. Photograph examples of Transite pipe are included in **Appendix A**.

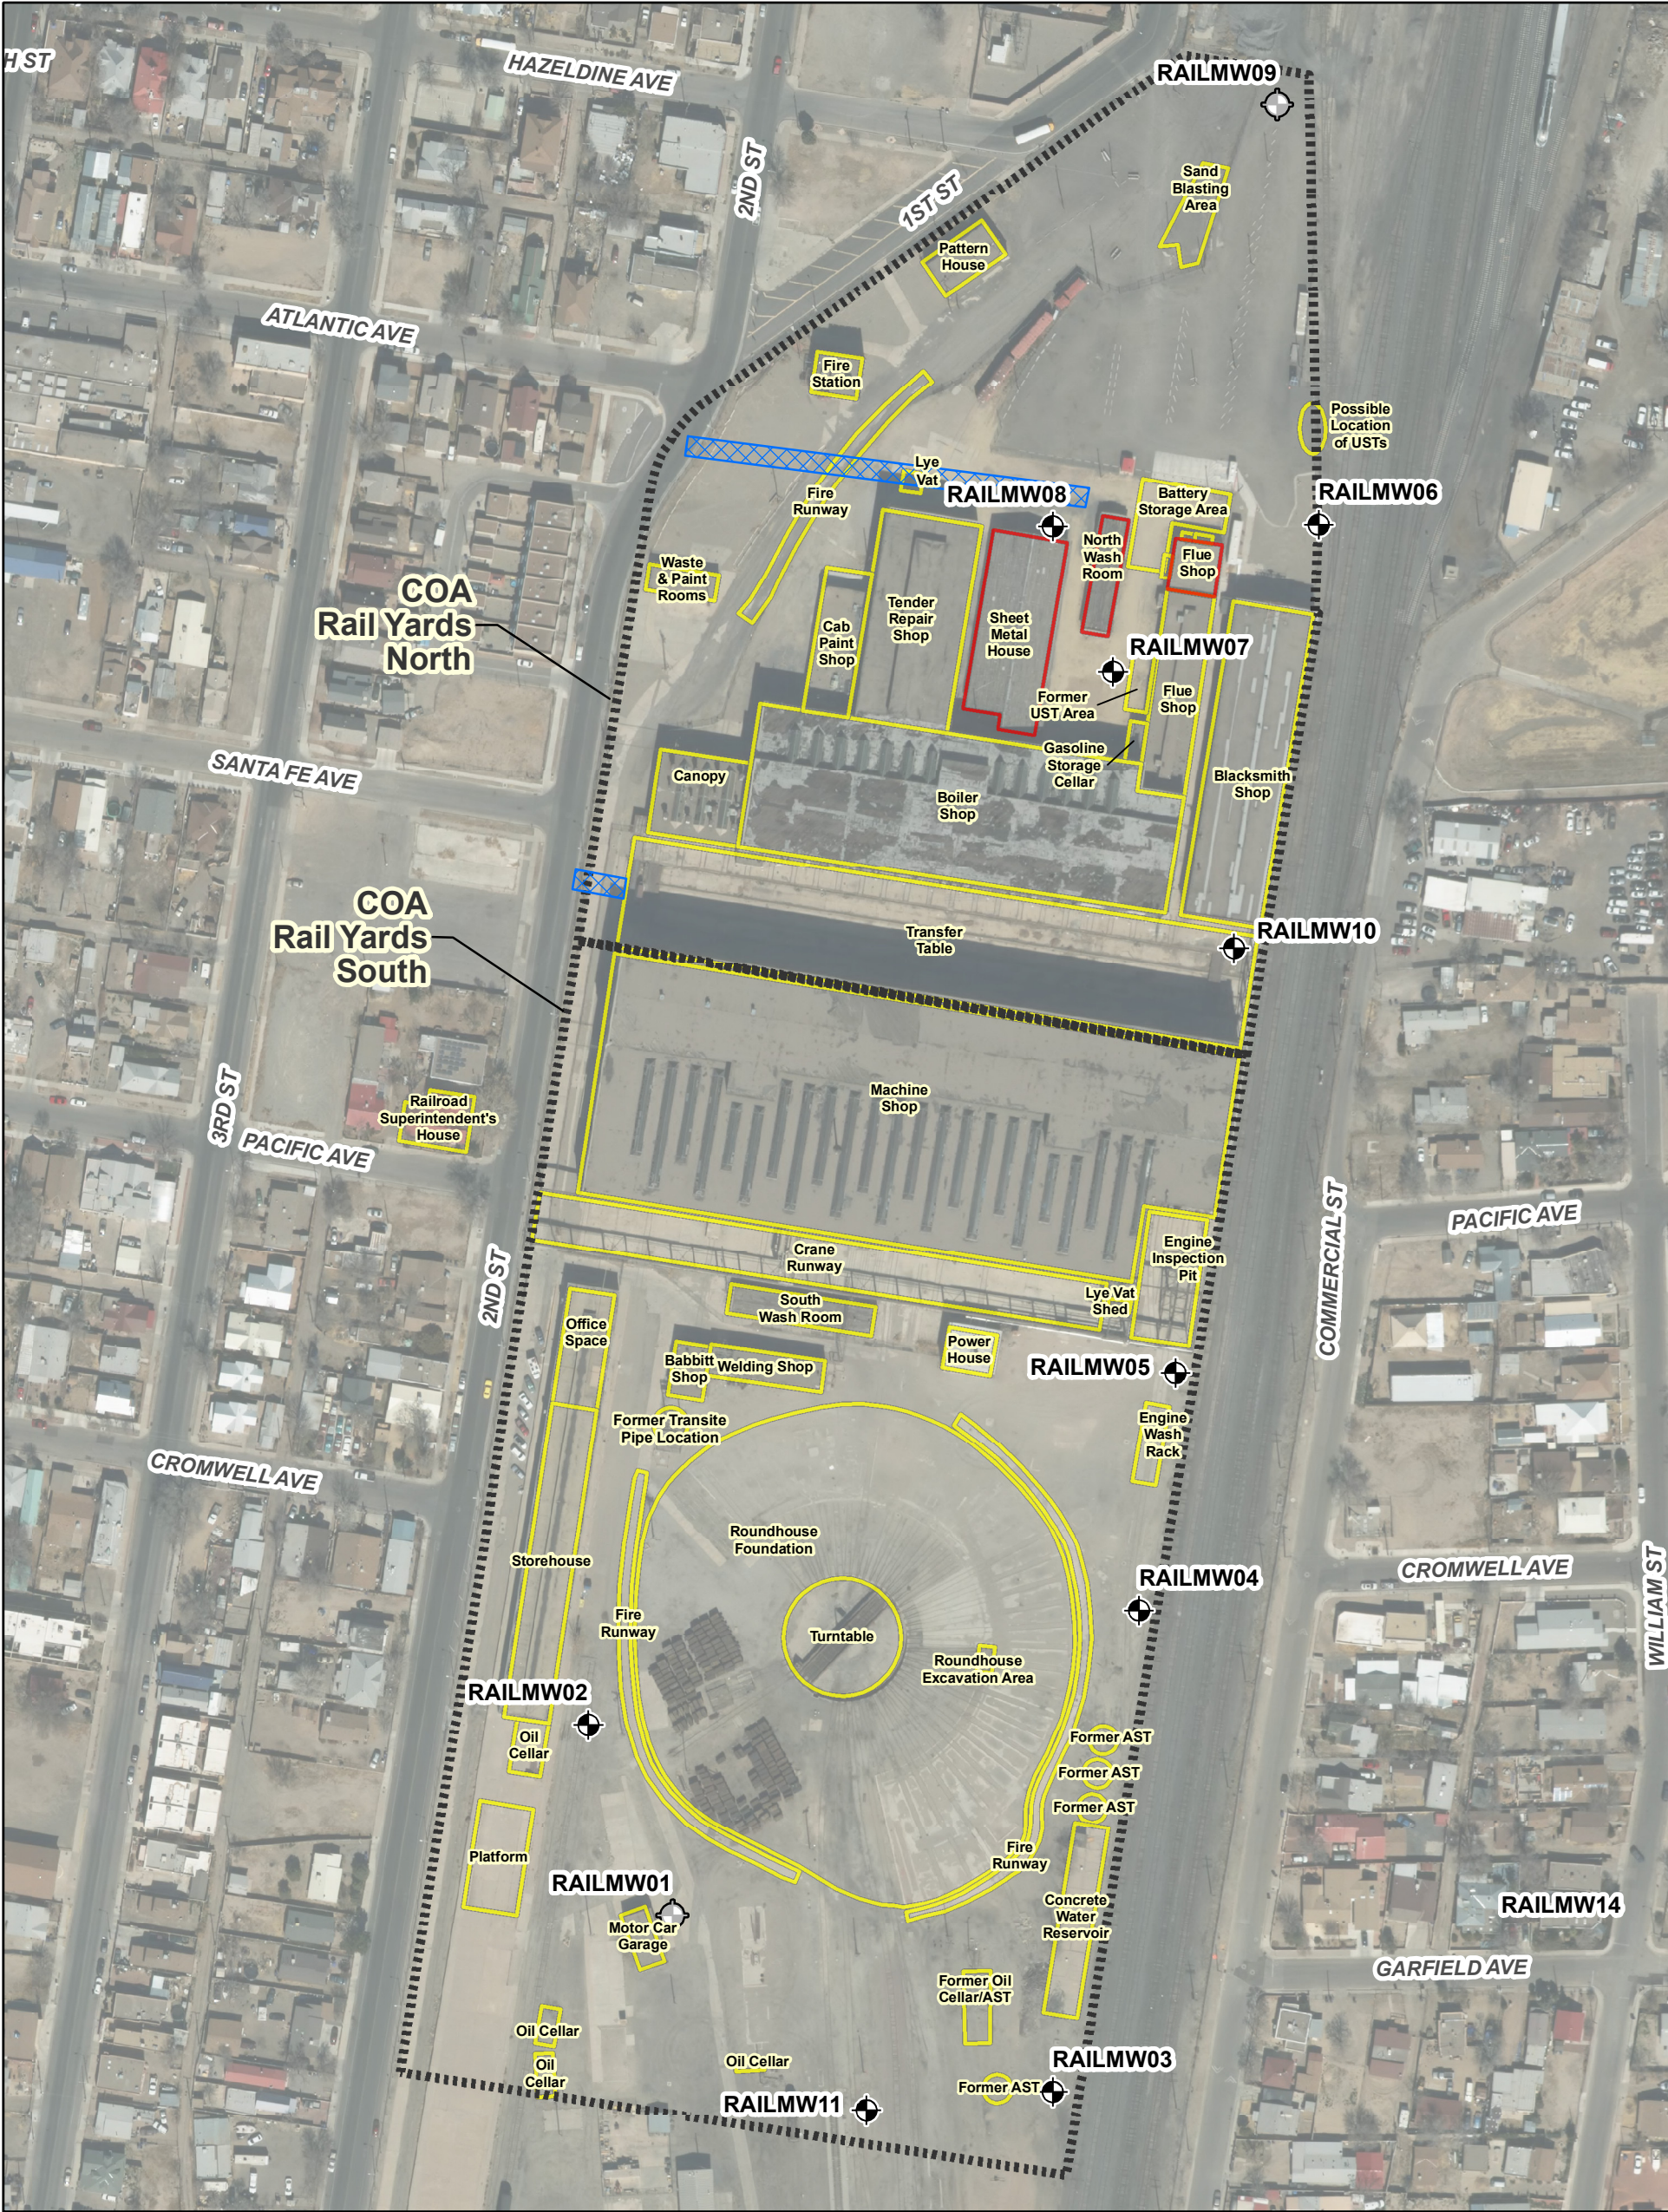
Figure 3  
Proposed Utility Trench  
Soil Management Plan  
Albuquerque Rail Yards,  
Albuquerque, New Mexico

Note:  
RAILMW01 is damaged and currently  
being evaluated for possible repair.

The proposed development of the Site is still being determined; the only known excavation activity to occur in the near future is to excavate two utility trenches within the COA Rail Yards North (**Figure 3**). Potable water, sewer, and natural gas utility lines will be placed in these areas. The main subsurface utility trench will be approximately 300-ft long, 15-ft wide, and 3-ft deep. A smaller trench may also be excavated south of this larger trench to install additional utility lines.

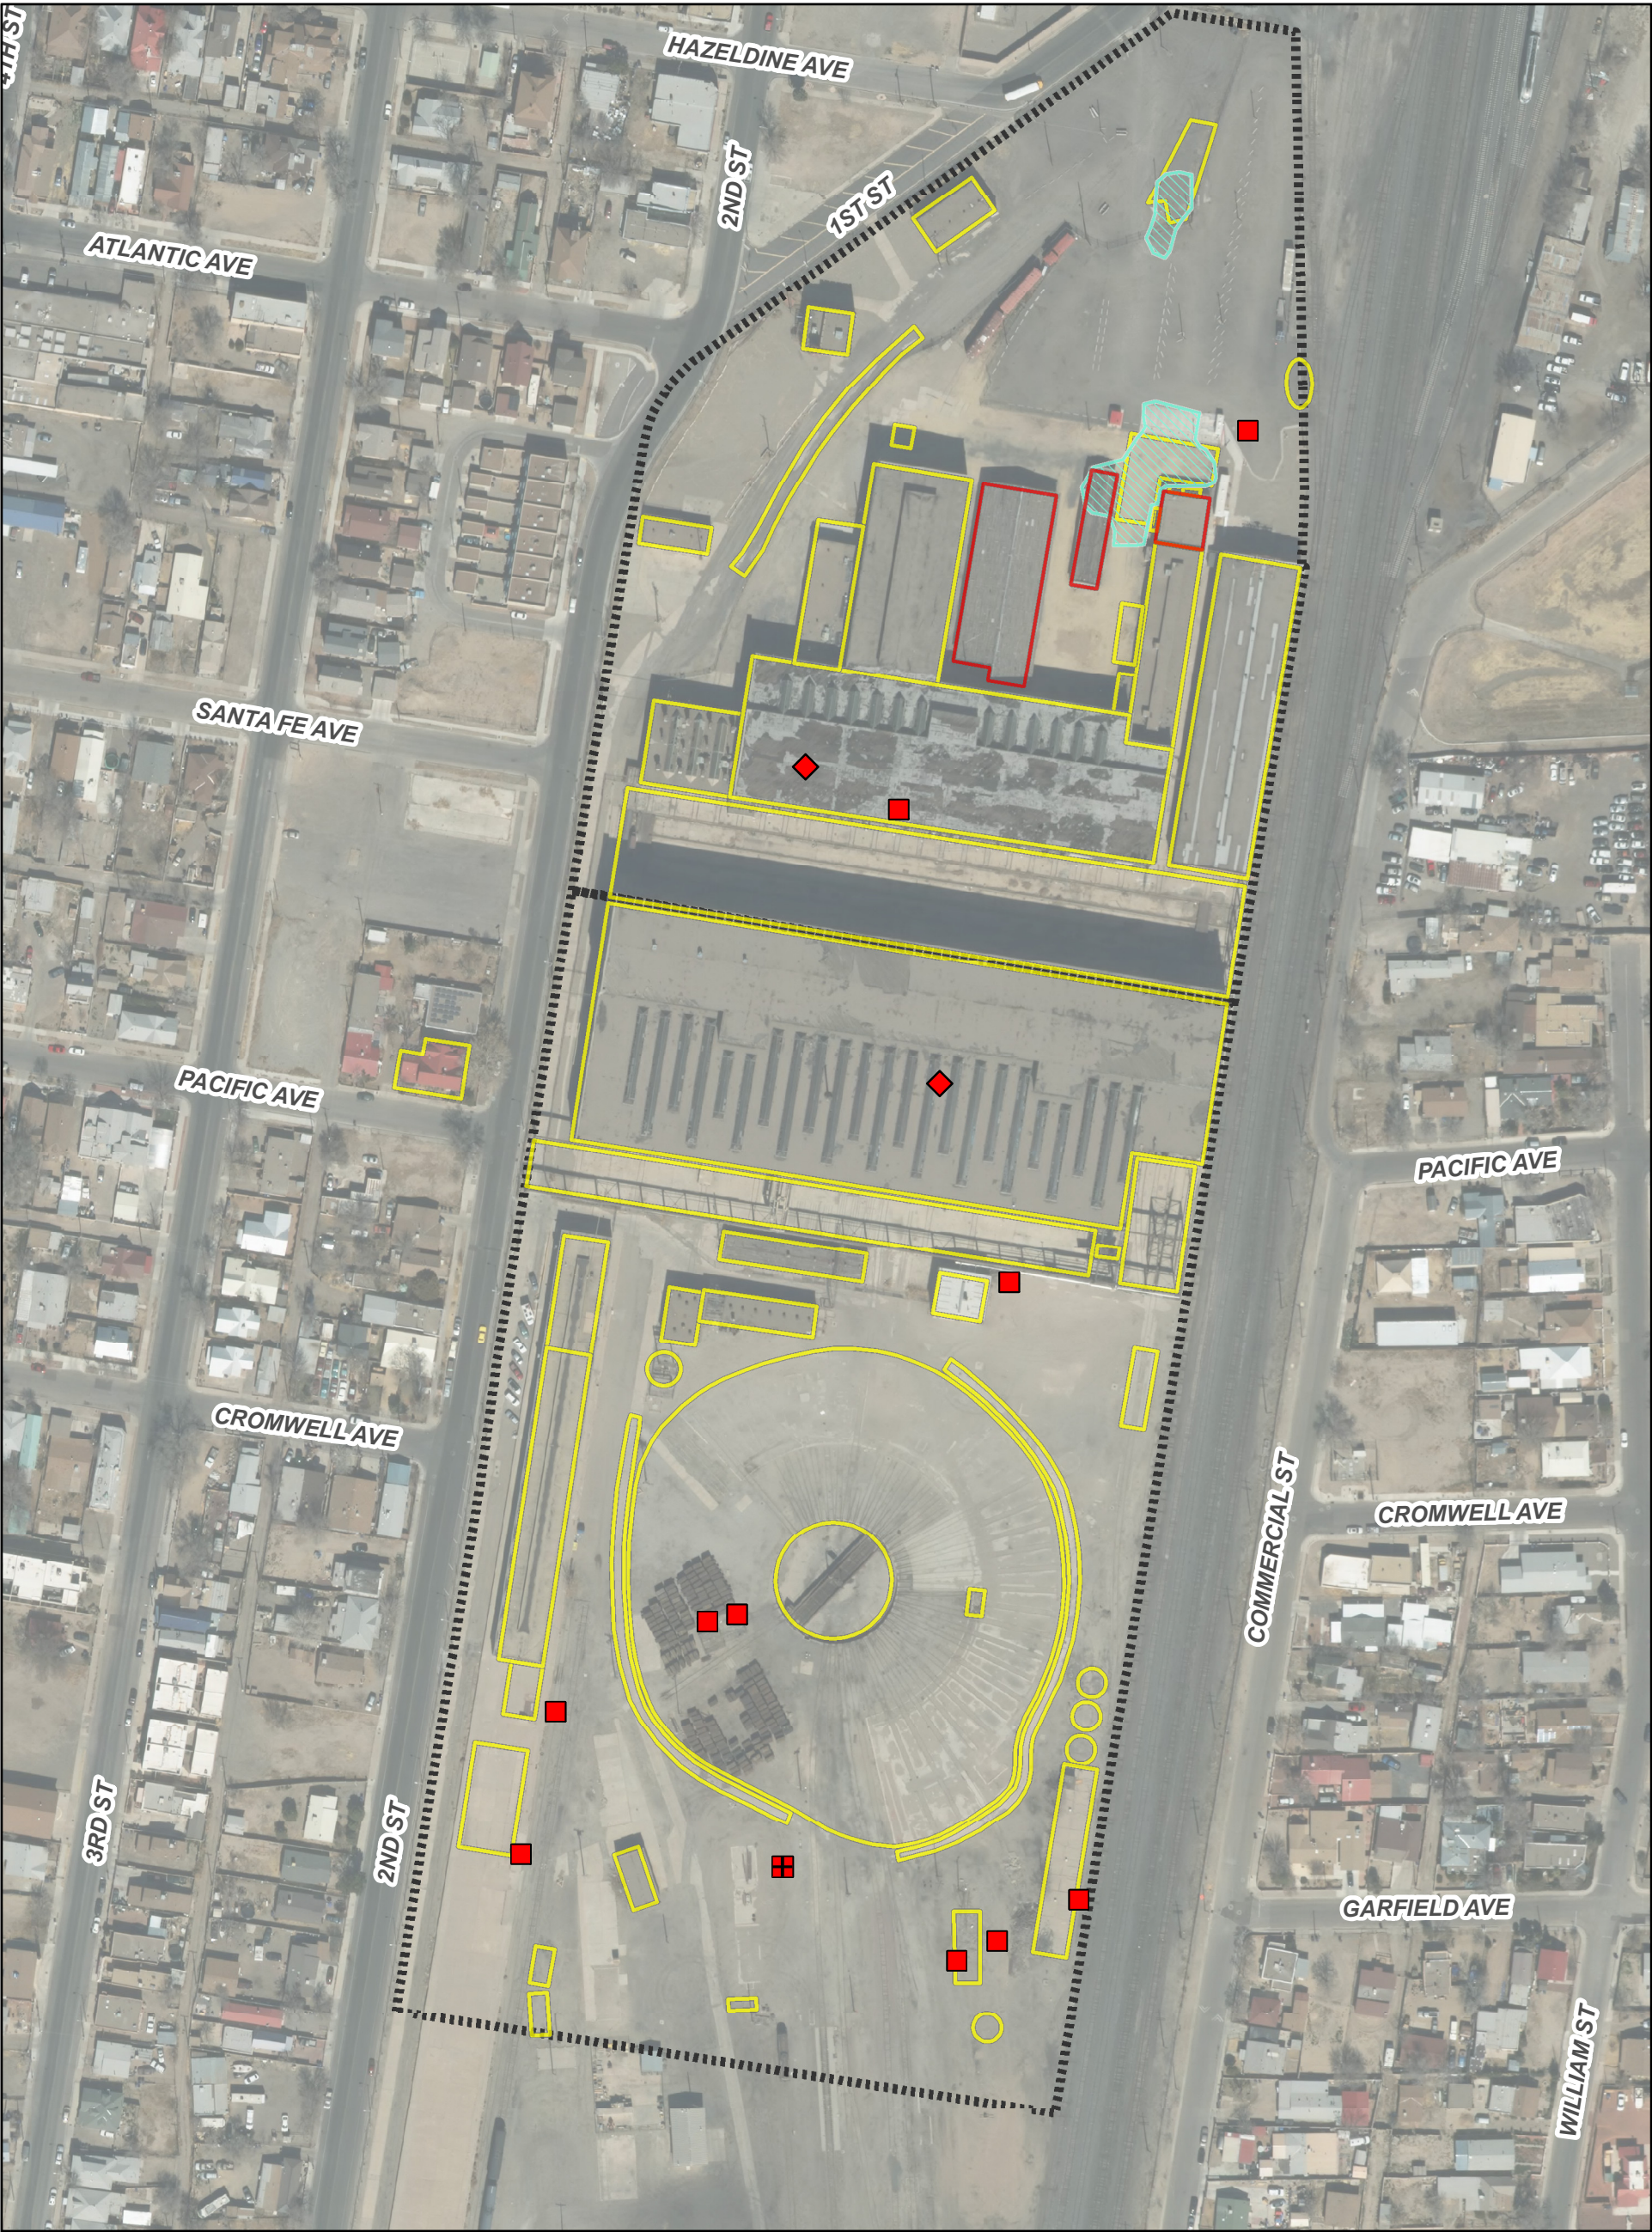
Figure 4a  
Residential SSL Exceedances  
(0-10 ft bgs), TPH DRO+MRO  
Soil Management Plan,  
Albuquerque Rail Yards,  
Albuquerque, New Mexico

Note: Some sample depths include a portion greater than 10 ft bgs (i.e., sample interval = 8 - 12 ft bgs).  
SSL: Soil Screening Levels (NMED, 2019)

These COPCs were derived from evaluating historical Site analytical data with the applicable New Mexico state regulatory standards, including NMED soil screening level (SSLs) (NMED, 2019). Petroleum-contaminated soil (PCS) was present in both the finer-grained and coarser-grained soil units. **Figure 4a** through **Figure 4c** illustrate where exceedances of metals, PAHs, and TPH exist on the Site.

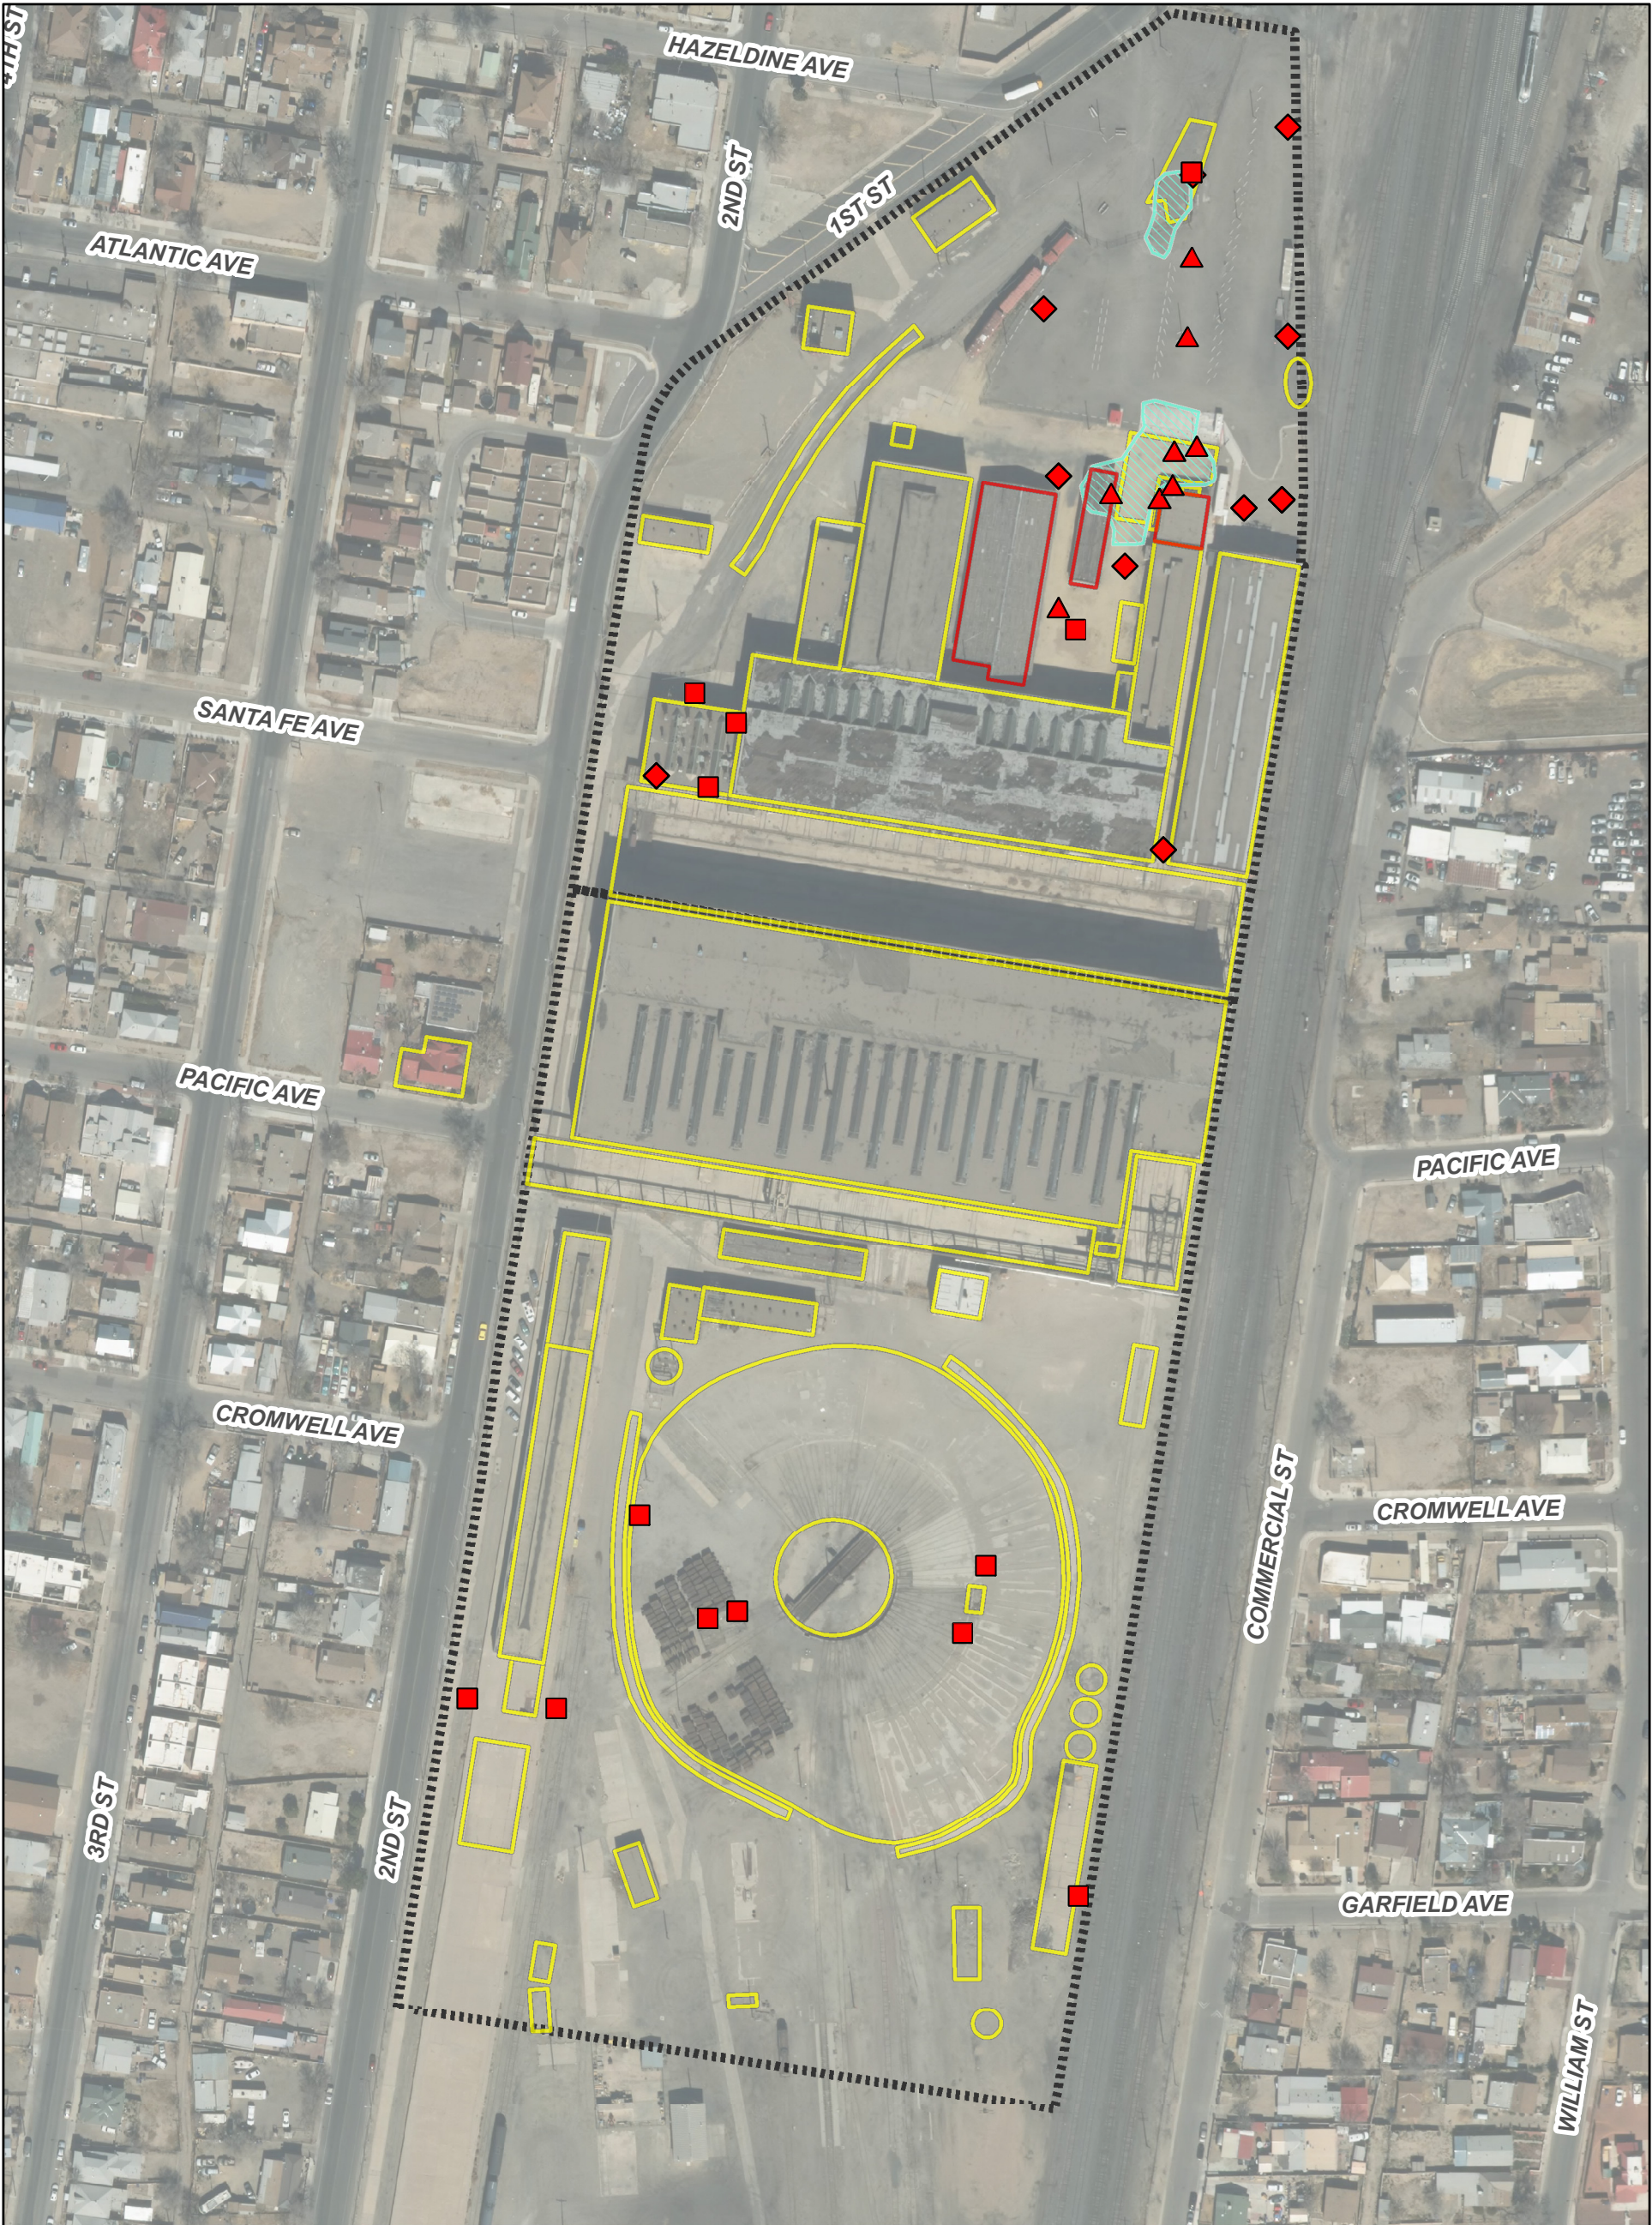
Figure 4b  
Residential and Site Specific Exceedances (0-10 ft bgs)  
for Antimony, Arsenic, Lead and/or Thallium  
Soil Management Plan,  
Albuquerque Rail Yards,  
Albuquerque, New Mexico

Notes:  
Some sample depths include a portion greater than 10 ft bgs (i.e., sample interval = 8 - 12 ft bgs).  
SSL: Soil Screening Levels (NMED, 2019).  
Lead is compared to its Site Specific SSL of 550 ppm.  
Antimony, Arsenic, and Thallium are compared to their respective SSLs.

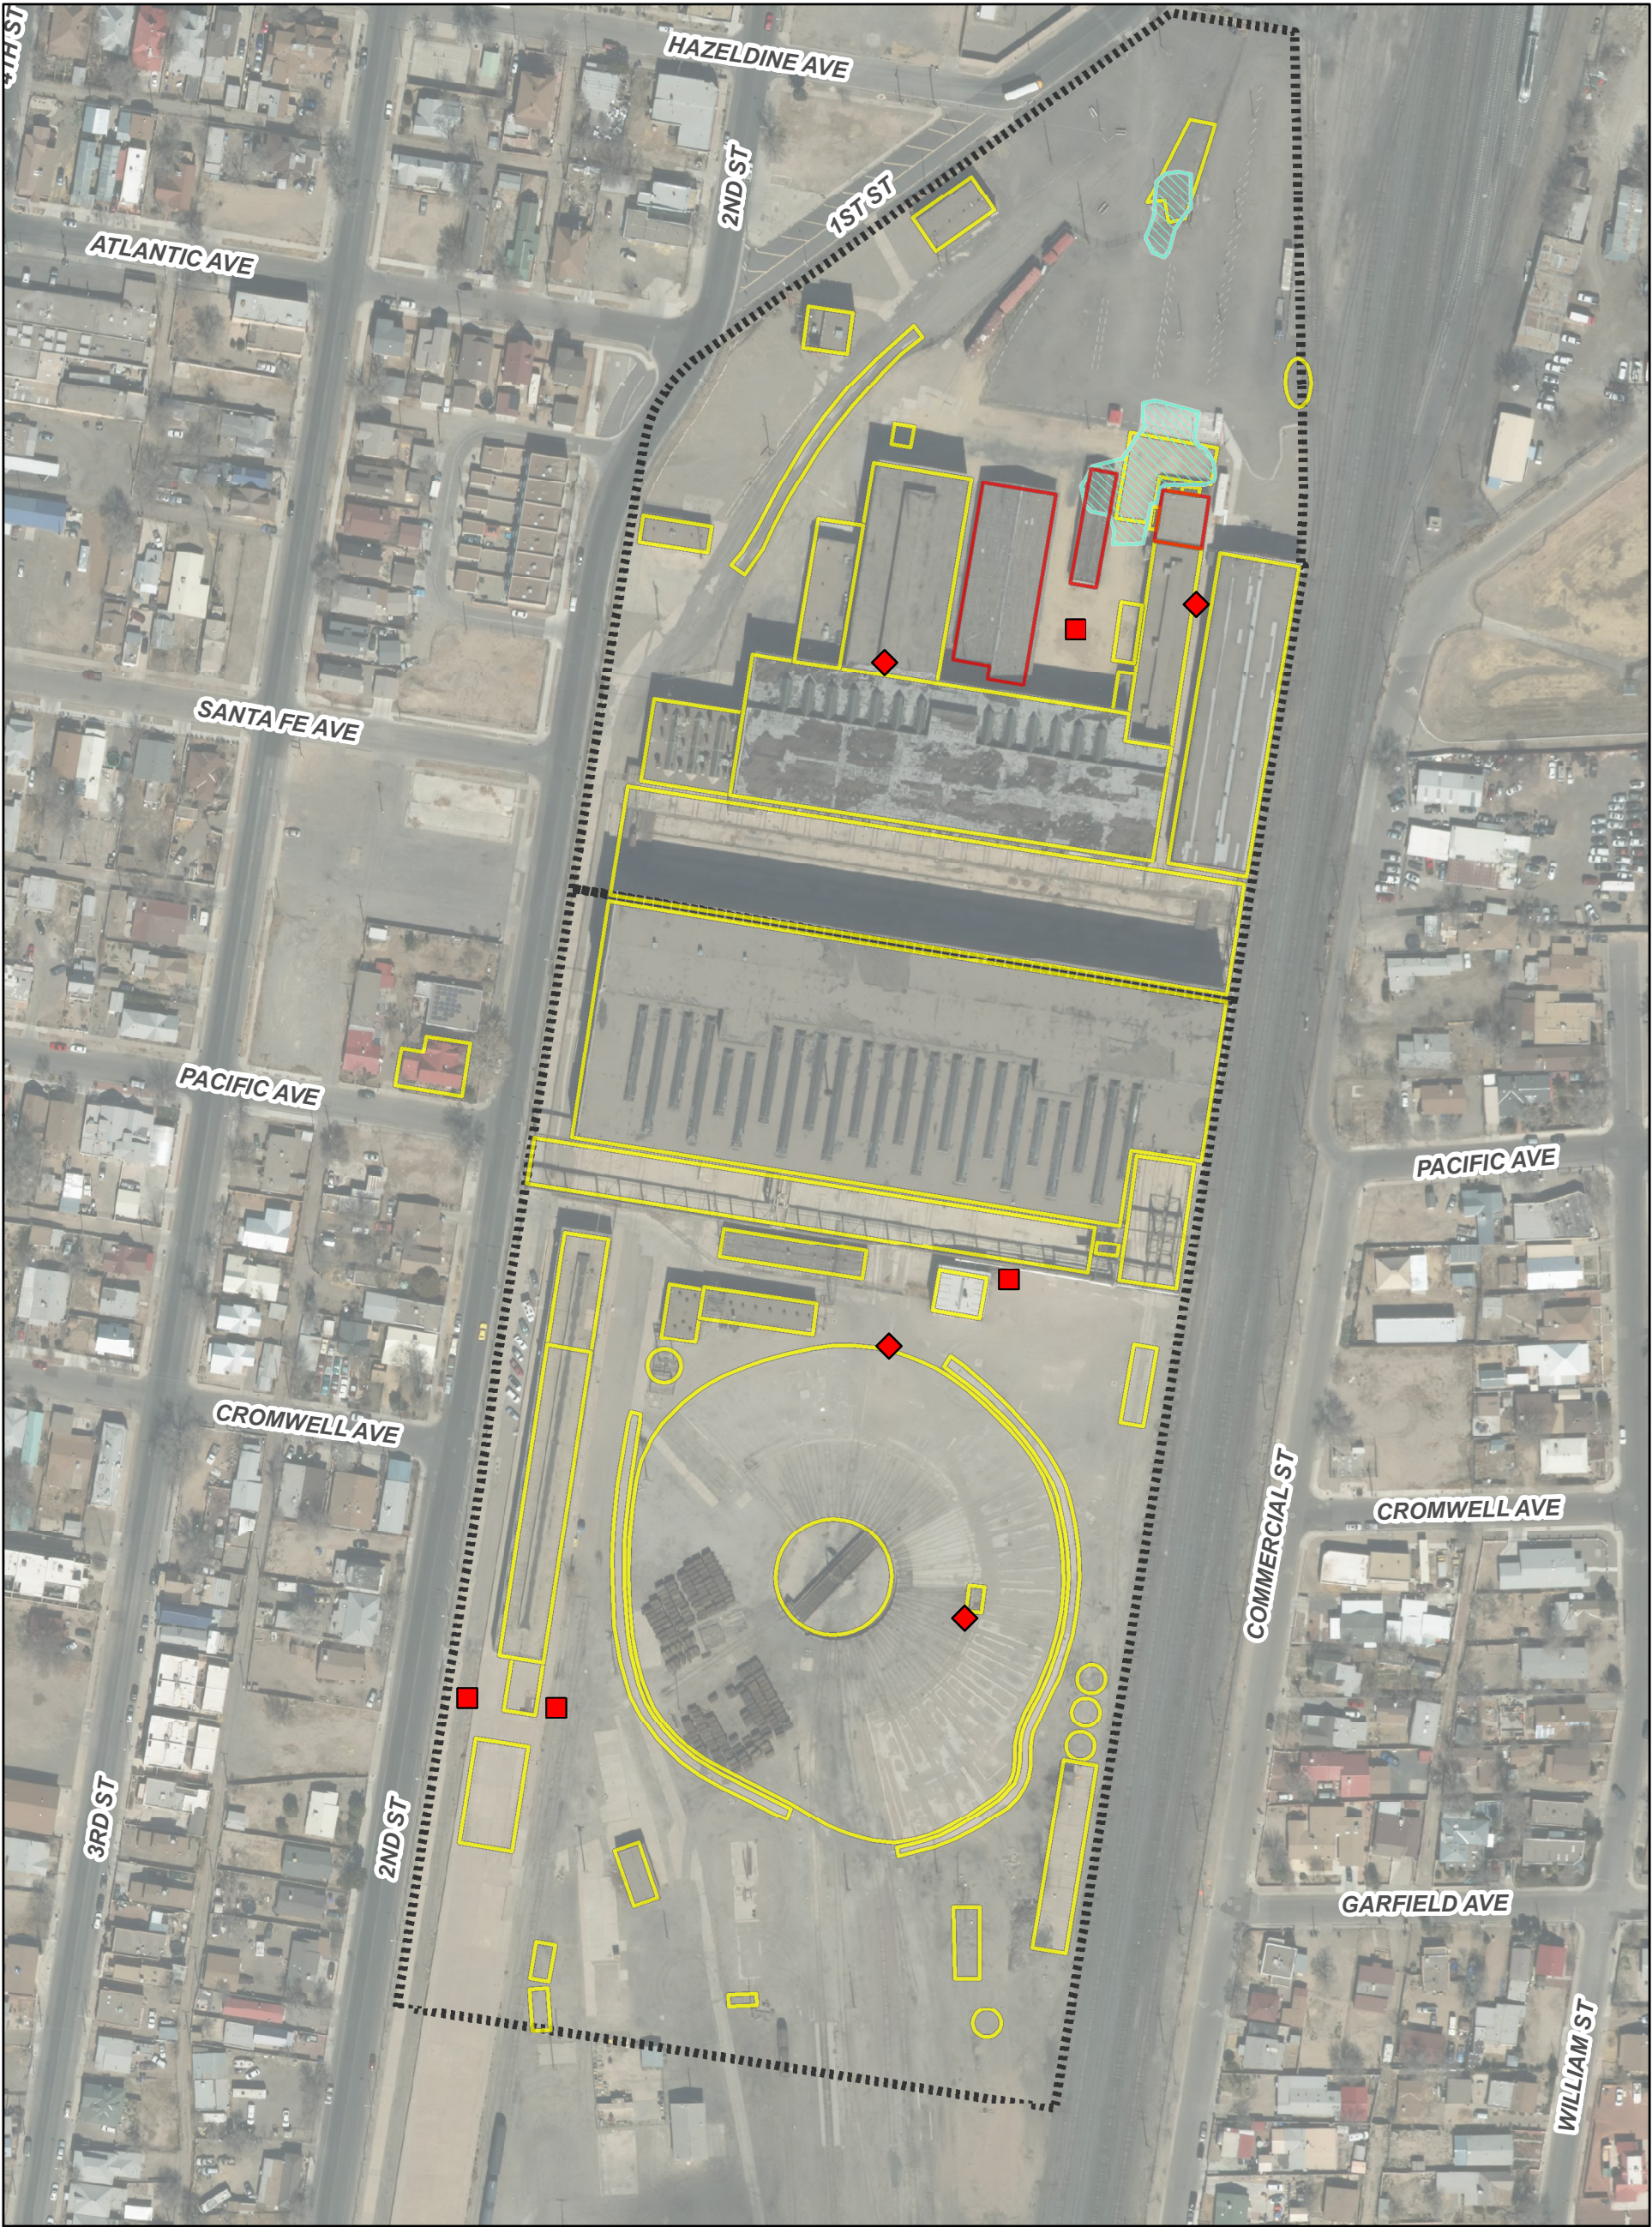
Figure 4c  
Residential SSL Exceedances  
(0-10 ft bgs), VOCs  
Soil Management Plan,  
Albuquerque Rail Yards,  
Albuquerque, New Mexico

Notes:  
Some sample depths include a portion greater than 10 ft bgs (i.e., sample interval = 8 - 12 ft bgs).  
SSL: Soil Screening Levels (NMED, 2019).  
VOCs: Volatile organic compounds  
VOC exceedances include: Benzo (a) anthracene, benzo (a) pyrene, benzo (b) fluoranthene, dibenzo (a, h) anthracene, and/or indeno (123, cd) pyrene.
