# **SOIL MANAGEMENT PLAN**

## **City of Albuquerque Rail Yards**

### **Albuquerque, Bernalillo County, New Mexico**

**July 16, 2020**

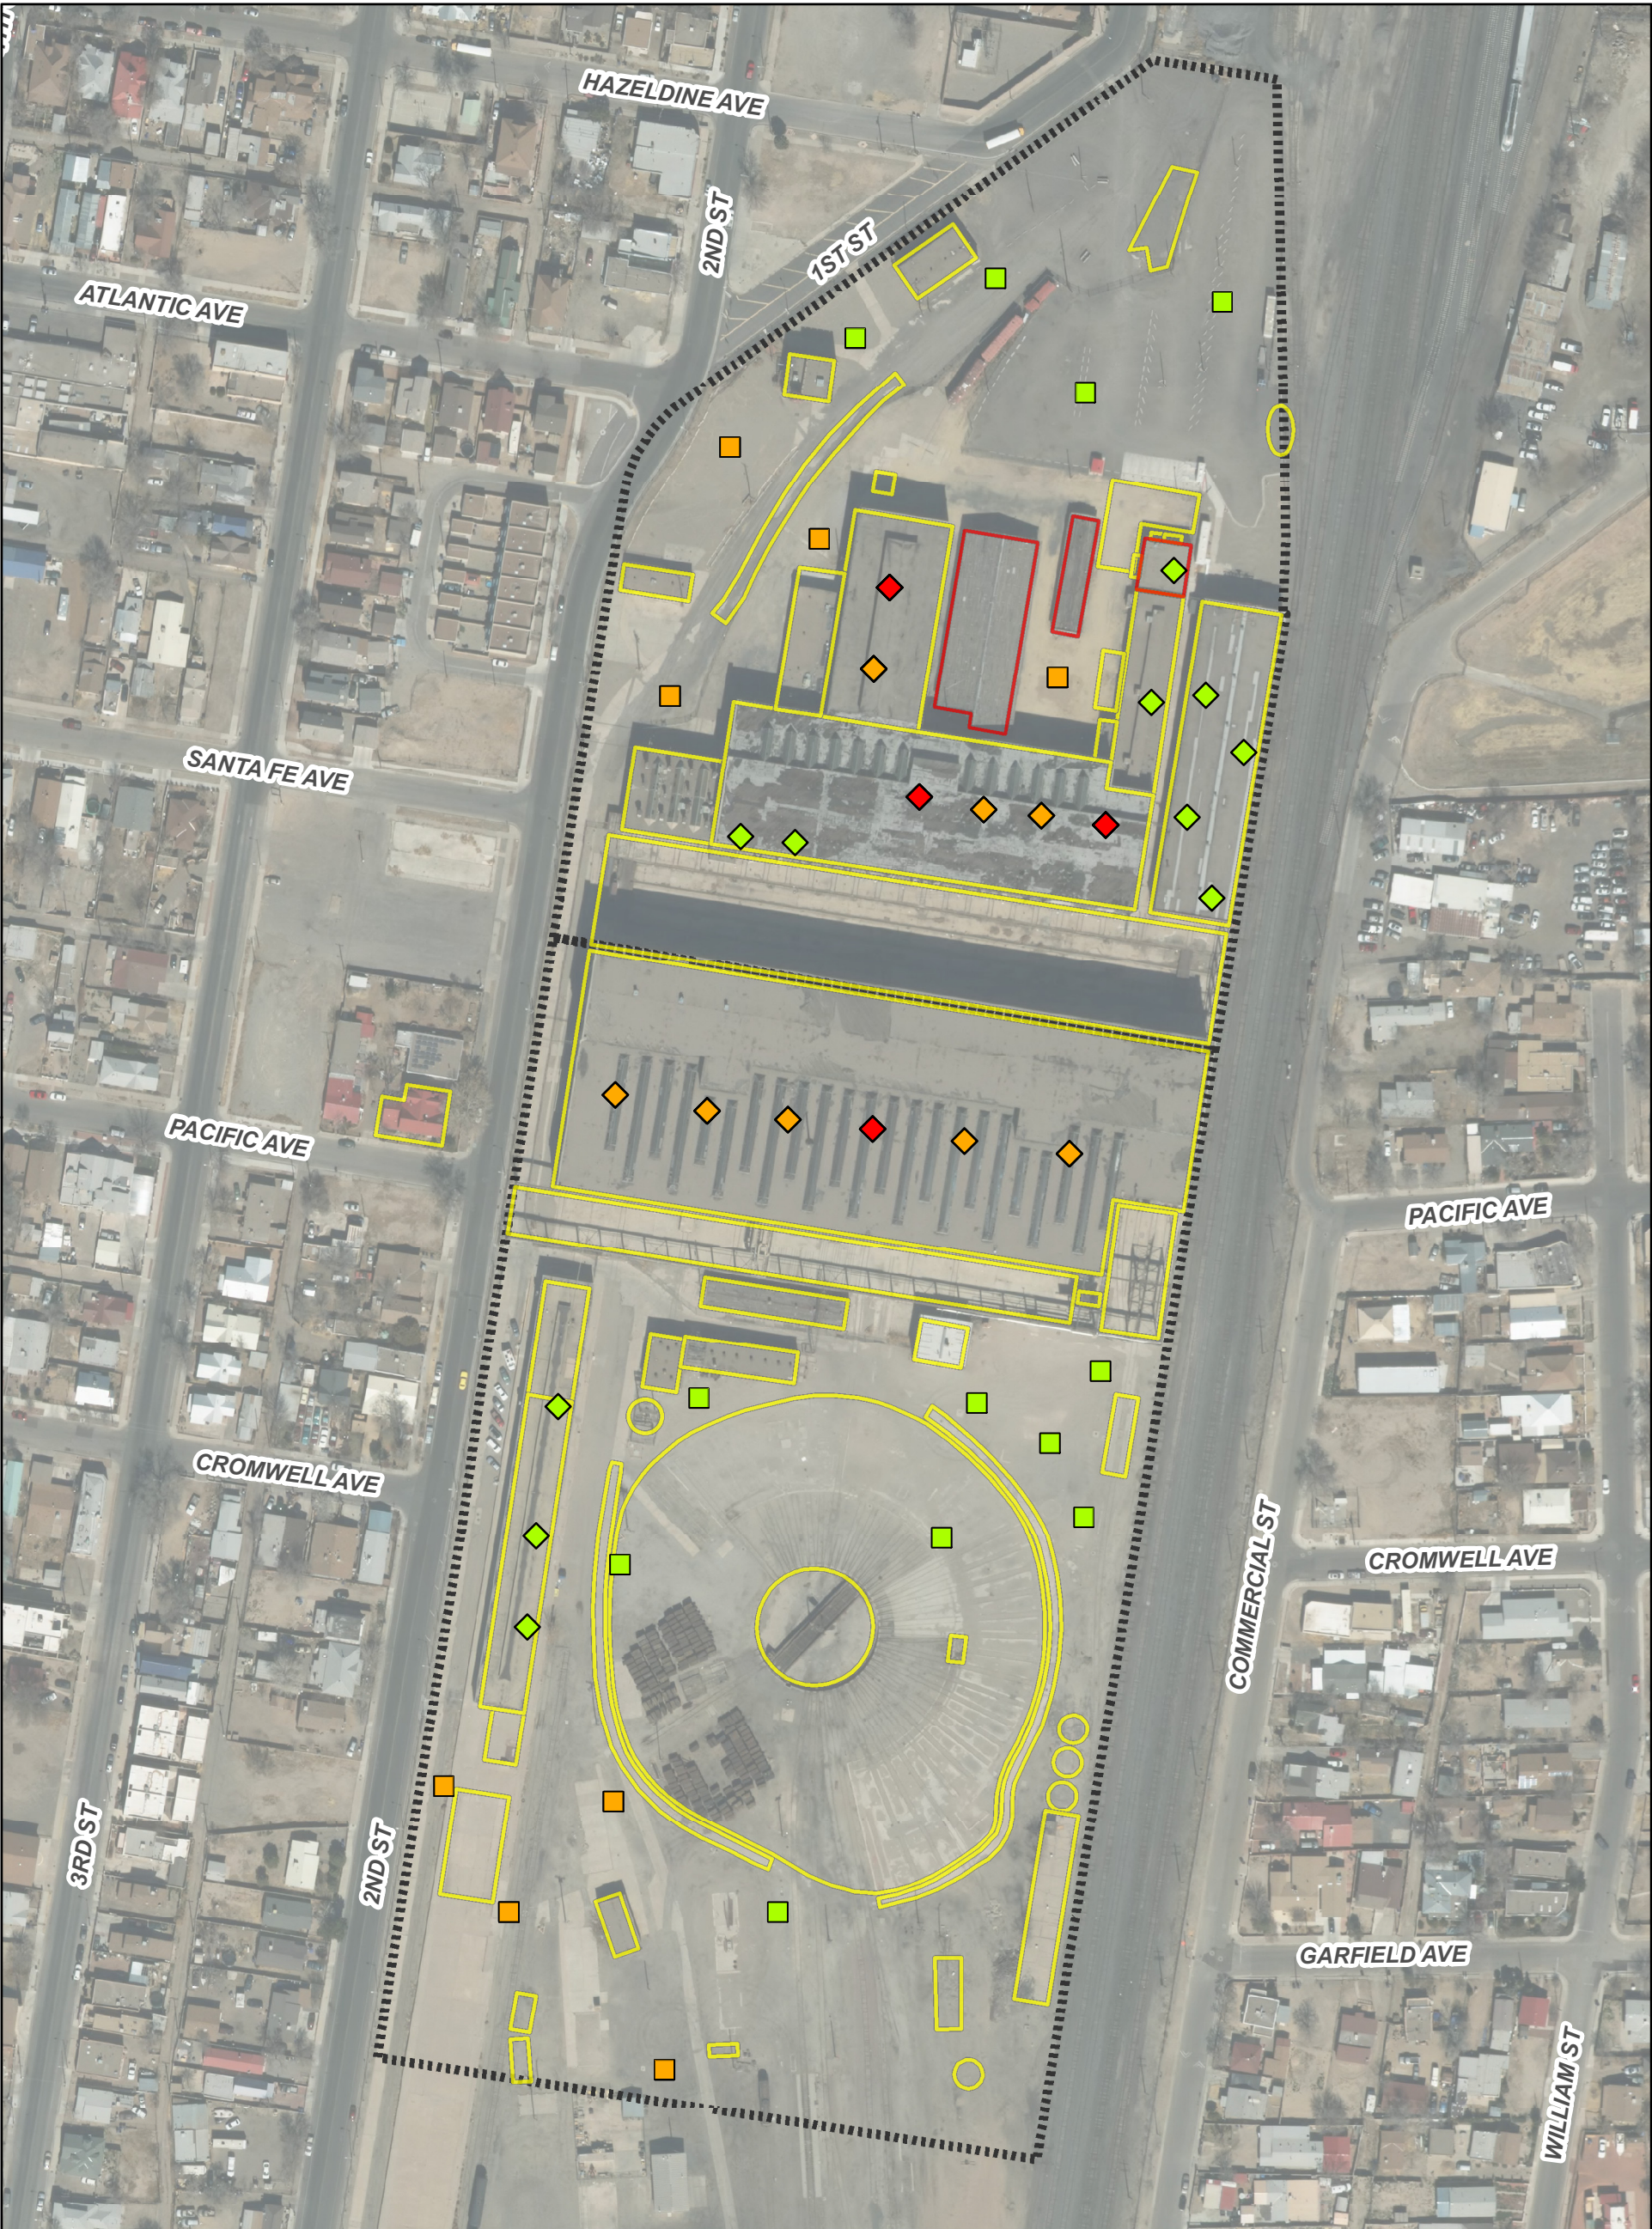
Figure 5a  
Naphthalene Soil Gas and Sub-Slab  
Soil Vapor Residential VISL Exceedance, 2016  
Soil Management Plan,  
Albuquerque Rail Yards,  
Albuquerque, New Mexico

Note: Some sample depths include a portion greater than 10 ft bgs  
(i.e., sample interval = 8 - 12 ft bgs).  
VISL: Vapor Intrusion Screening Levels (NMED, 2019)

identified as other Site COPCs for Site redevelopment activities. **Figure 5a** through **Figure 5d** illustrate where exceedances of soil vapor CPOCs exist on the Site.

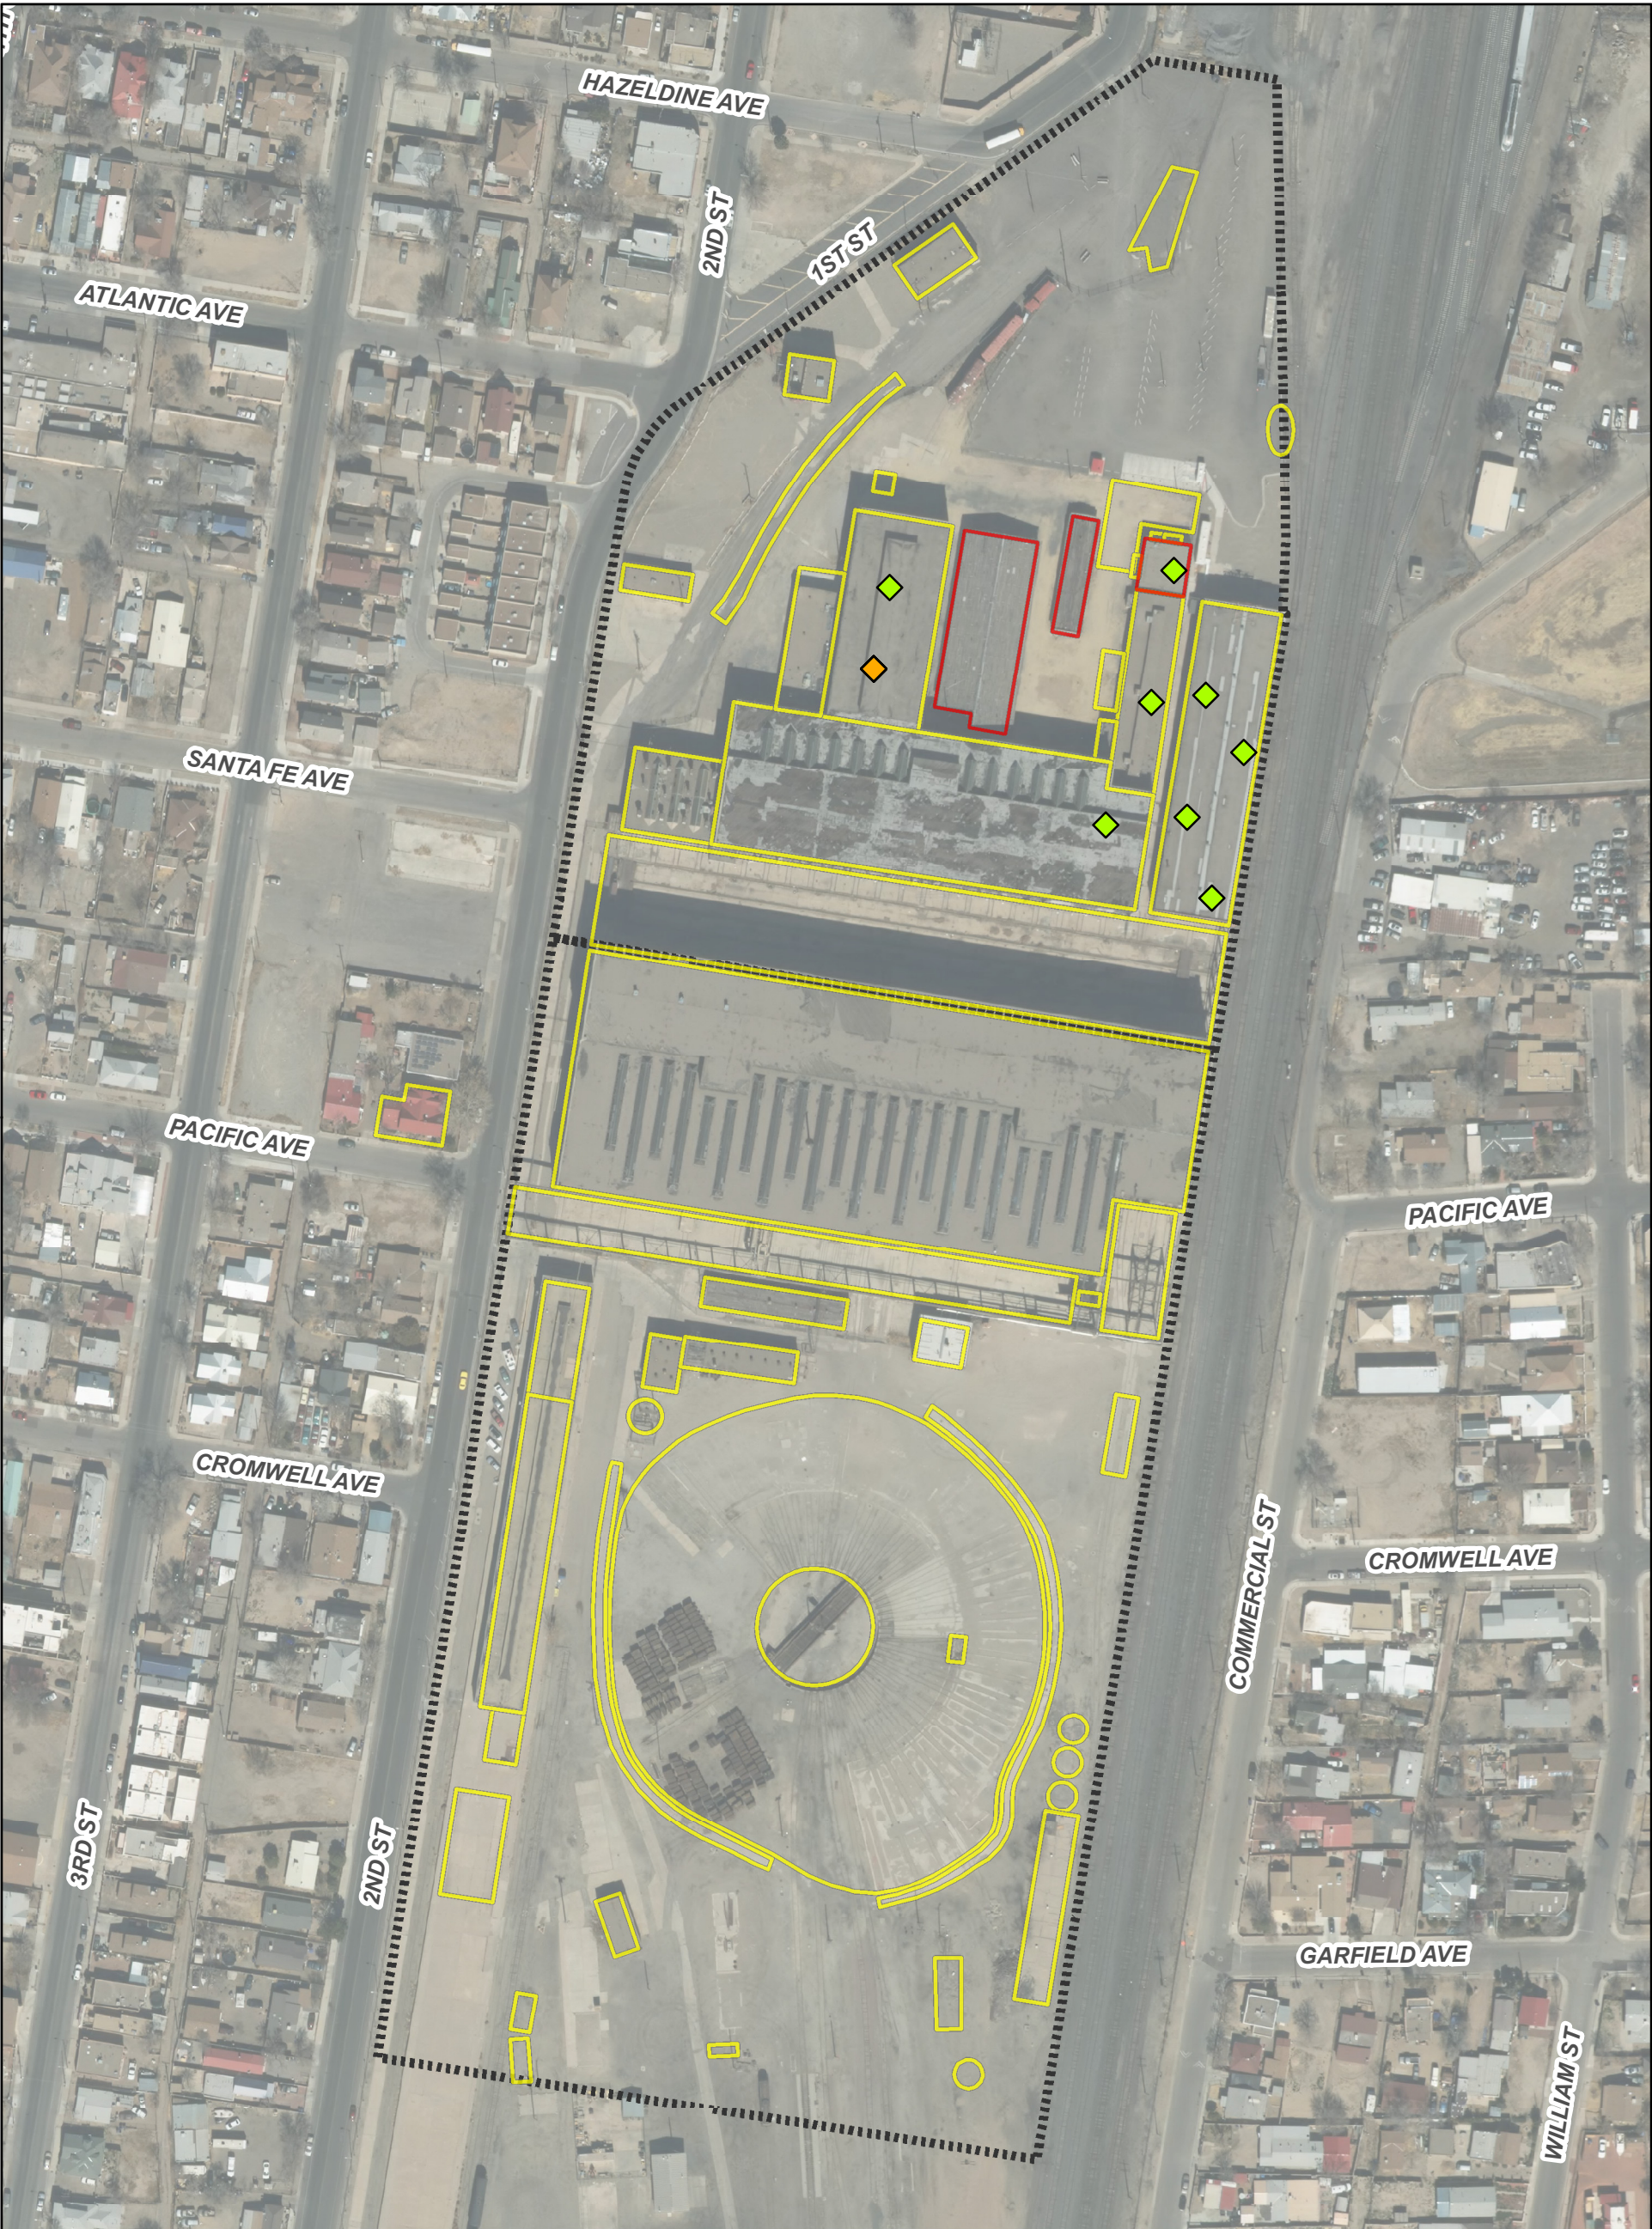
Figure 5b  
Naphthalene Soil Gas and Sub-Slab  
Soil Vapor Residential VISL Exceedance, 2018  
Soil Management Plan,  
Albuquerque Rail Yards,  
Albuquerque, New Mexico

Note: Some sample depths include a portion greater than 10 ft bgs  
(i.e., sample interval = 8 - 12 ft bgs).  
VISL: Vapor Intrusion Screening Levels (NMED, 2019)

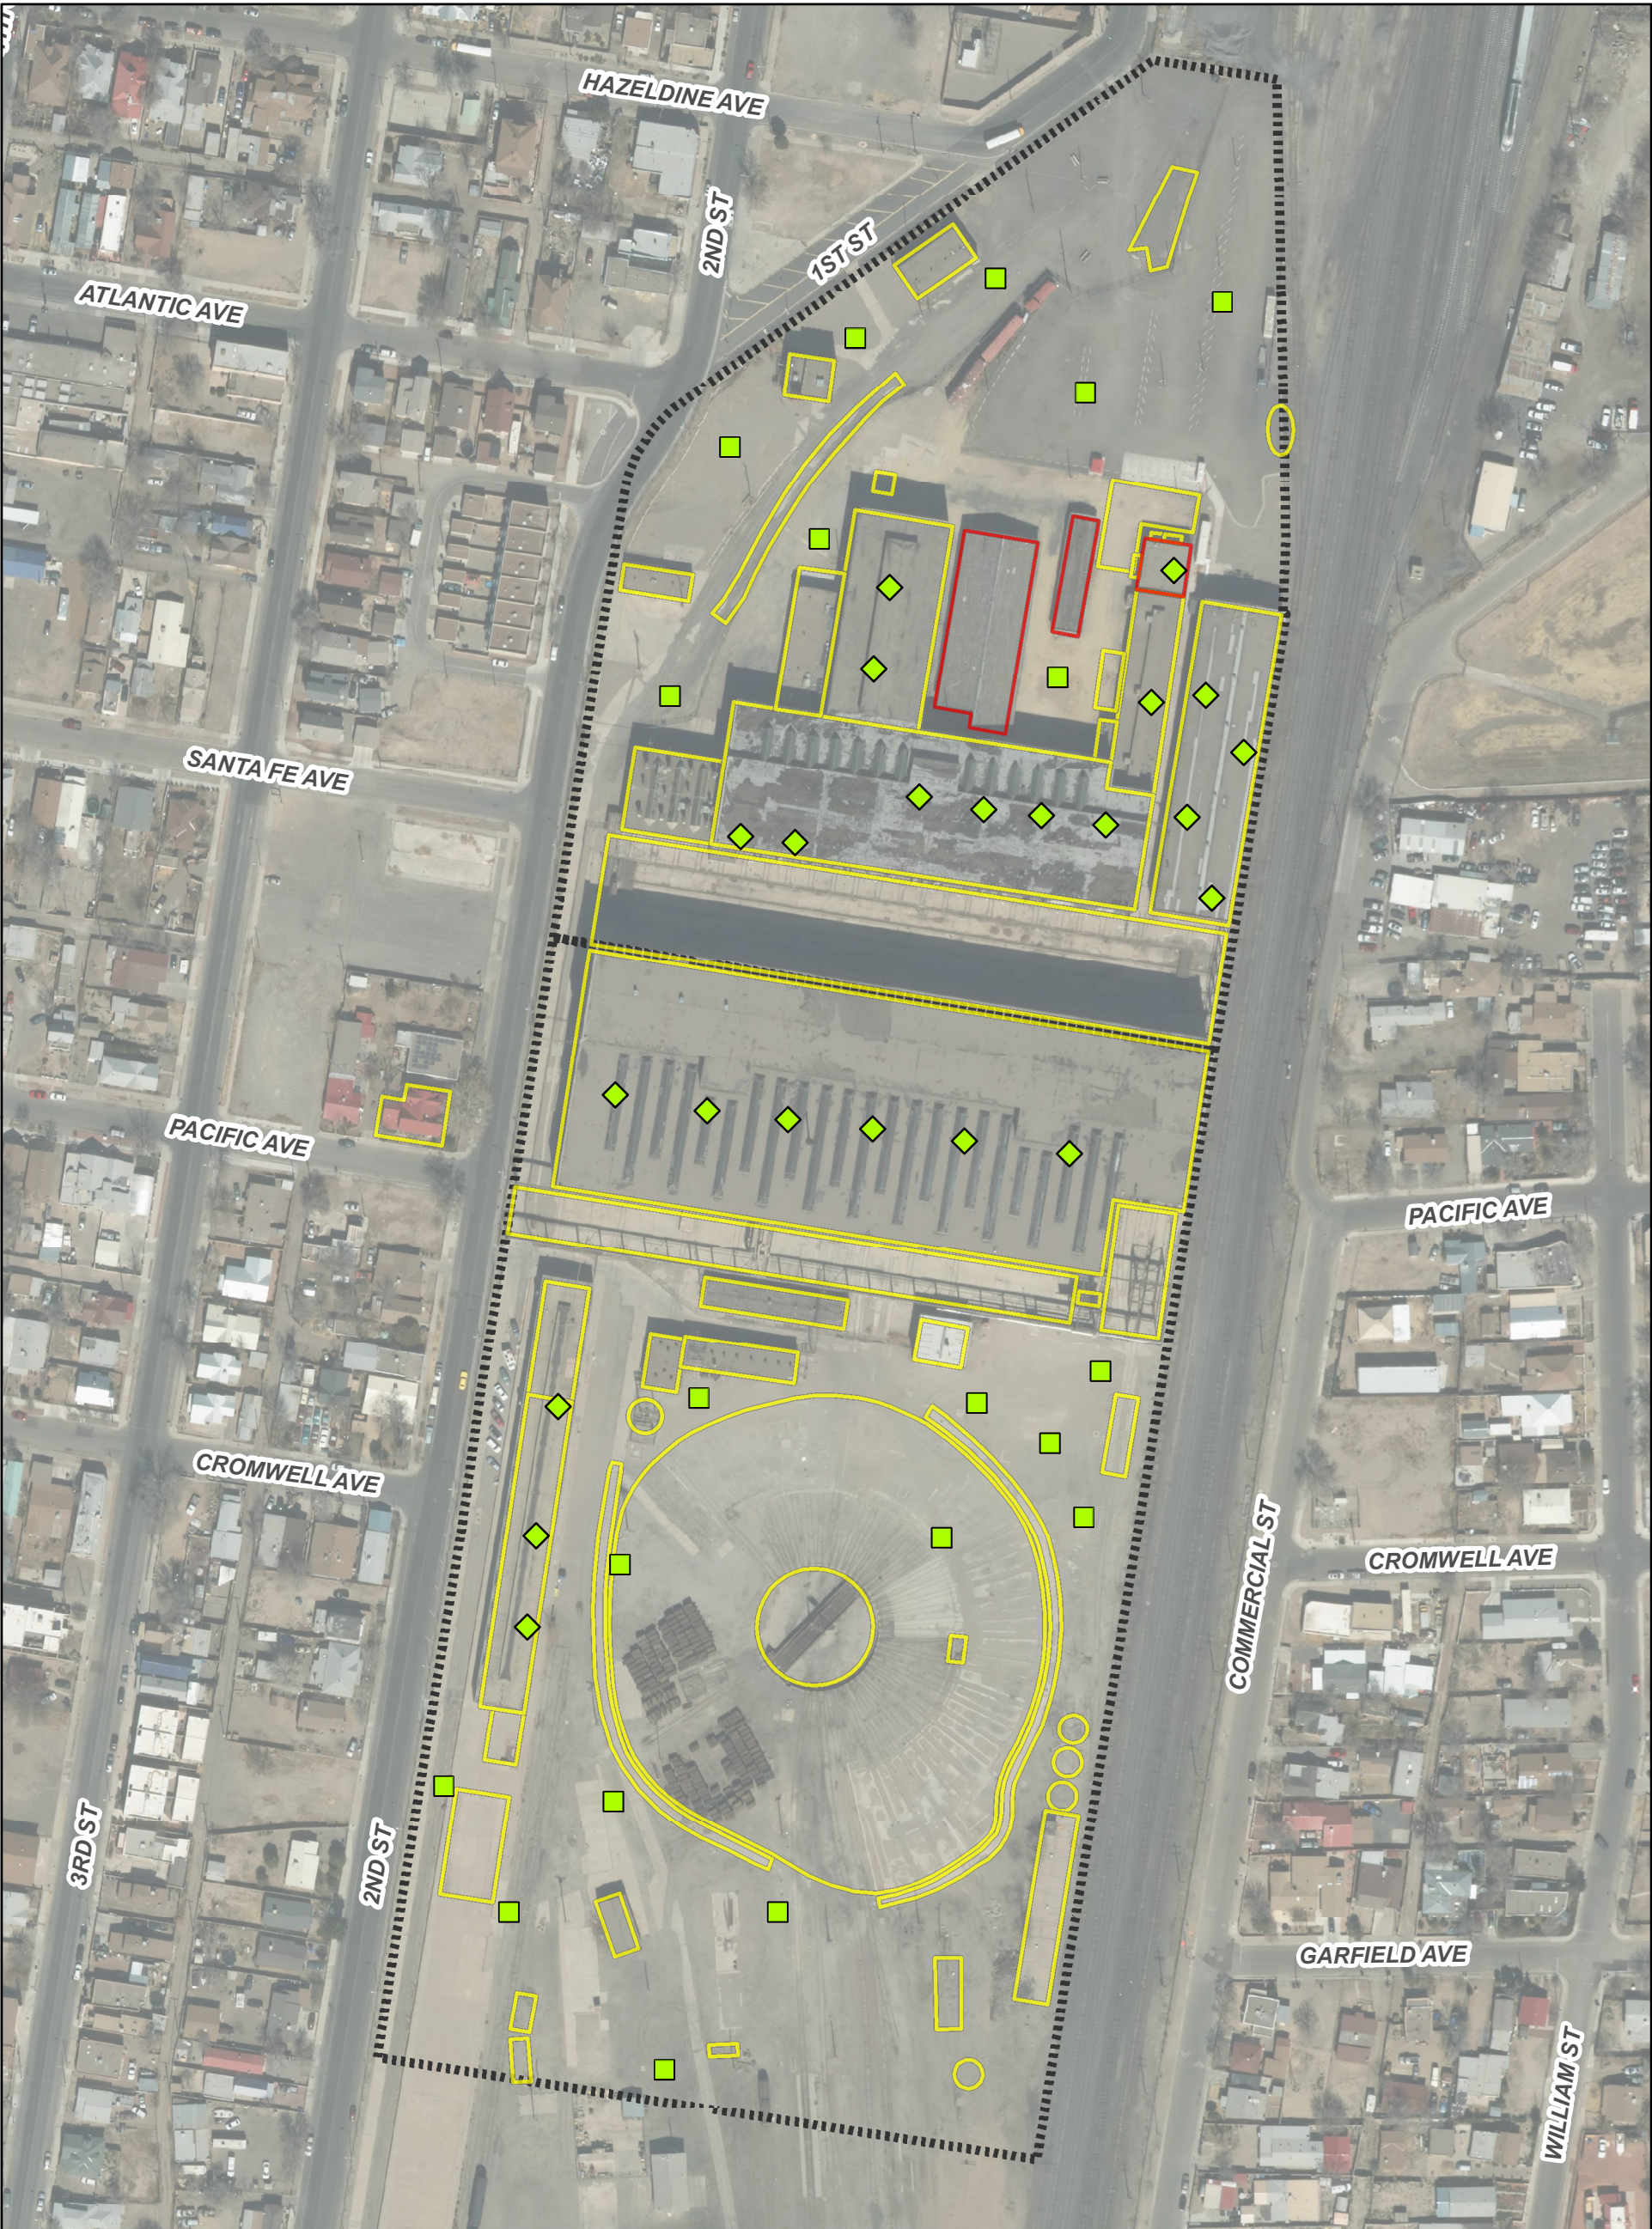
Figure 5c  
Trichloroethene Soil Gas and Sub-Slab  
Soil Vapor Residential VISL Exceedance, 2016  
Soil Management Plan,  
Albuquerque Rail Yards,  
Albuquerque, New Mexico

Note: Some sample depths include a portion greater than 10 ft bgs  
(i.e., sample interval = 8 - 12 ft bgs).  
VISL: Vapor Intrusion Screening Levels (NMED, 2019)

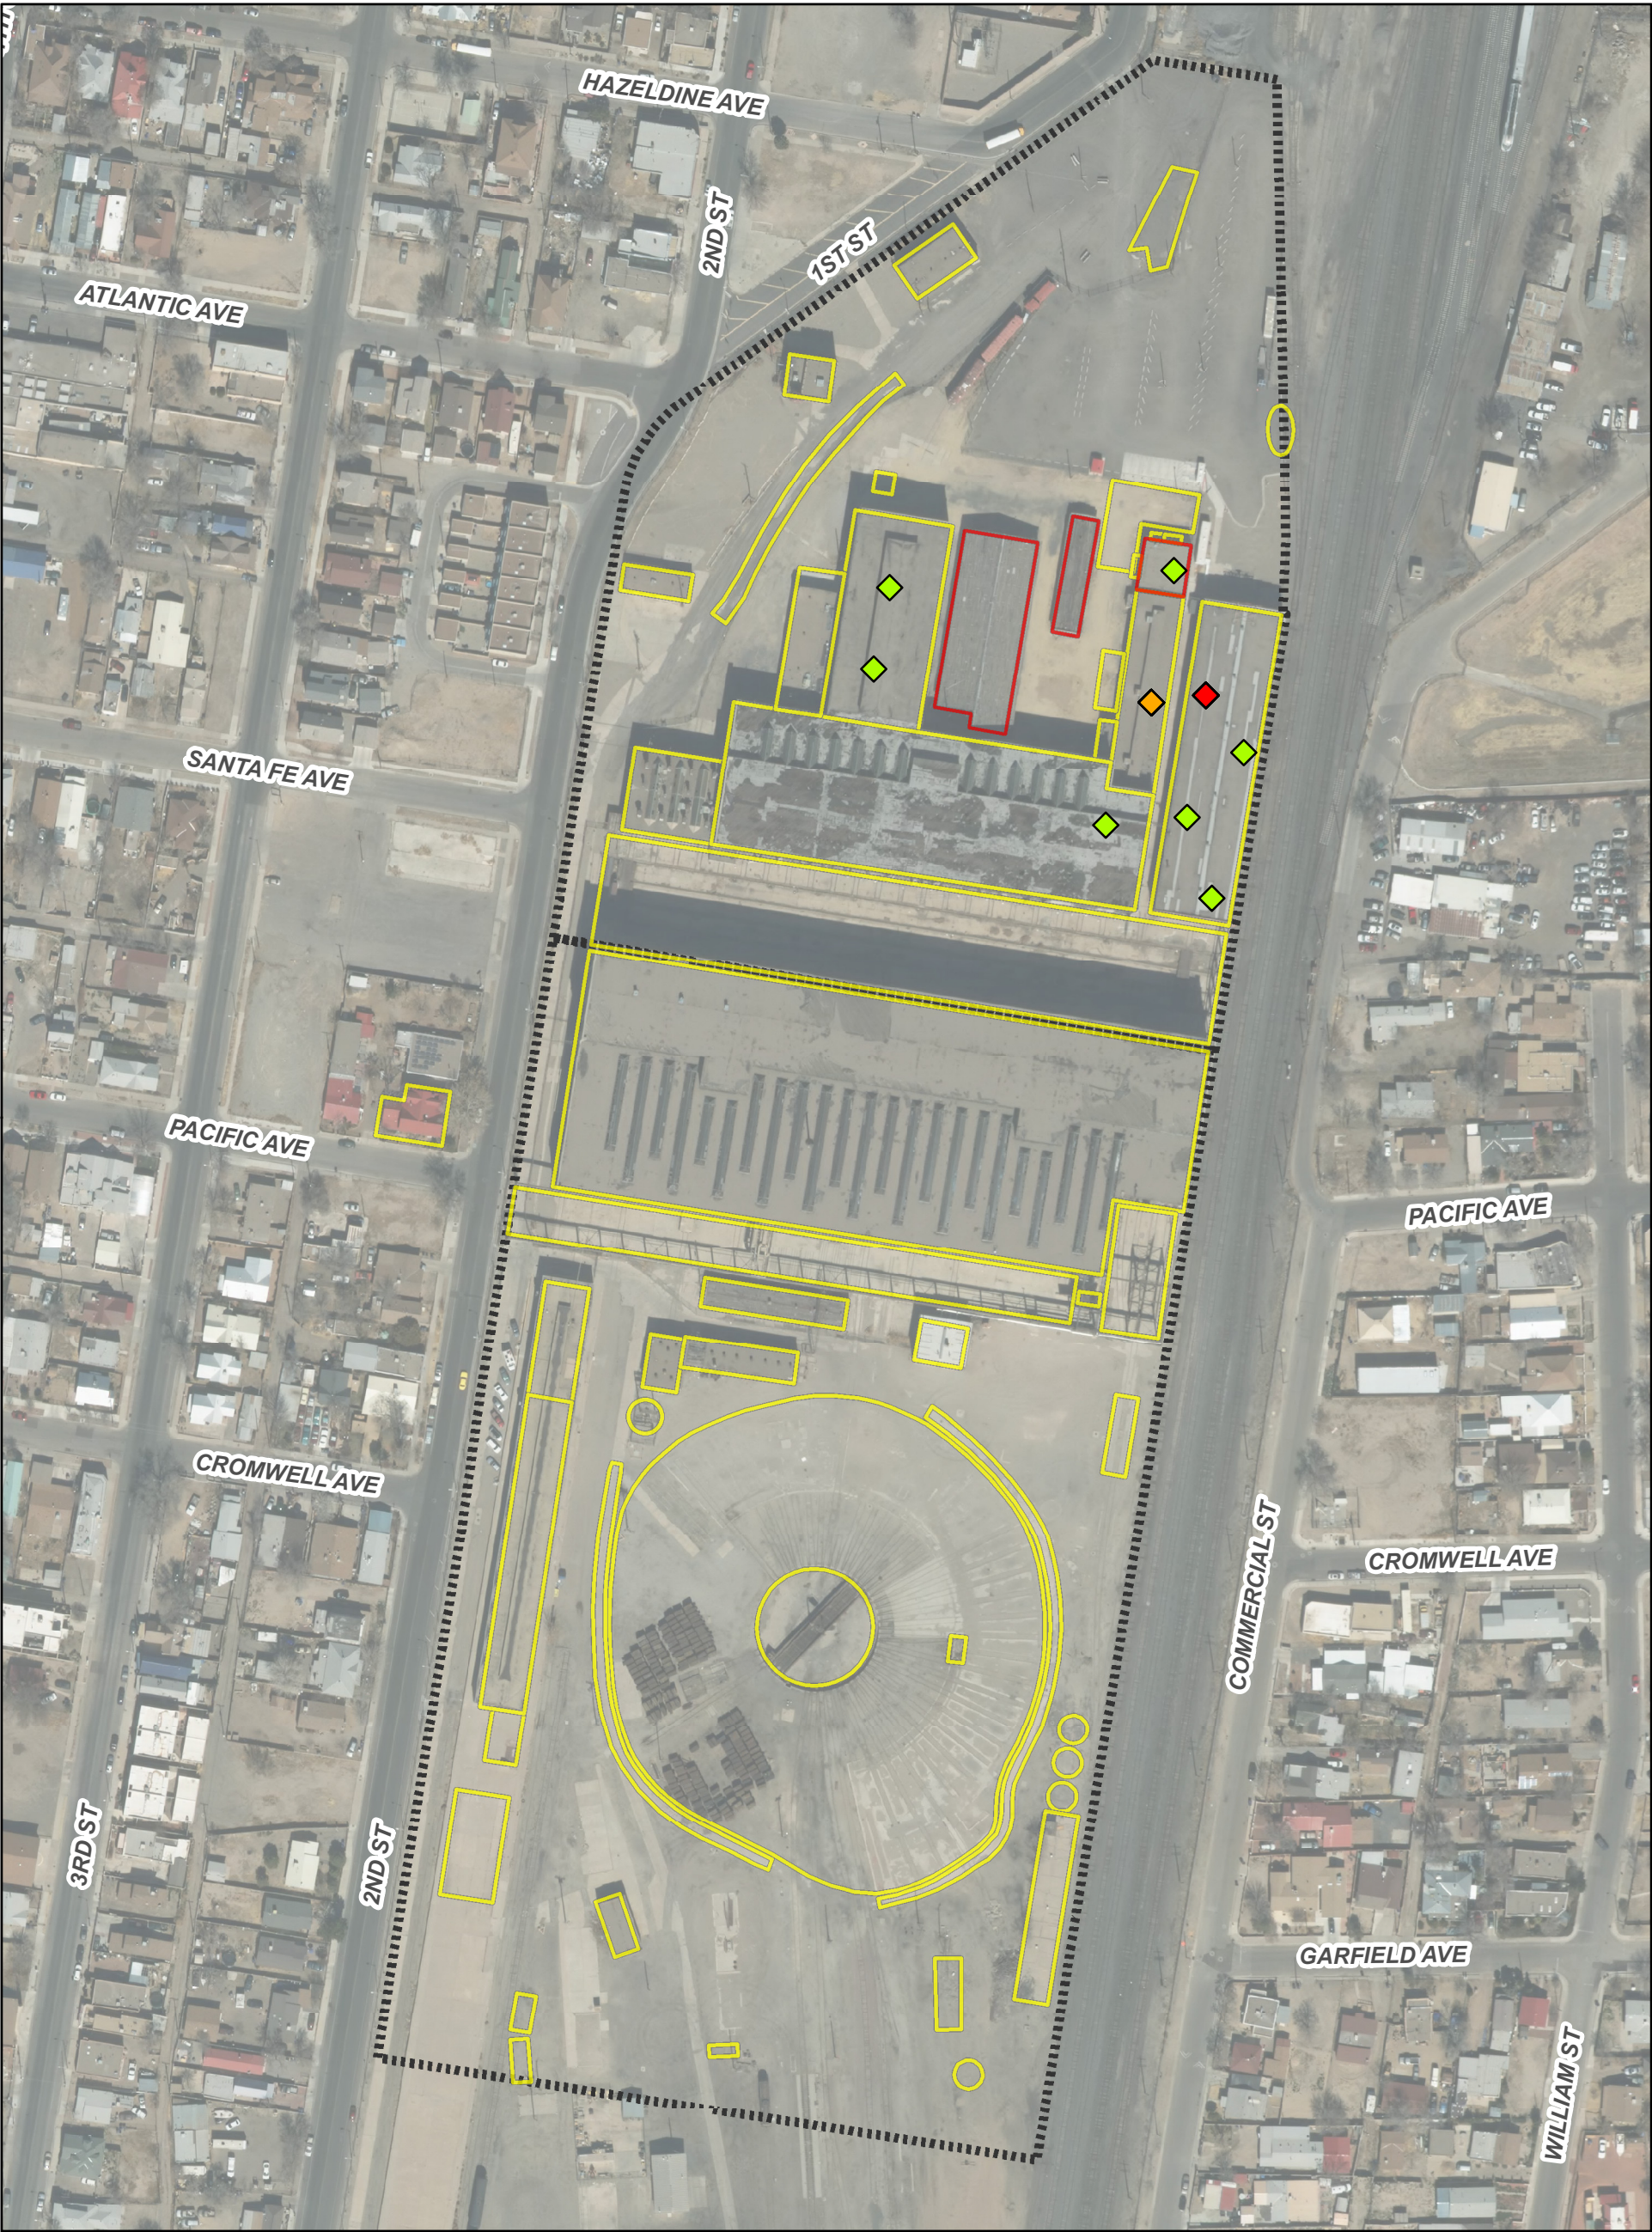
Figure 5d  
Trichloroethene Soil Gas and Sub-Slab  
Soil Vapor Residential VISL Exceedance, 2018  
Soil Management Plan,  
Albuquerque Rail Yards,  
Albuquerque, New Mexico

Note: Some sample depths include a portion greater than 10 ft bgs (i.e., sample interval = 8 - 12 ft bgs).  
VISL: Vapor Intrusion Screening Levels (NMED, 2019)

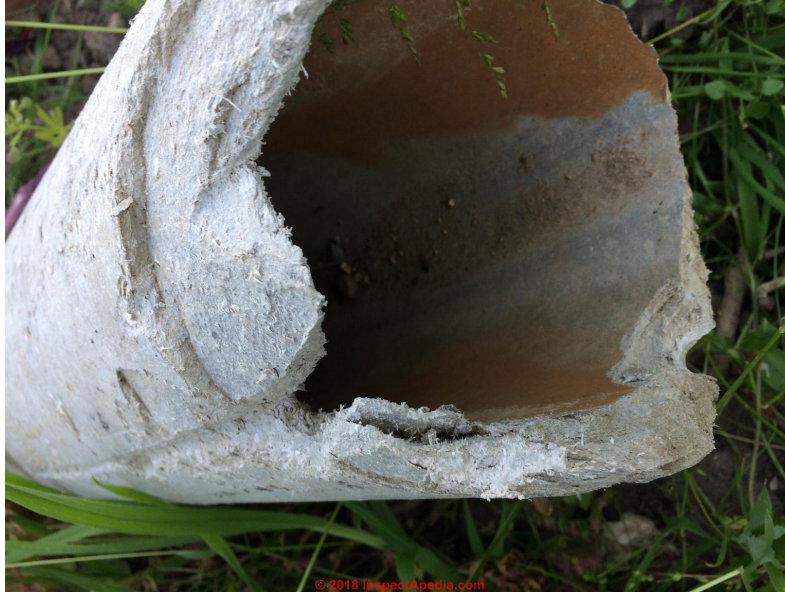
No. 1 – Example of transite pipe.

Transite pipe (pipe made from an asbestos-cement material) was identified in the subsurface near transformers located south of the Babbitt Shop (**Figure 2**). Samples of the Transite pipe contained 25% to 30% asbestos (Terracon, 2005). The pipe appeared to be the remnant of piping used for hot/cold water used throughout the main buildings. It is unclear whether any Transite pipe has been removed from the COA Rail Yards and therefore any future excavation activities must proceed with caution and be aware that this material may be encountered. Photograph examples of Transite pipe are included in **Appendix A**.

It is not anticipated that buried solid waste or debris will be encountered at the Site during construction activities; however, should it be encountered, this material should be observed for the presence of contaminated material and segregated from excavated soil as practicable. Asbestos containing Transite pipe was historically identified in the southern portion of the Site, just south of the Babbitt Shop (**Figure 2**). During all excavation activities, but especially in the area to the south of the Babbitt Shop, be cautious that encountering buried Transite pipe is possible. If any buried piping is encountered, it should be handled with care to prevent as much damage as possible and segregated from excavated soil. The COA will then evaluate the removed piping for the presence of asbestos, either by sampling or visual observation, and then coordinate for appropriate disposal. Please see **Appendix A** that includes example photographs of Transite pipe.
