# Annual Report Format

## National Pollutant Discharge Elimination System Stormwater Program MS4 Annual Report Format

NMR04A014 City of Albuquerque

What is the reporting period for this report? (mm/dd/yyyy) From 2023-07-01 to 2024-06-30

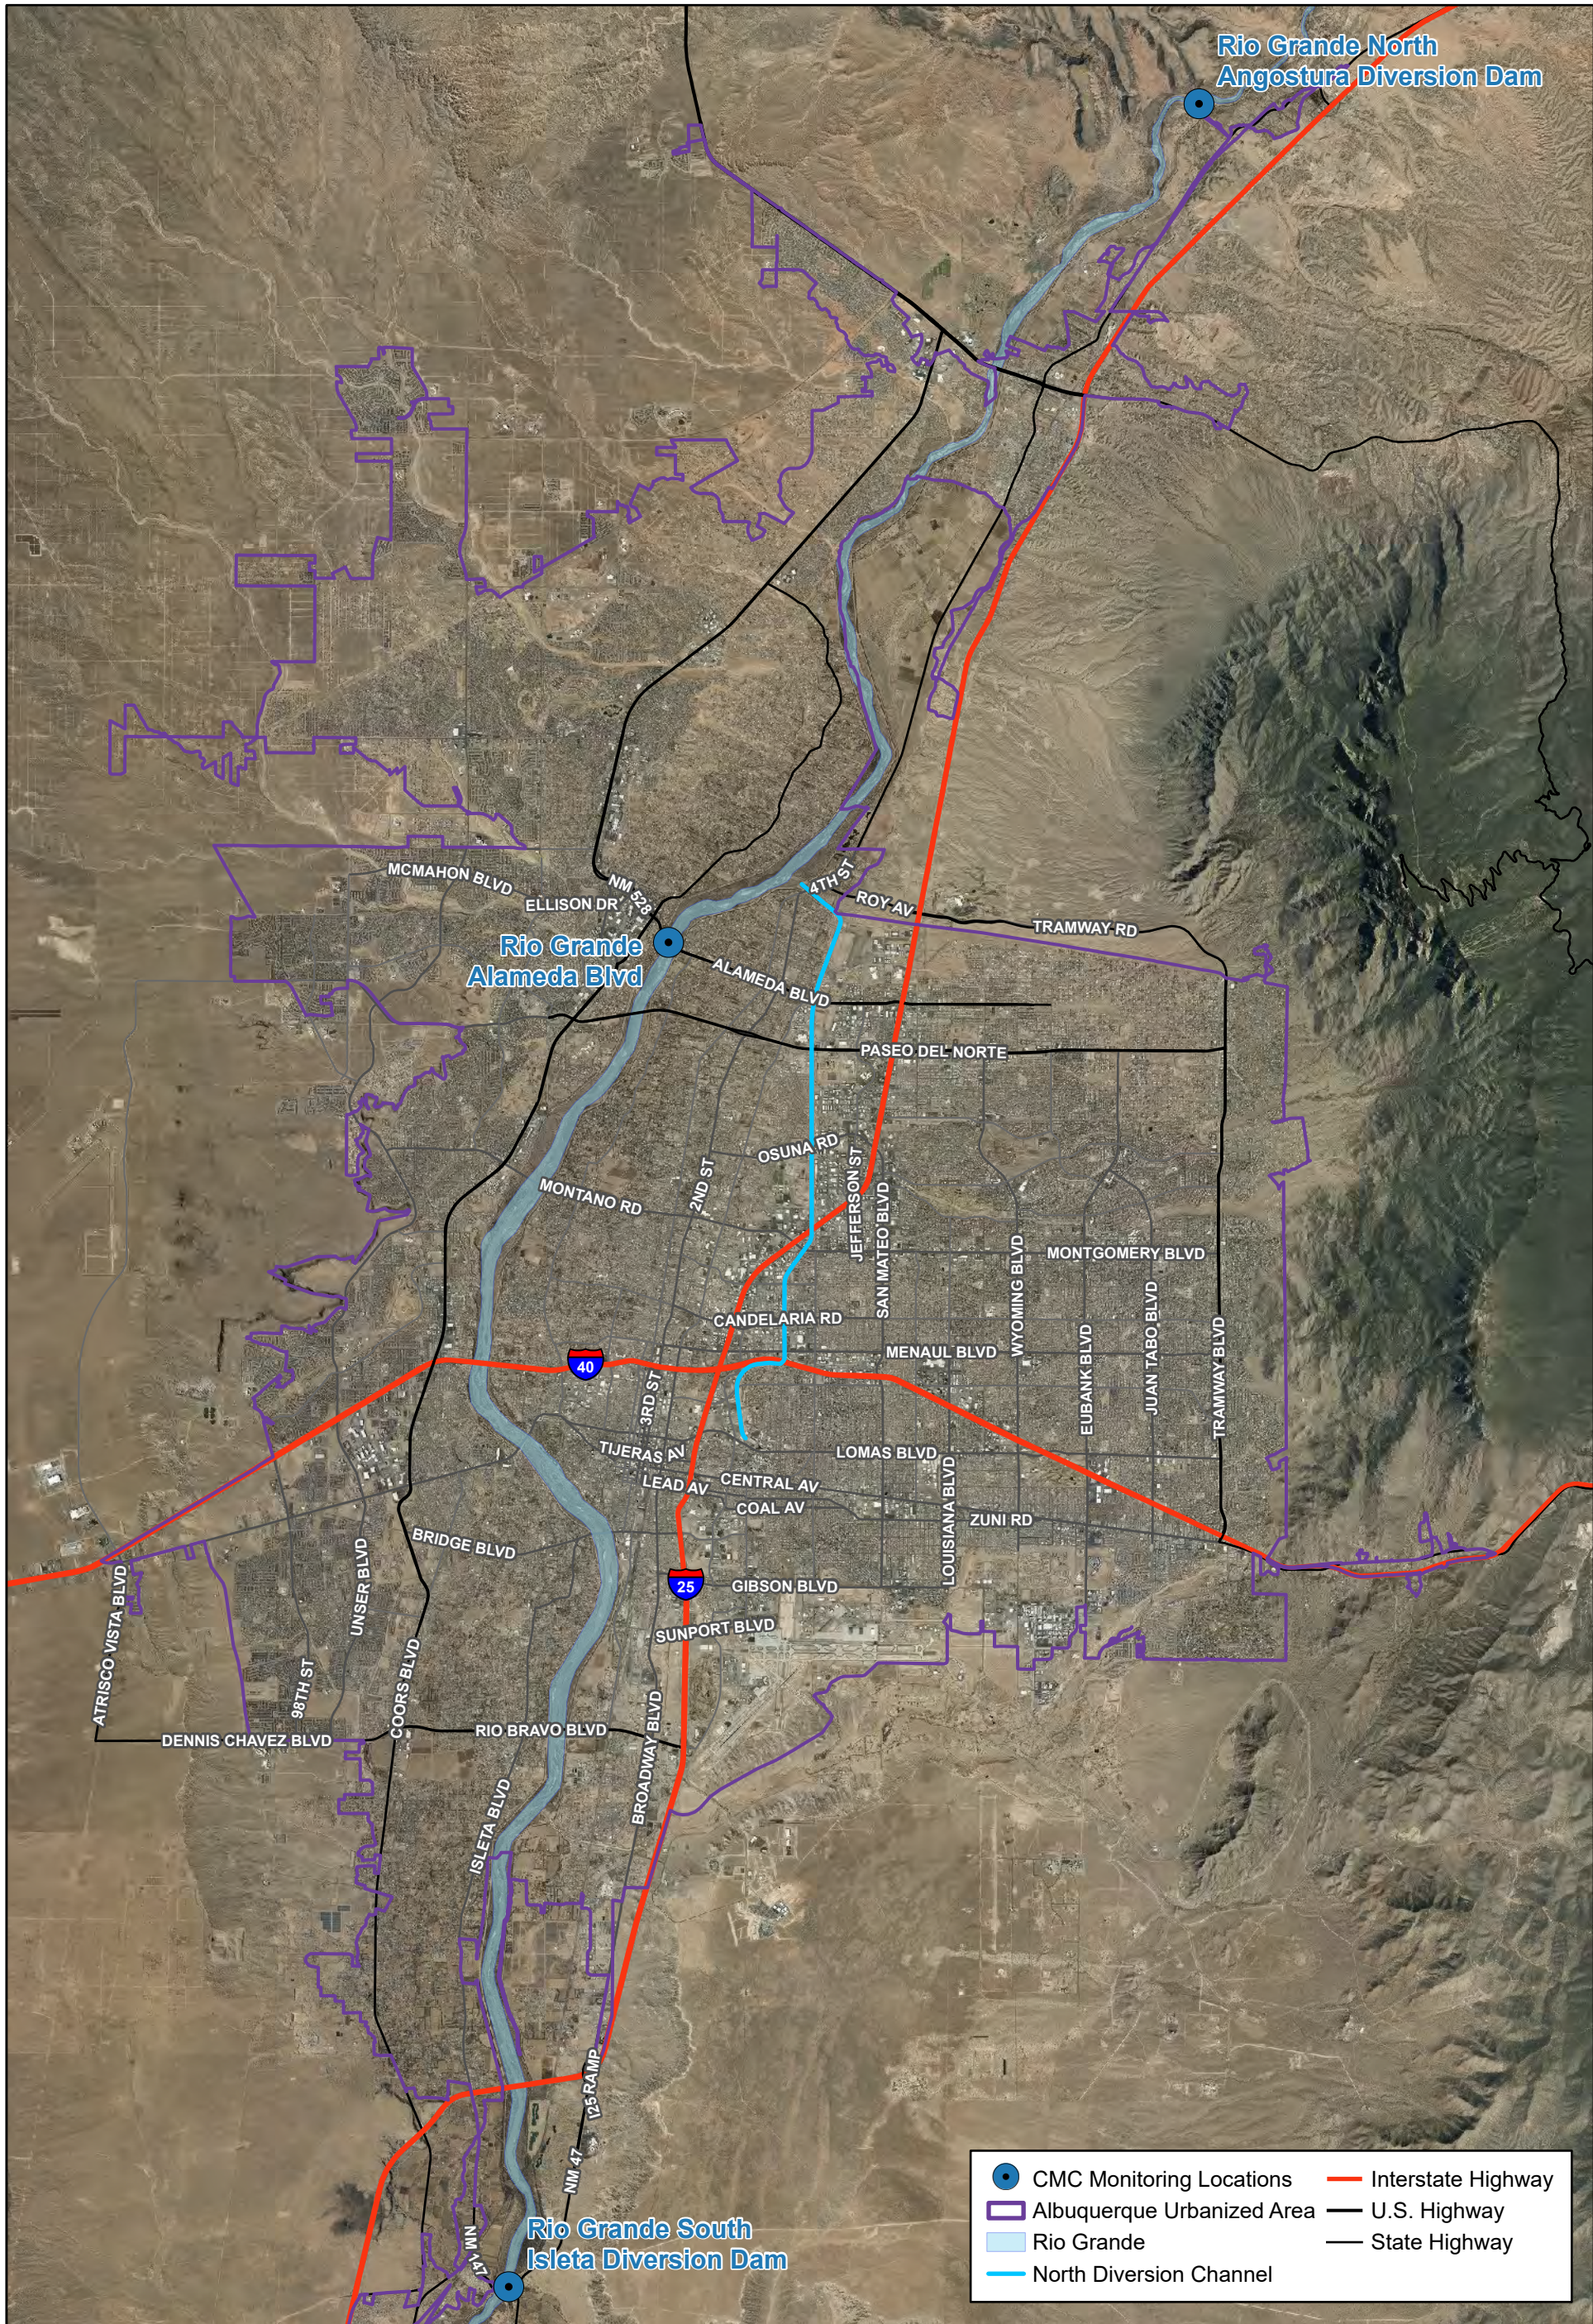
**Figure 1**  
**Monitoring Locations**

Rio Grande North – In-stream sampling within the Rio Grande was performed upstream of the Angostura Diversion Dam at the north end of the watershed. The location is upstream of all inputs from the Urban Area (UA) to the river and provides the background water conditions.

Rio Grande South – In-stream sampling within the Rio Grande was performed at the Isleta Bridge at the south end of the watershed. The location is downstream of all inputs from the UA to the river and provides the downstream water conditions. These locations have been accepted by EPA and the New Mexico Environment Department (NMED) to meet the WSB MS4 Permit requirements in Part III.A.

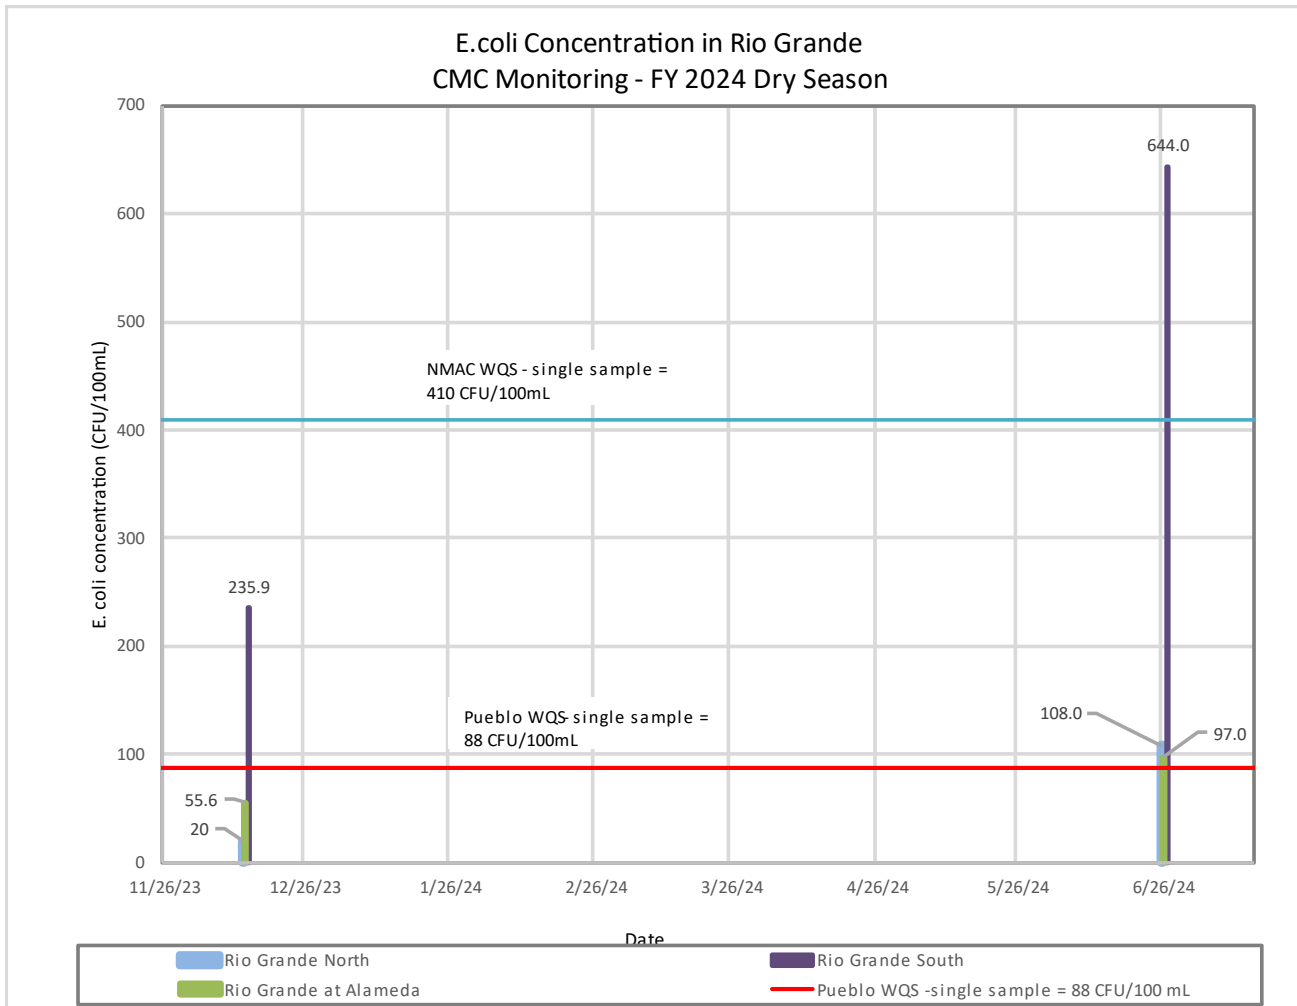
**Figure 2: E. coli Monitoring Results in Rio Grande CMC Monitoring – FY 2024 Dry Season**

As a reminder, in January 2017 the CMC members clarified with NMED that the units MPN/100 mL and CFU/100 mL are considered to be interchangeable for the purposes of this stormwater quality monitoring reporting. The New Mexico and Pueblo of Isleta WQSs for E. coli are currently in units of CFU/100 mL, while the lab reports are typically in units of MPN/100mL. The graph presented in this section uses units of CFU/100 mL to be consistent with the WQS units. Refer to Figure 2 for a graphical representation of E. coli results from December 2023 through June 2024.

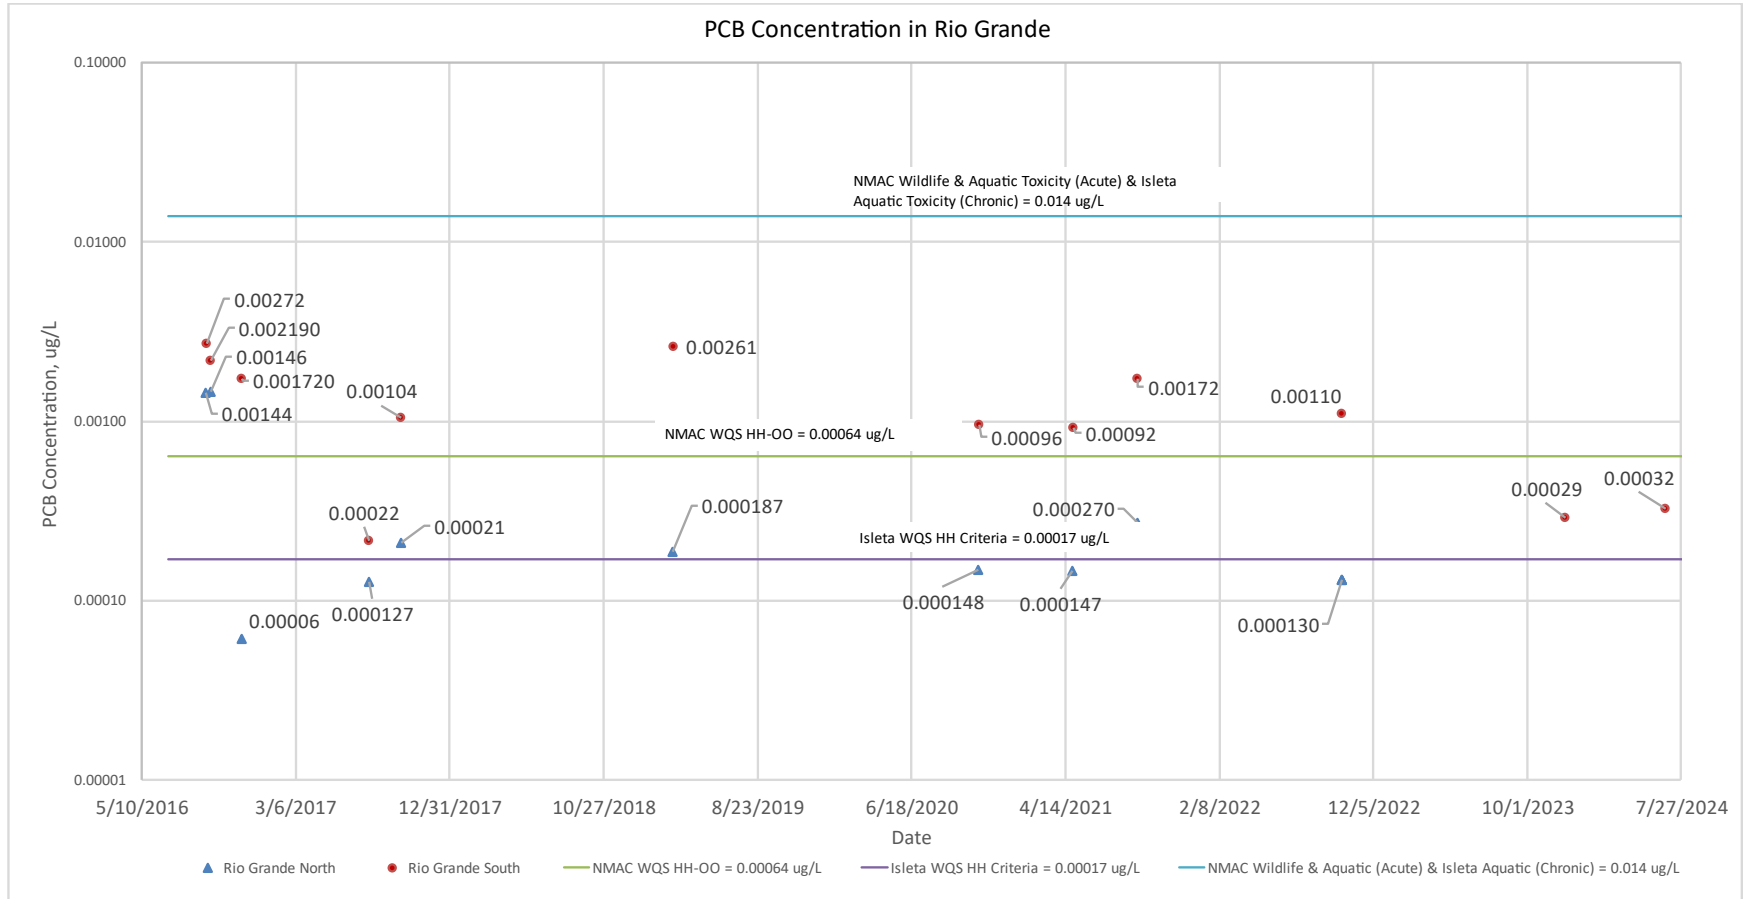
**Figure 3: PCB Monitoring Results in Rio Grande  
 CMC Monitoring – 2016 - 2024**

There are multiple surface WQS values listed for PCBs in both the Pueblo of Isleta and the State of New Mexico standards for the various designated uses. The PCB results for samples collected from the Rio Grande during the FY 2024 dry season stormwater events were below the minimum quantification level (MQL) established in EPA standards for the MS4 NPDES Permit (Appendix F, 0.2 ug/L for PCBs). PCBs were not detected for the both the December 2023 and June 2024 Rio Grande North samples. However, both samples from the Rio Grande South location were above the Pueblo of Isleta human health criteria (based on fish consumption only) WQS for surface waters. The human health-organism only criterion is based upon human consumption of fish and other aquatic life that bioaccumulate contaminants over time. The PCB results from 2016 through 2024 are shown in Figure 3, relative to several of the WQSs for PCBs.

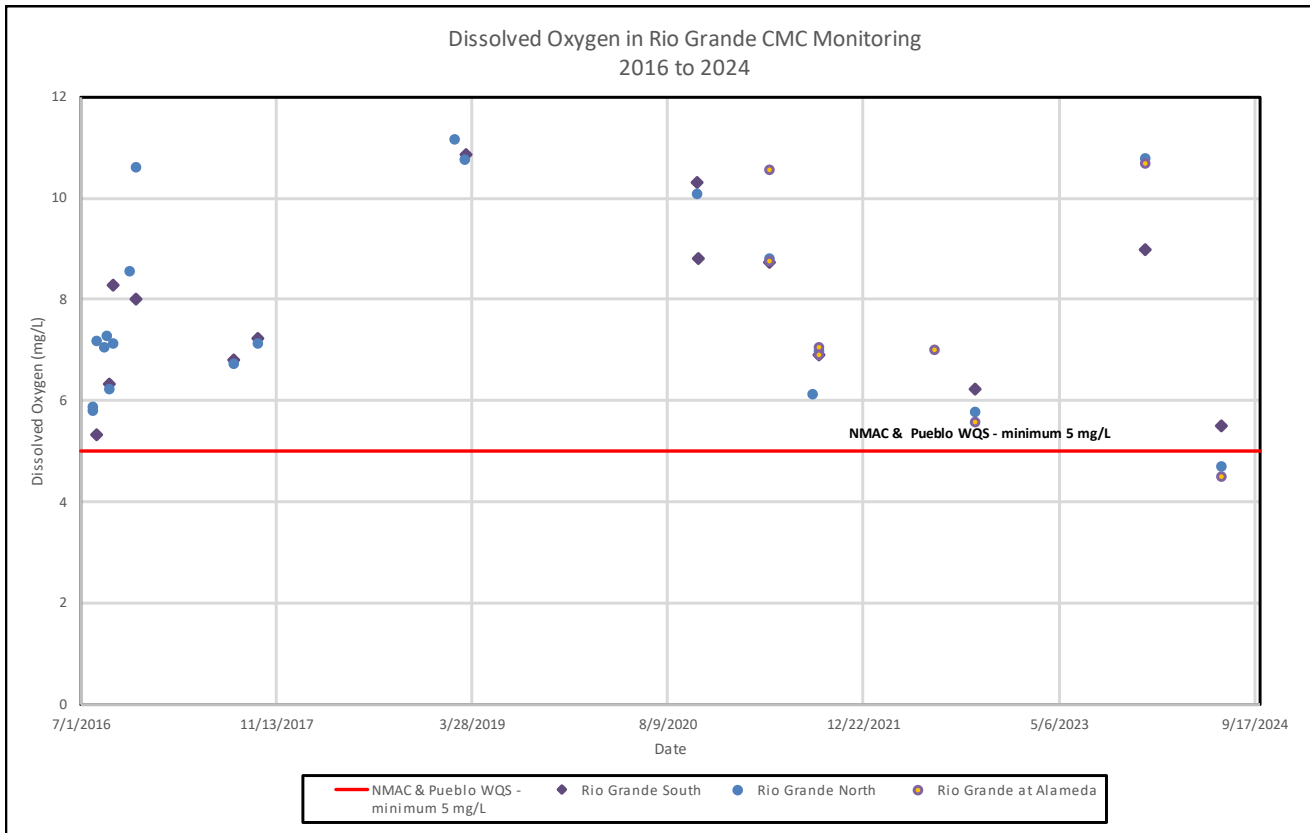
**Figure 4: Dissolved Oxygen (DO) Monitoring Results in the Rio Grande CMC Monitoring – 2016 – 2024**

This provides the MS4s with specific monitoring data showing that stormwater did not cause or contribute to exceedances of applicable DO WQSs in the Rio Grande from any of the CMC samples from 2016 to 2024. Refer to Figure 4 for CMC DO results and comparison to applicable WQSs.

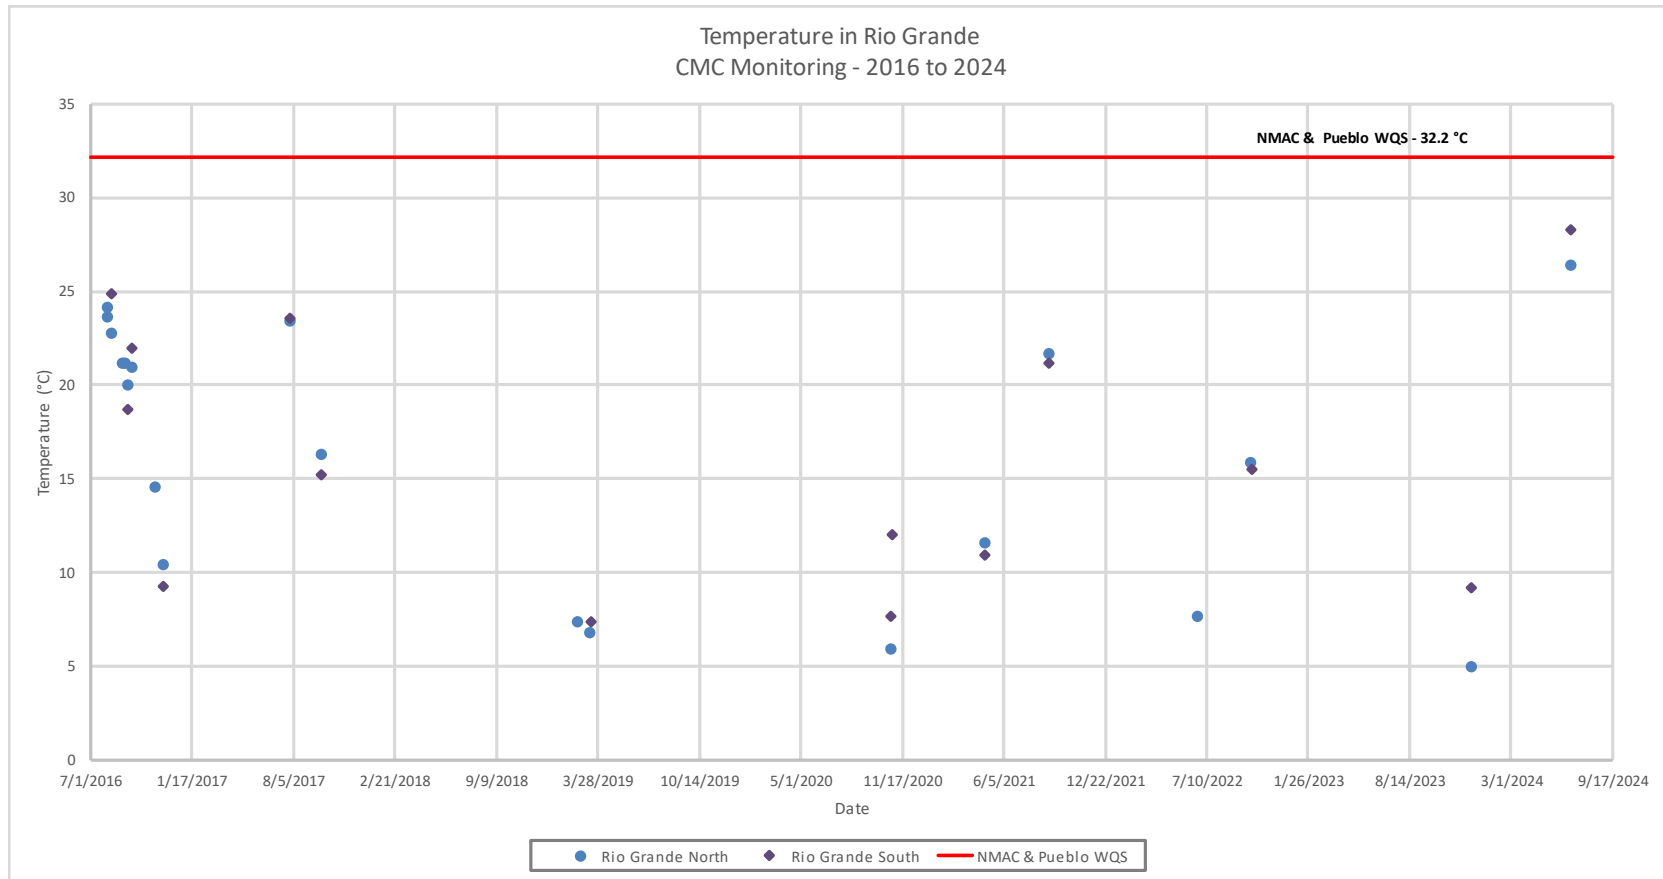
**Figure 5: Temperature Monitoring Results in the Rio Grande CMC Monitoring – 2016 - 2024**

Temperature is listed in the WSB MS4 Permit as a special condition (currently only applicable to the City of Albuquerque and AMAFCA). Past data submitted to EPA and NMED by the MS4 permittees have proven that stormwater discharges into the Rio Grande are not raising the Rio Grande temperature above the WQSs. The data collected during this FY 2024 dry season monitoring also supports this conclusion. All the temperature field readings taken in the Rio Grande during the CMC FY 2024 dry season were below 32.2°C (90°F), which is the WQS for the State of New Mexico and for the Isleta and Sandia Pueblos. Refer to Figure 5 for temperature results and comparison to applicable WQSs for all CMC samples taken upstream and downstream of the MRG MS4 area from 2016 to 2024.

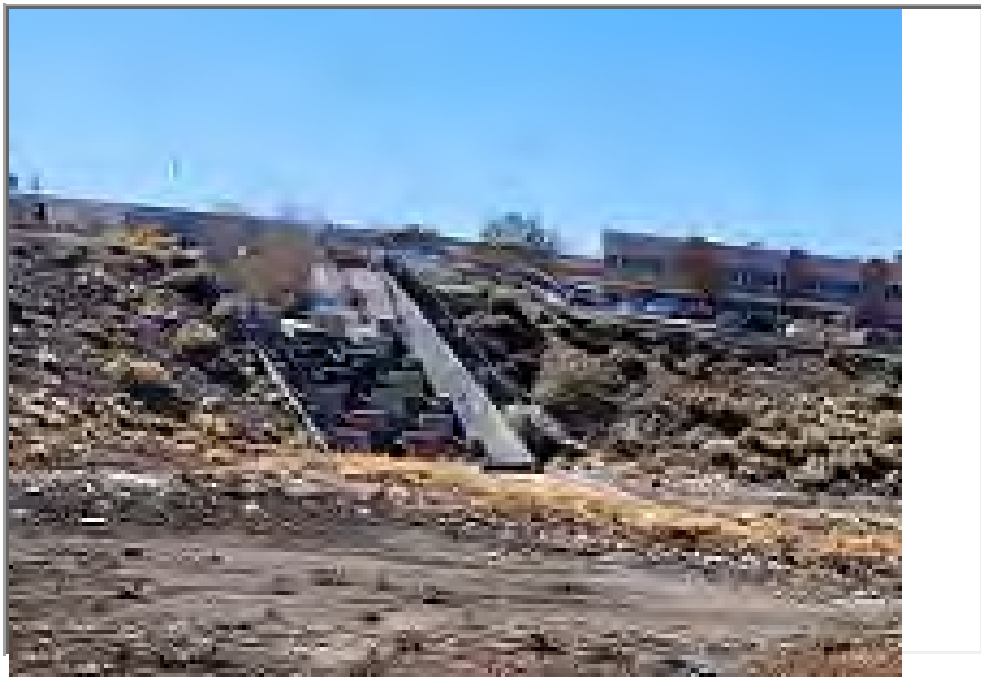
LOCATION **BARELAS PUMPING PLANT INFLOW**

OUTFALL\_NO **4** QUAD **SW** GRID **L-13** SAMPLED

Source of Flow **groundwater infiltration to the storm lines**

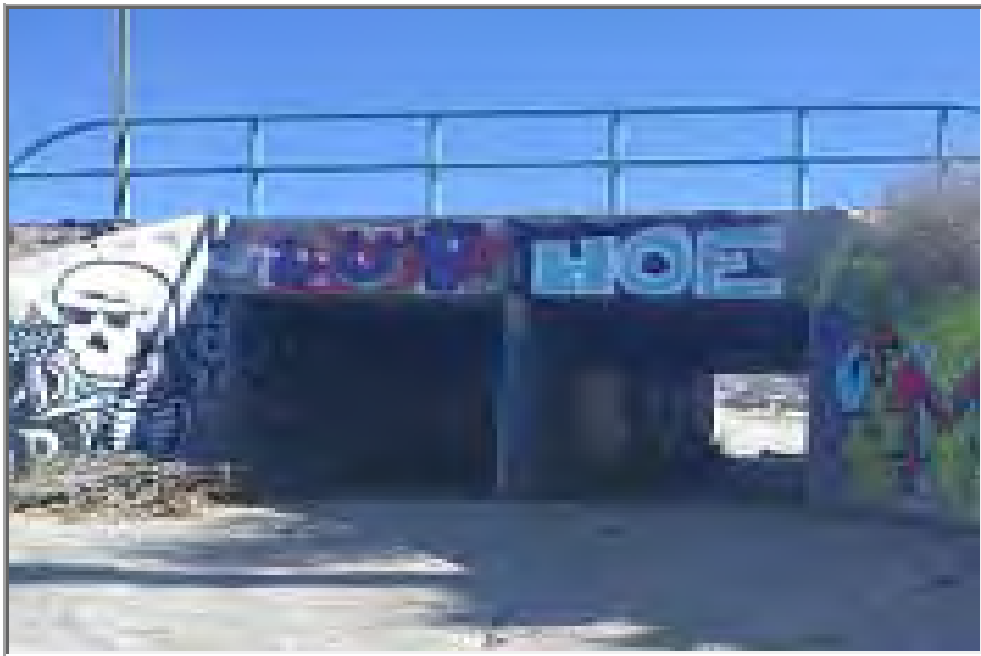
LOCATION	<b>SAN ANTONIO ARROYO AT RIO GRANDE</b>					
OUTFALL_NO	6	QUAD	NW	GRID	F-12	SAMPLED <input type="checkbox"/>
DATE_INSP	3/22/2024	TIME	10:00am	Inspected by	JA/DL	
WEATHER	SUNNY	flow	NO	FLOW_GPM	0	
APPEARANCE	na		GROSS POLLUTANT	na		
Source of Flow	na

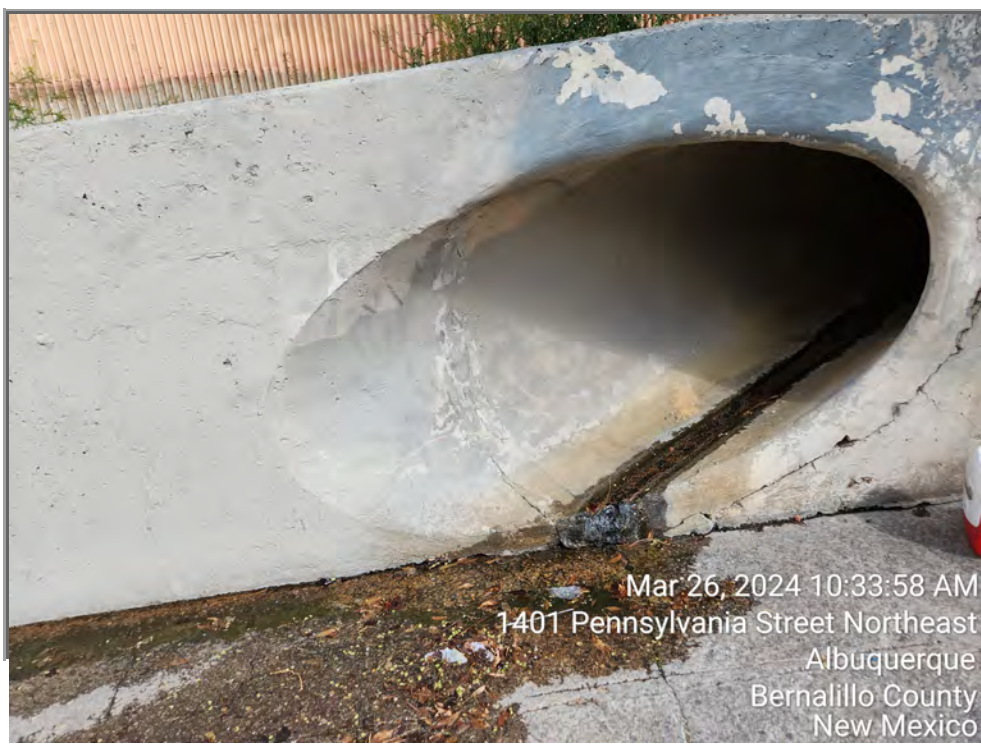
LOCATION **NDC AT TUCKER**

AIR_TEMP_F	48	Lab	HALL ENVIRONMENTAL
WATER_TEMP_F	37	Lab_Report	2212536
pH	8.29	E_coli_Coliform_mpn/100ml	1046.2
CONDUCTIVITY_Umos/cm	300	Ammonia_mg/l	<5
BOD_mg/l	<12.	Nitrite_NO2_mg/l	<0.5
COD_mg/l	176	Nitrate_NO3_mg/l	<0.5
TSS_mg/l	16	TKN_Tot_Kjeld_N_mg/l	<5
TDS_mg/l	240	Phosphorus_total_mg/l_P	0.09
N-Hexane Extractable-(Oil_Grease)_mg/l	<9.5	Hardness_mg/l_CaCO3	120
Floride_mg/l	<0.5	Chlorine_mg/l	<0.05

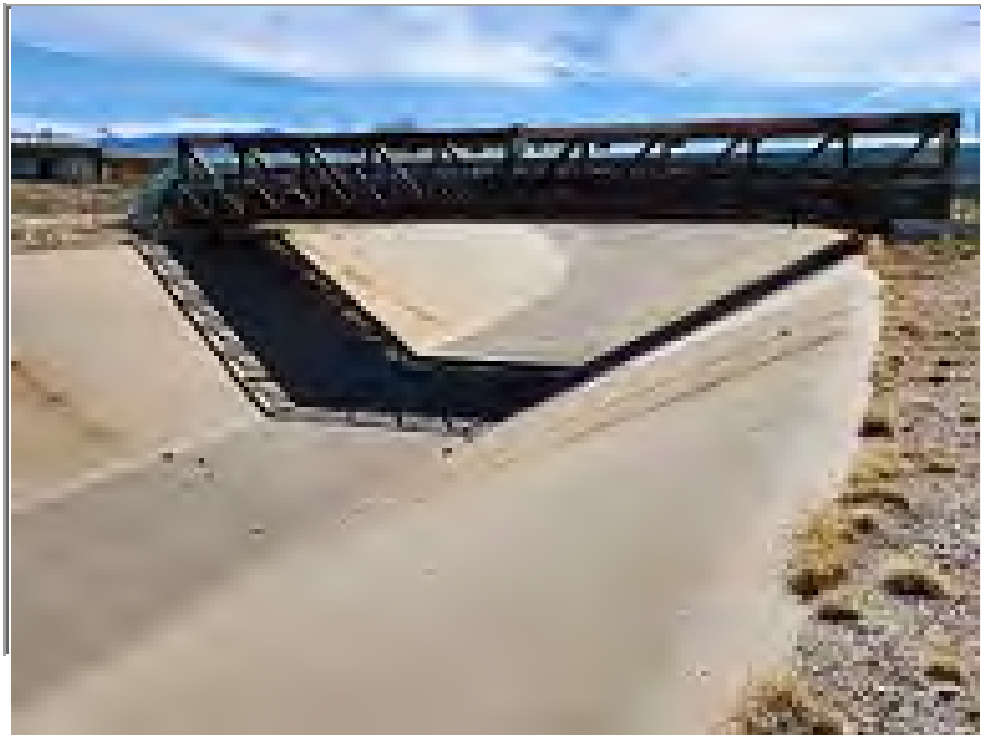
LOCATION	<b>SOUTH PINO ARROYO AT WASHINGTON NE</b>						
OUTFALL_NO	12	QUAD	NE	GRID	D-17	SAMPLED	<input type="checkbox"/>
DATE_INSP	3/5/2024	TIME	10:00am	Inspected by	JA/DL		
WEATHER	CLOUDY	flow	NO	FLOW_GPM	0		
APPEARANCE	na		GROSS POLLUTANT	na			
Source of Flow	na

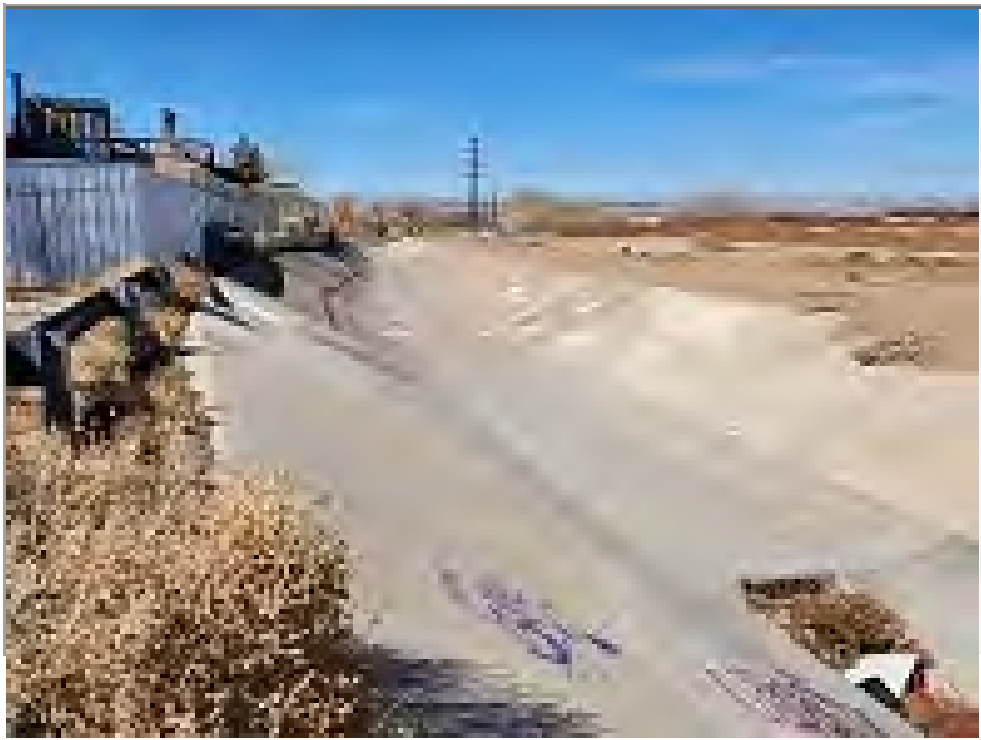
LOCATION	<b>NORTH PINO ARROYO AT TIBURON NE</b>					
OUTFALL_NO	13	QUAD	NE	GRID	D-17	SAMPLED <input type="checkbox"/>
DATE_INSP	3/5/2024	TIME	11:00am	Inspected by	JA/DL	
WEATHER	CLOUDY	flow	NO	FLOW_GPM	0	
APPEARANCE	na		GROSS POLLUTANT	na		
Source of Flow	na

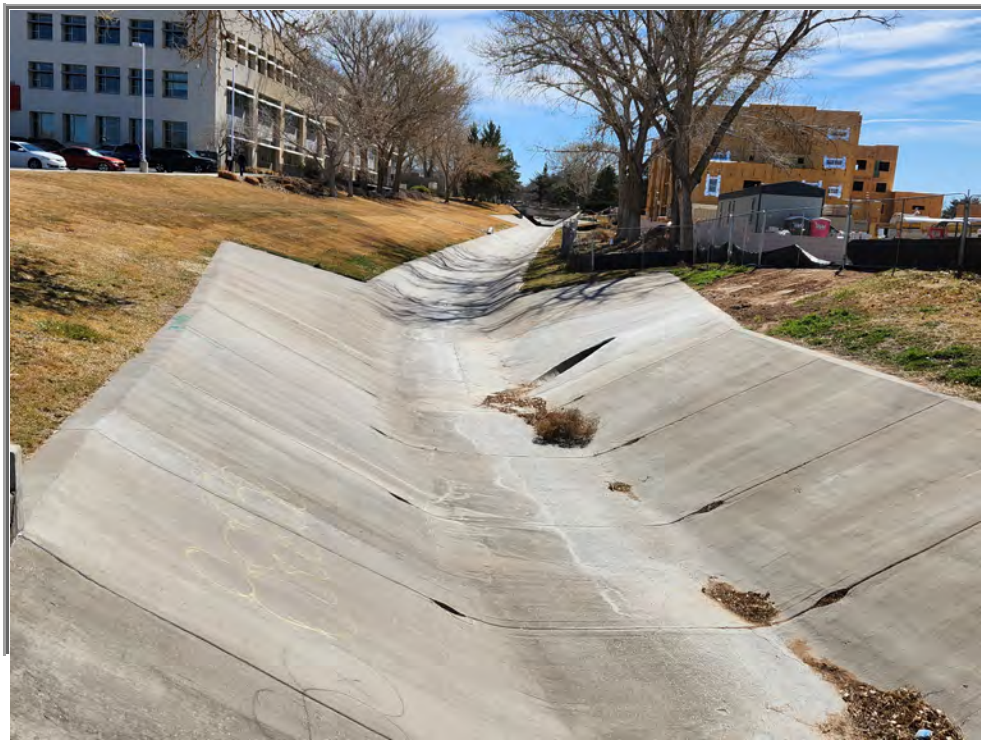
LOCATION	<b>SOUTH DOMINGO BACA ARROYO AT WASHINGTON NE</b>						
OUTFALL_NO	14	QUAD	NE	GRID	C-17	SAMPLED	<input checked="" type="checkbox"/>
DATE_INSP	3/5/2024	TIME	12:30pm	Inspected by	SK		
WEATHER	CLOUDY	flow	NO	FLOW_GPM	0		
APPEARANCE	na	GROSS POLLUTANT	na				
Source of Flow	na

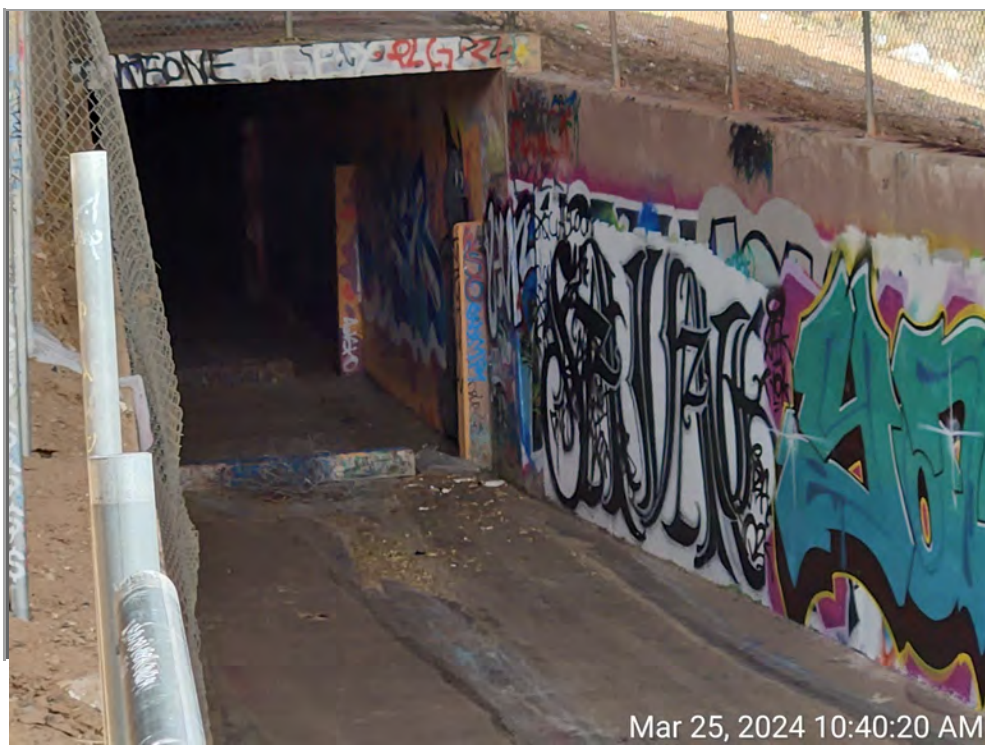
LOCATION	<b>SNOW VISTA ARROYO AT DE VARGAS SW</b>						
OUTFALL_NO	17	QUAD	SW	GRID	M-09	SAMPLED	<input type="checkbox"/>
DATE_INSP	3/5/2024	TIME	10:30am	Inspected by	JA/DL		
WEATHER	SUNNY	flow	NO	FLOW_GPM	0		
APPEARANCE	na		GROSS POLLUTANT	na			
Source of Flow	na

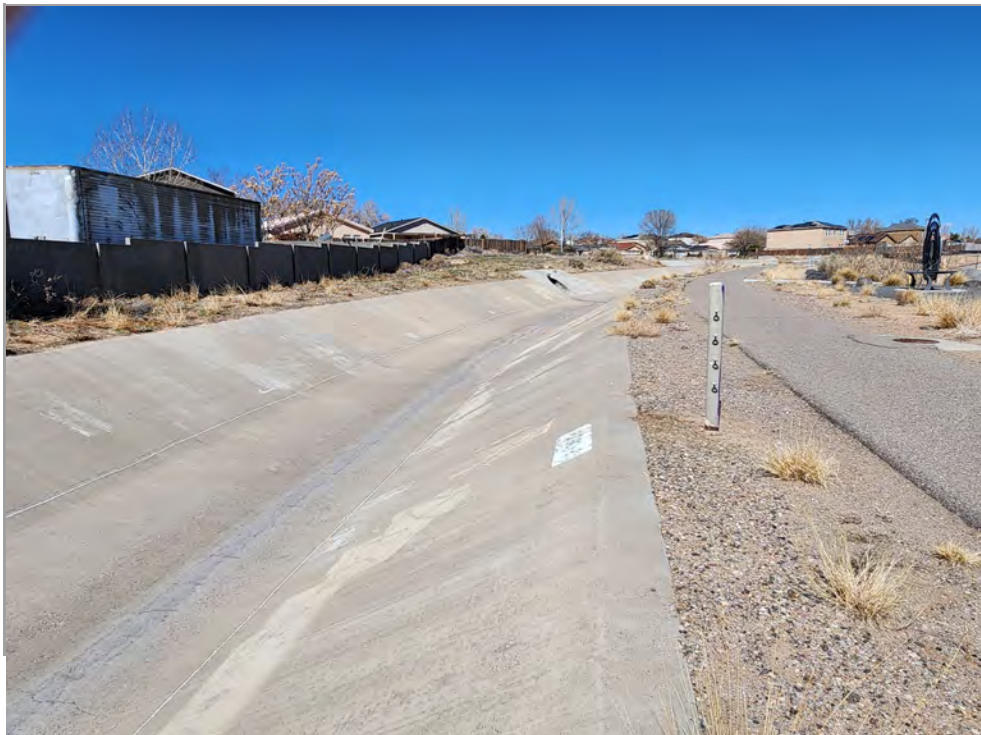
LOCATION	<b>MONTANO EAST OF COORS NW</b>						
OUTFALL_NO	18	QUAD	NW	GRID	E-12	SAMPLED	<input type="checkbox"/>
DATE_INSP	3/1 /2024	TIME	11:00am	Inspected by	JA/DL		
WEATHER	CLOUDY	flow	NO	FLOW_GPM	0		
APPEARANCE	na		GROSS POLLUTANT	na			
Source of Flow	na

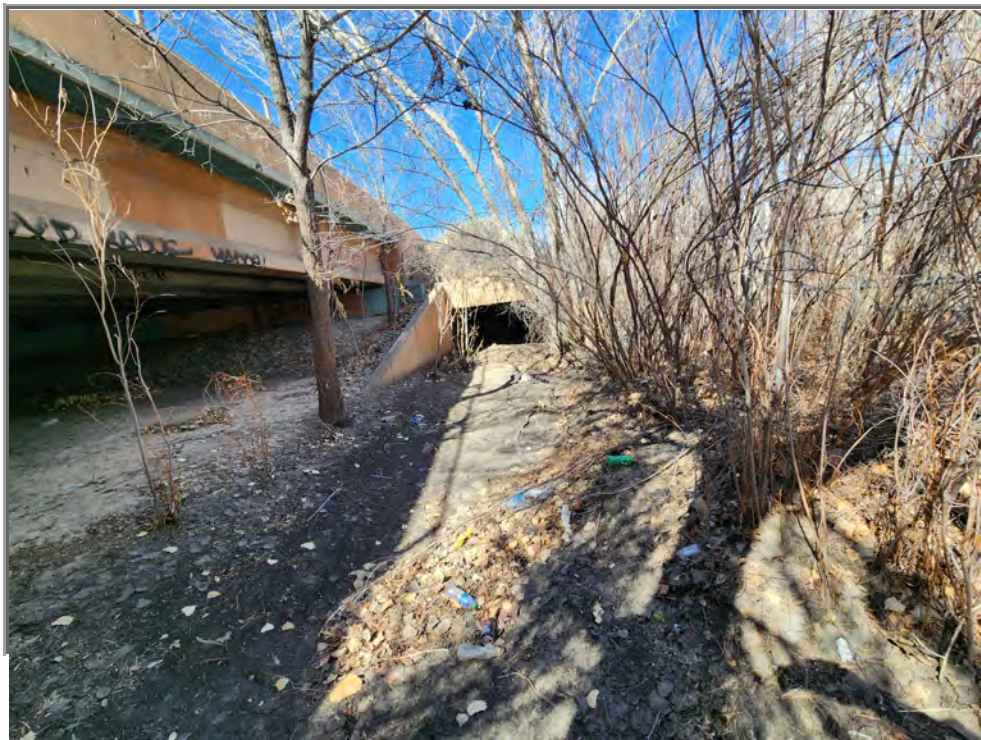
LOCATION	<b>MONTANO NW PS-47 WEST OF RIO GRANDE BLVD</b>						
OUTFALL_NO	19	QUAD	NW	GRID	F-12	SAMPLED	<input type="checkbox"/>
DATE_INSP	3/5/2024	TIME	9:20am	Inspected by	NR		
WEATHER	SUNNY	flow	NO	FLOW_GPM	0		
APPEARANCE	na	GROSS POLLUTANT	na				
Source of Flow	na

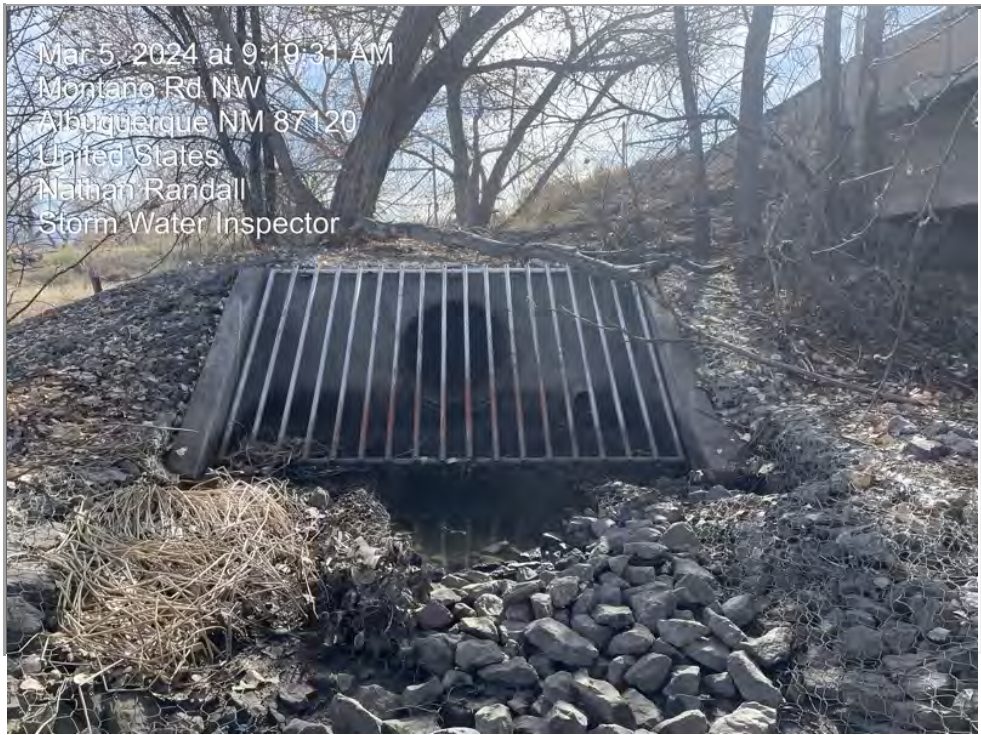
LOCATION	<b>CANDELARIA NW PS-40 AT RIO GRANDE</b>						
OUTFALL_NO	20	QUAD	NW	GRID	G-12	SAMPLED	<input type="checkbox"/>
DATE_INSP	3/5/2024	TIME	8:00am	Inspected by	NR		
WEATHER	SUNNY	flow	NO	FLOW_GPM			
APPEARANCE		GROSS POLLUTANT					
Source of Flow

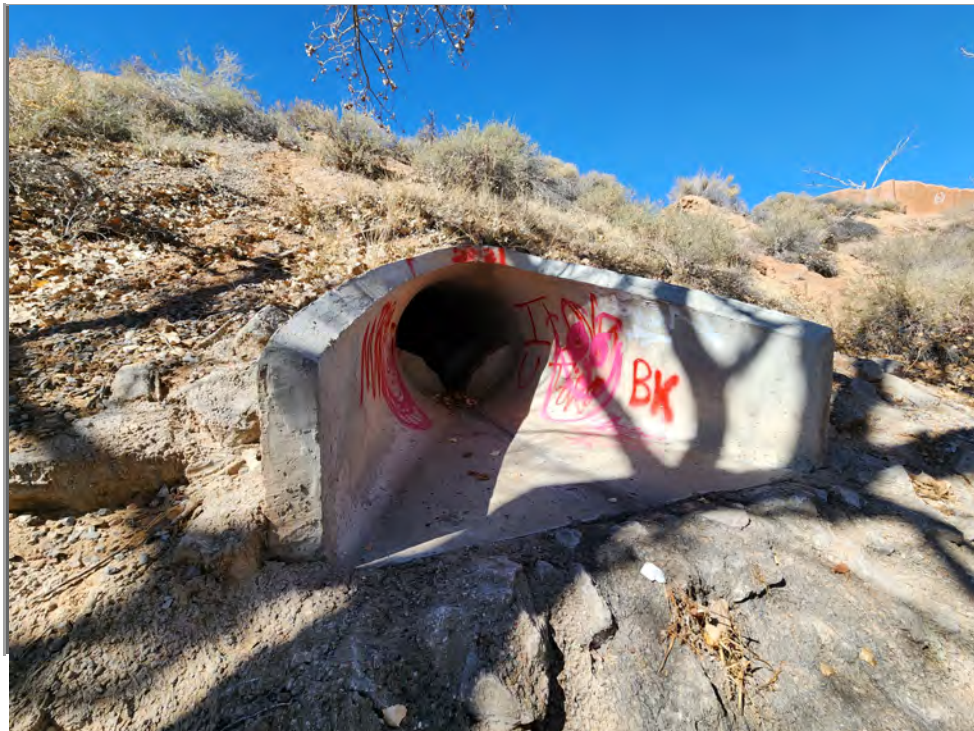
LOCATION	<b>SNOW GOOSE AT OXBOW BLUFF NW</b>					
OUTFALL_NO	22	QUAD	NW	GRID	G-11	SAMPLED <input type="checkbox"/>
DATE_INSP	4/5/2024	TIME	11:30am	Inspected by	KO	
WEATHER	SUNNY	flow	NO	FLOW_GPM	0	
APPEARANCE	na		GROSS POLLUTANT	na		
Source of Flow	na

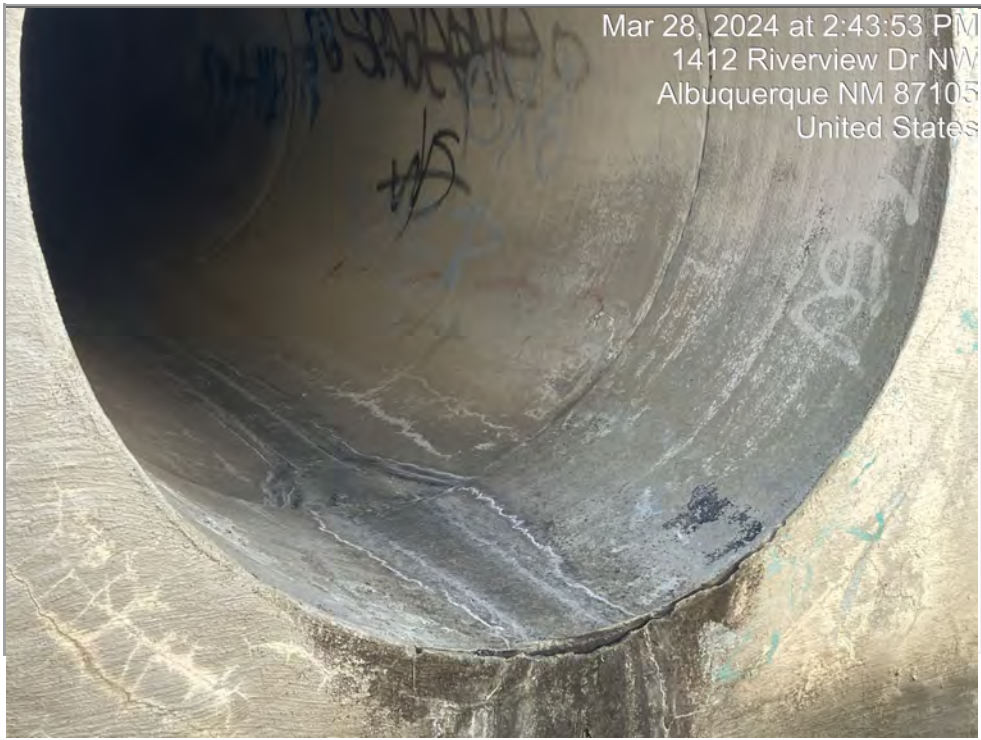
LOCATION	<b>REDLANDS - GRANDE VISTA NW</b>						
OUTFALL_NO	24	QUAD	NW	GRID	G-12	SAMPLED	<input type="checkbox"/>
DATE_INSP	3/20/2024	TIME	3:05	Inspected by	JA/DL		
WEATHER	SUNNY	flow	NO	FLOW_GPM	0		
APPEARANCE	na		GROSS POLLUTANT	na			
Source of Flow	na

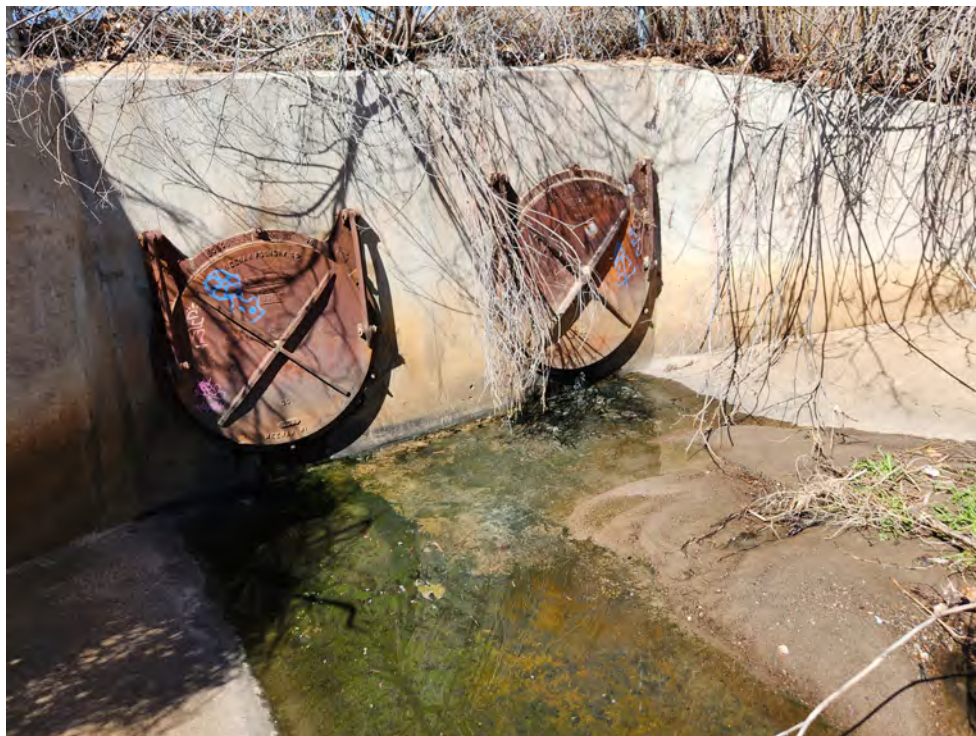
LOCATION	<b>CENTRAL-SUNSET-OSAGE PS-44 THE 36 AND 42 IN PIPES</b>						
OUTFALL_NO	33	QUAD	NW	GRID	J-12	SAMPLED	<input checked="" type="checkbox"/>
DATE_INSP	3/21/2024	TIME	10:30am	Inspected by	JA/DL		
WEATHER	SUNNY	flow	YES	FLOW_GPM	0.5		
APPEARANCE	clear	GROSS POLLUTANT	none				
Source of Flow	groundwater at the Atrisco park

AIR_TEMP_F	48	Lab	Eurofins	
WATER_TEMP_F		Lab_Report	885-1678-1	
pH	7.7	E_coli_Coliform_mpn/100ml	90.1	
CONDUCTIVITY_Umos/cm	360	Ammonia_mg/l	0.7	
BOD_mg/l	2	Nitrite_NO2_mg/l	ND	
COD_mg/l	80	Nitrate_NO3_mg/l	0.66	
TSS_mg/l	ND	TKN_Tot_Kjeld_N_mg/l	0.96	
TDS_mg/l	210	Phosphorus_total_mg/l_P	0.35	
N-Hexane Extractable-(Oil_Grease)_mg/l	ND	Hardness_mg/l_CaCO3	92	
Fluoride_mg/l	ND	Chlorine_mg/l	ND

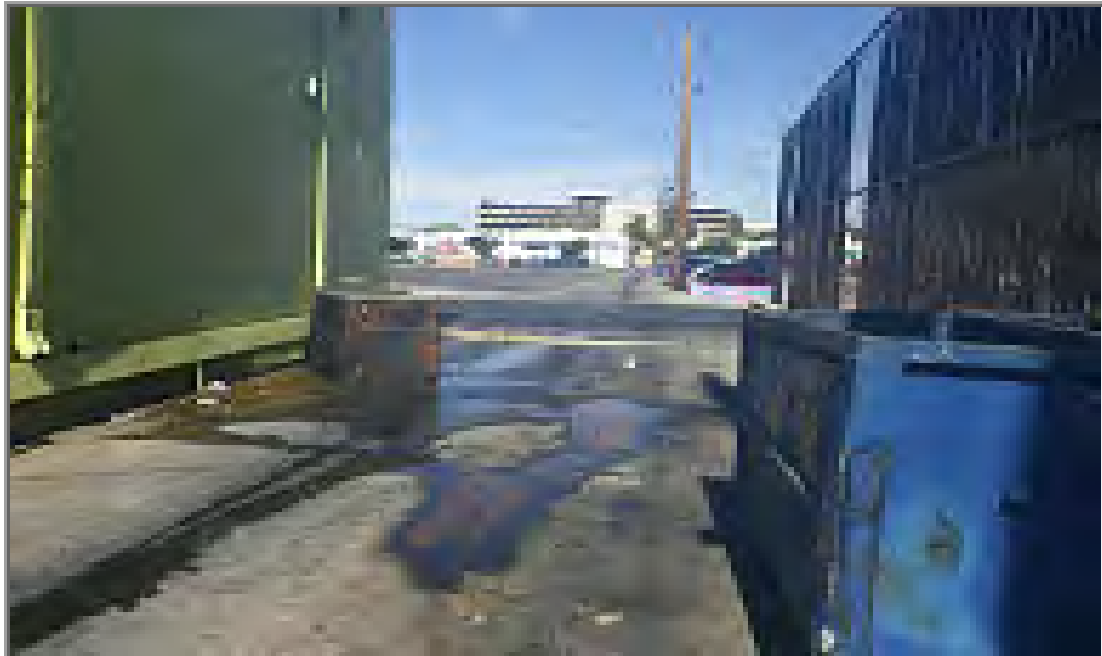
Address **SUSHI HANA AT 521 CENTRAL NW**

Field Observation THE COOKING GREASE WAS COVERING LARGE AREA IN THE ALLEY

Initial Action COVERED THE GREASE WITH ABSORBENT AND ASKED THE MANAGER TO CLEN IT UP AND HE DID.

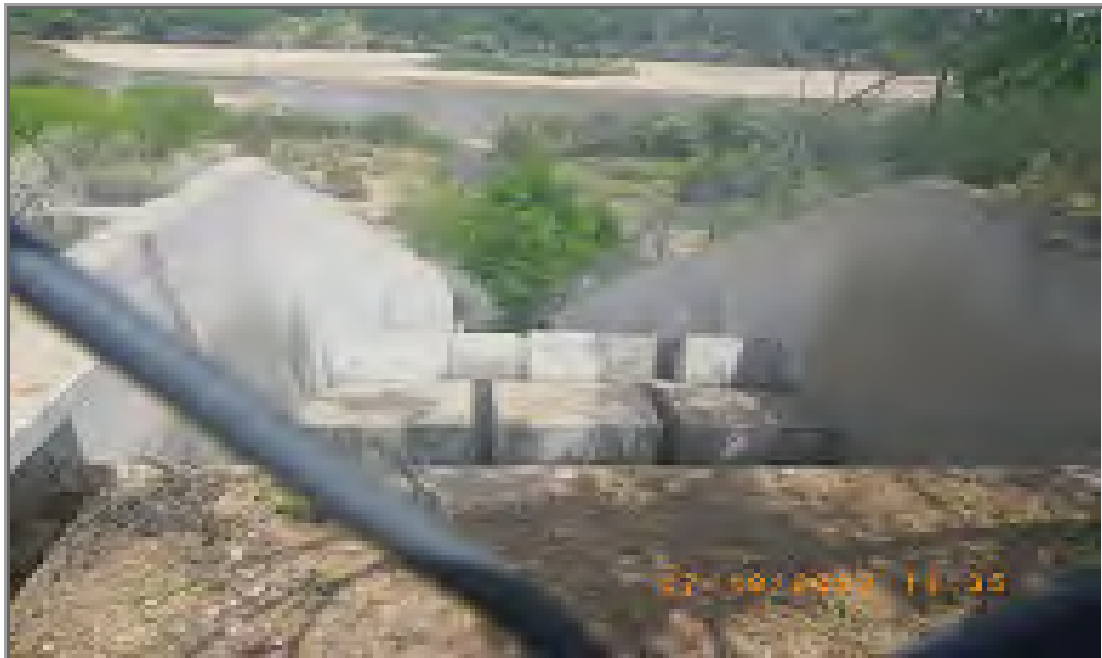
Address **SEQUOIA OUTFALL AT 3536 SEQUOIA NW**

Field Observation THERE IS NO ACCESS TO THE OUTFALL TO INSPECT IT OR REMOVE THE TRASH

Initial Action NO ACTION. IT JUST HAPPENED THAT A BIG WATER WAVE CLEARED THE OUTFALL PATH.

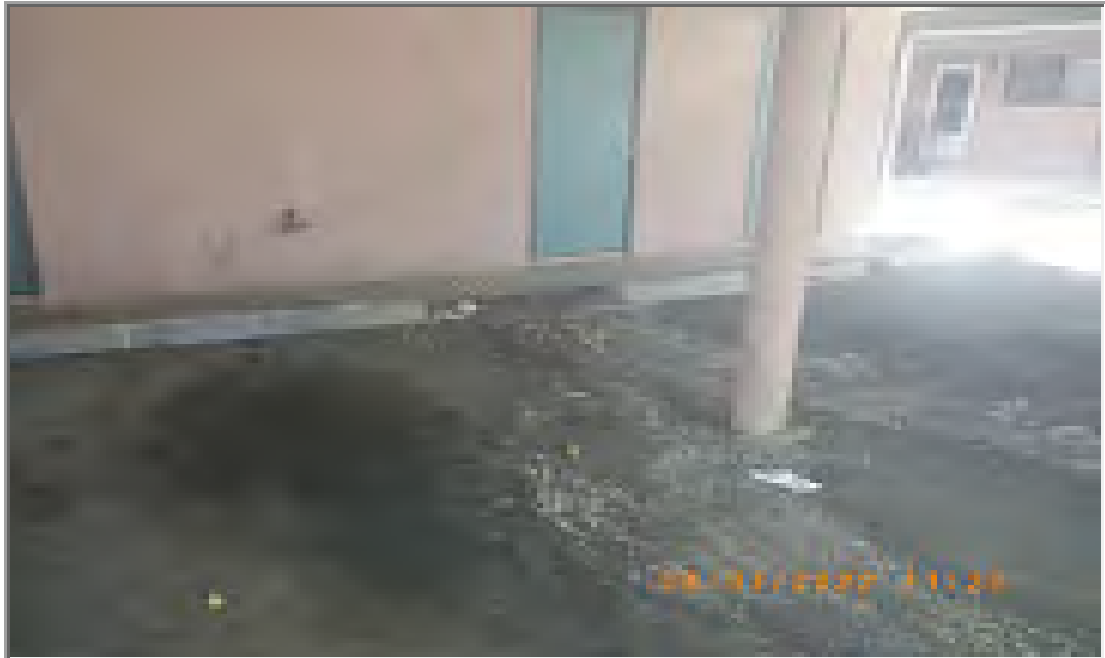
Complaint HOUSE SIDE SEWER GOING INTO THE STREET AND GOING INTO STORM DRAIN. CODE ENFORCEMENT NEEDS TO BE CONTACTED AGAIN ON THIS ADDRESS WHICH HAS BEEN LEAKING FOR ABOUT A MONTH NOW.

Field Observation SEWAGE WAS FLOWING OUT OF CLEAN OUT POINT

Initial Action I SPOKE TO THE MANAGER AND HE SAID THE PLUMBER IS COMING TO FIX IT TODAY.
