# Annual Report Format

## National Pollutant Discharge Elimination System Stormwater Program MS4 Annual Report Format

NMR04A014 City of Albuquerque

What is the reporting period for this report? (mm/dd/yyyy) From 2023-07-01 to 2024-06-30

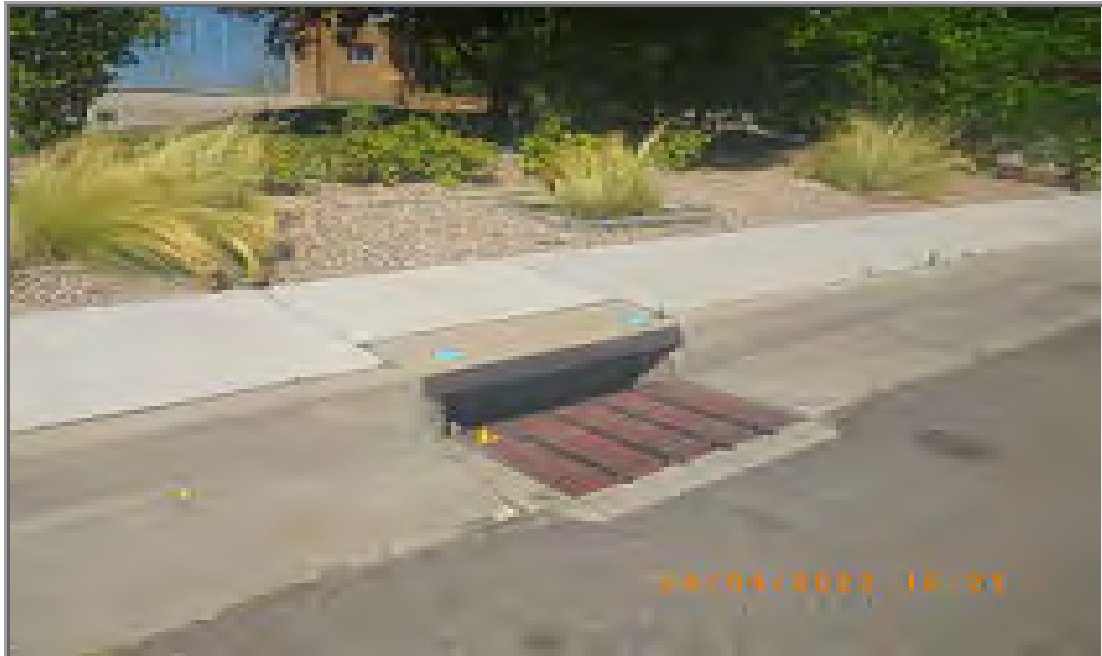
Address **1401 FREEMAN NW**

Field Observation ALL THE INLETS WERE DRY AND NO FOUL ODOR WAS COMING FROM THE INLETS.

Initial Action DISTRIBUTED EDUCATIONAL MATERIAL AT THIS AREA AND GLUED NO DUMP SIGNS ON THE INLETS.

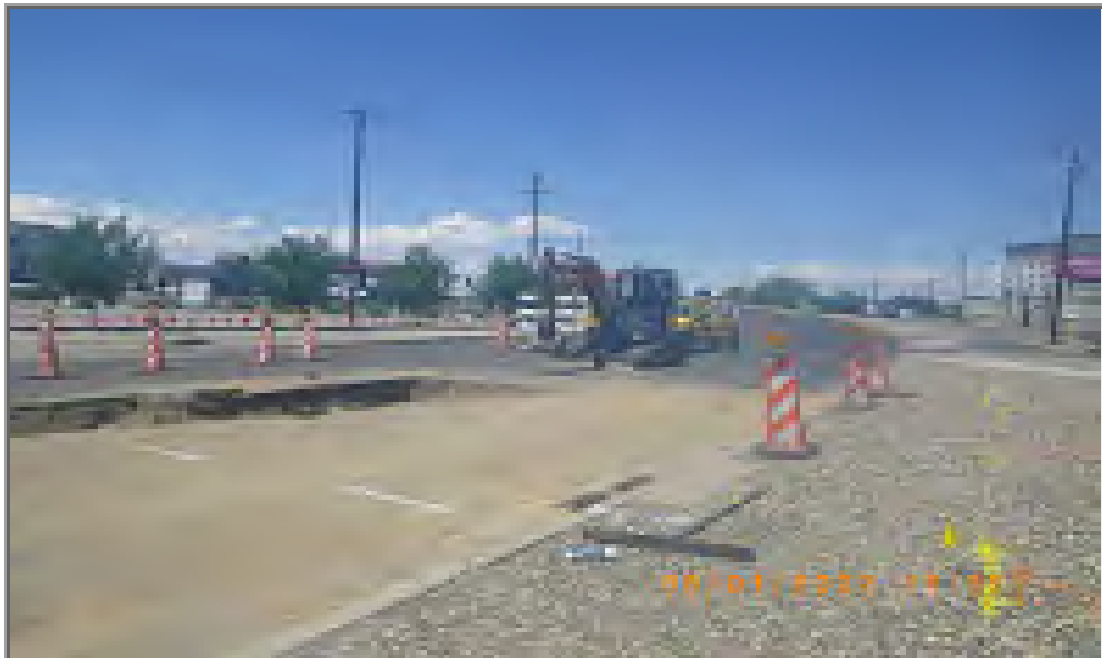
Address **AZ AUTOMOTIVE AT 4906 JEFFERSON NE**

Complaint A PRIVATE SEWER LINE LEAKING. THIS IS AN OPEN EXCAVATION, WUA BARRICADES ARE ON SITE, EXCAVATION IS FULL OF SEWAGE AND IS OVERFLOWING.

Field Observation THE CONTRACTOR WAS ON SITE FIXING THE LEAK.

NO ACTION NEEDED

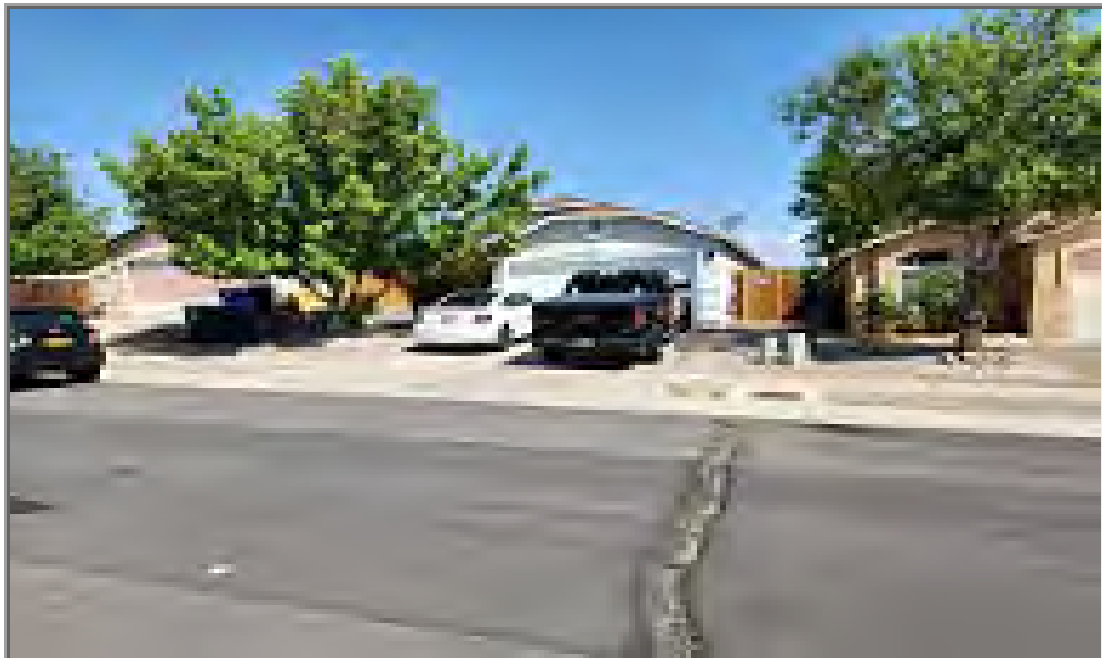
Address **4516 HILTON NE**

Field Observation NO PROBLEM

Initial Action NO ACTION

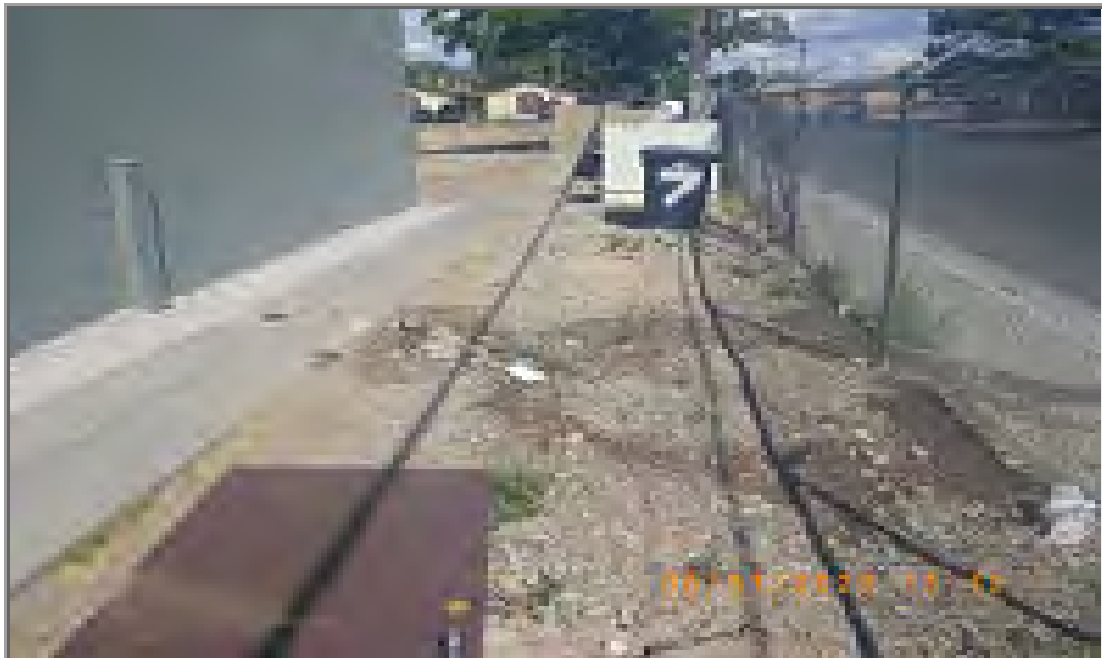
Address **5935 WYOMING BLVD NE**

Complaint THE BUSINESS LOCATED AT 5935 WYOMING BLVD NE HAS A PRIVATE SEWER LINE LEAKING IN THE STREET AND GOING DOWN THE STORM DRAIN.

Field Observation UNABLE TO LOCATE THE LEAK, THIS MALL IS TOO BIG.

Initial Action NO ACTION

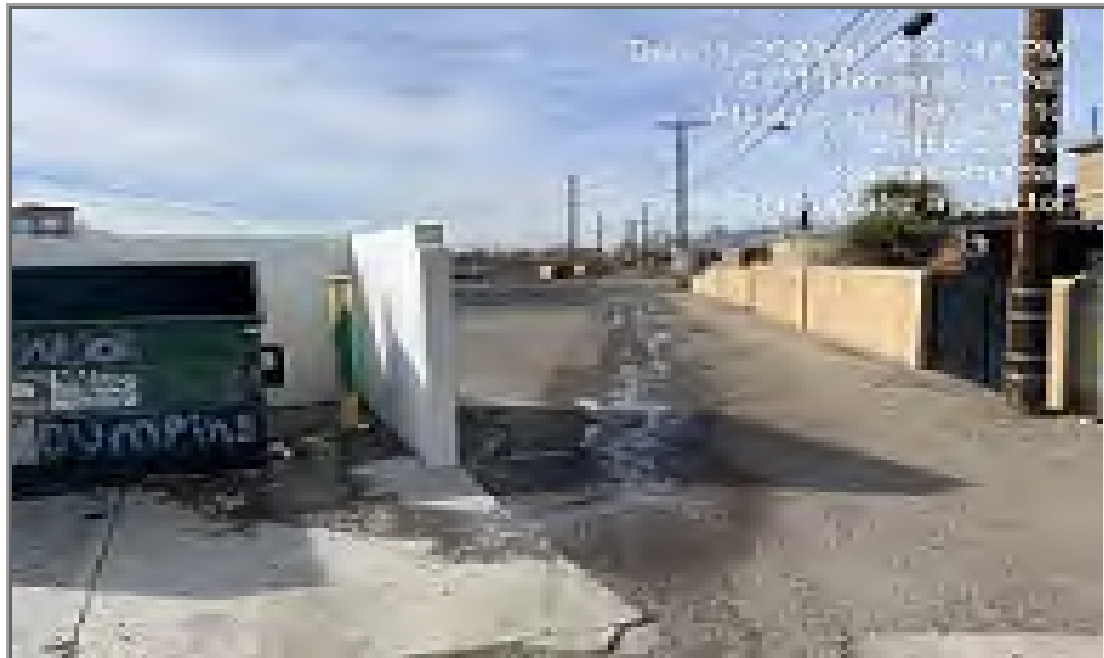
Address **6104 MCLEOD NE**

Field Observation THE GUTTER WAS WET

Initial Action THE INSPECTOR ASKED THEM TO STOP DUMPING ANY GREY WATER TO THE GUTTER AND GAVE THE EDUCATIONAL MATERIAL

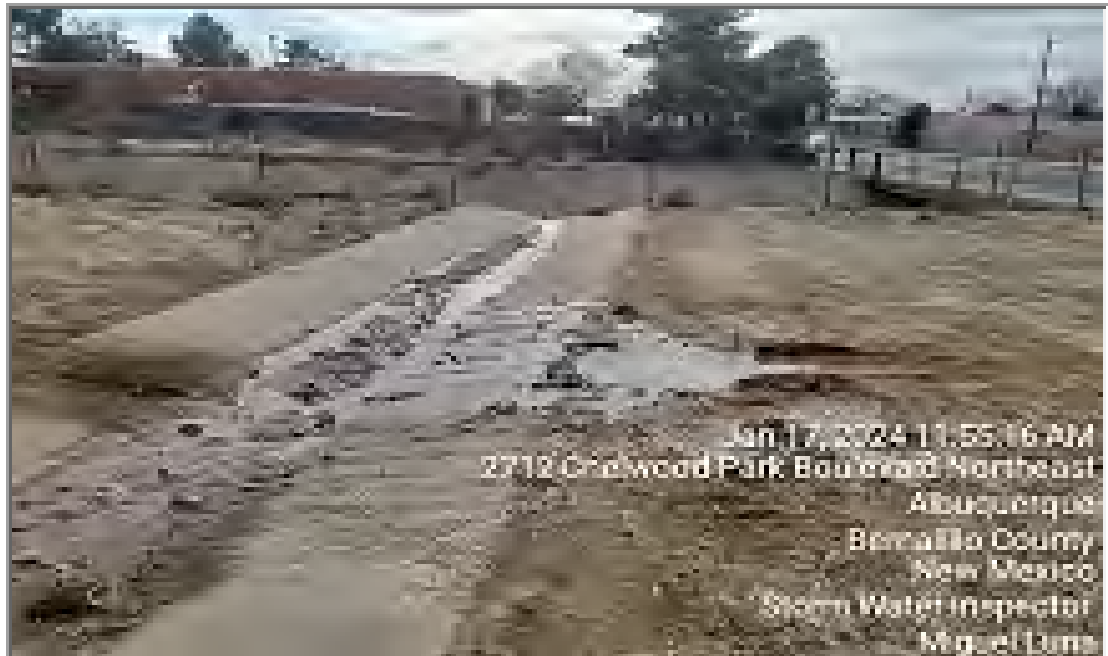
Address **6000 MONTANO PLAZA NW**

Field Observation THE PRIVATE MH AT THIS ADDRESS WAS OVERFLOWING

Initial Action THE MANAGER FIXED THE CLOG AND CLEANED UP THE AREA

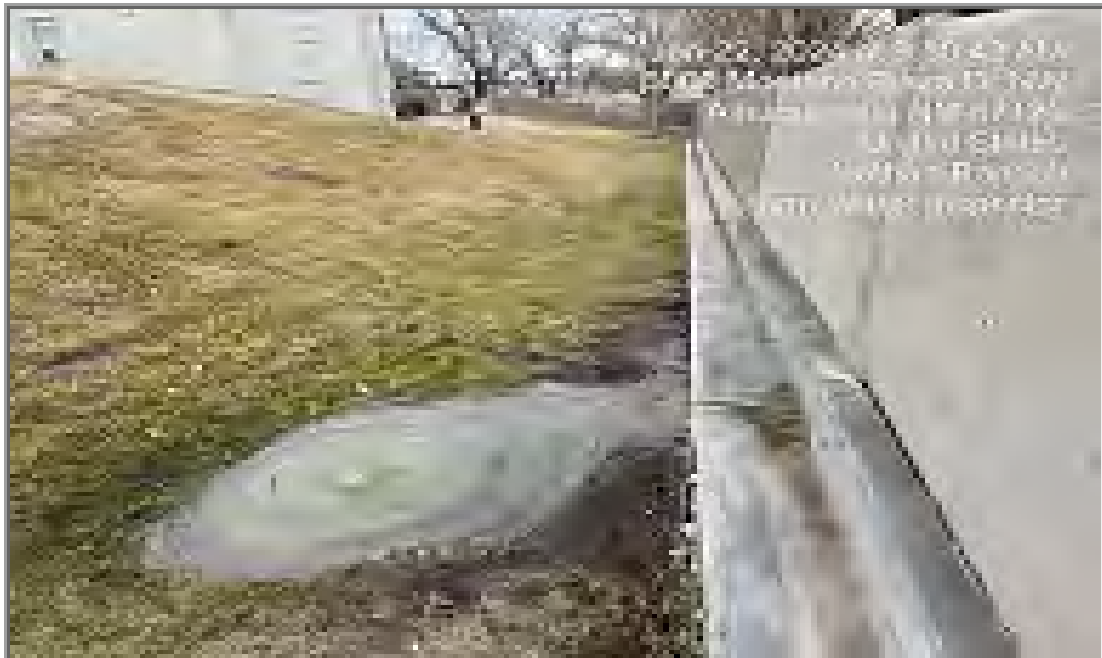
Address **246 WISCONSIN NE**

Field Observation SEWAGE OVERFLOW AT CLENOUT POINT

Initial Action THE LAND LOARD IS IN THE PROCESS OF FIXING THE LINE.

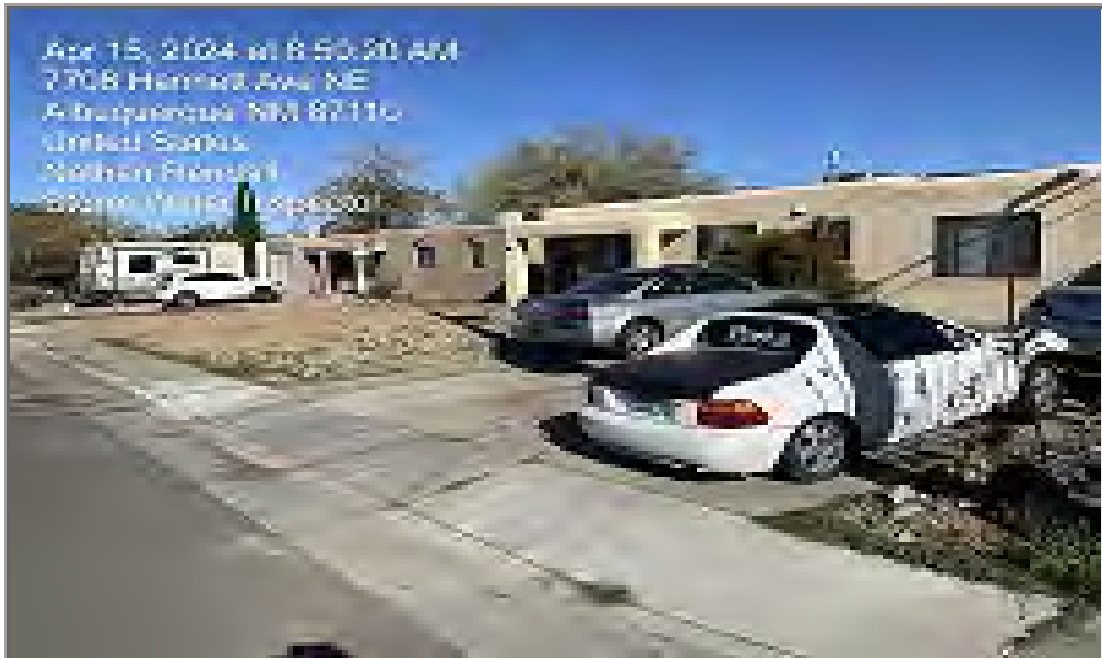
Address **1420 1/2 WALTER NE**

Field Observation THERE WERE SEVERAL OIL SPOTS AT THIS ADDRESS ON THE SIDE WALK AND STREET.

Initial Action NOBODY WAS HOME. LEFT EDUCATIONAL MATERIAL AT THIS ADDRESS

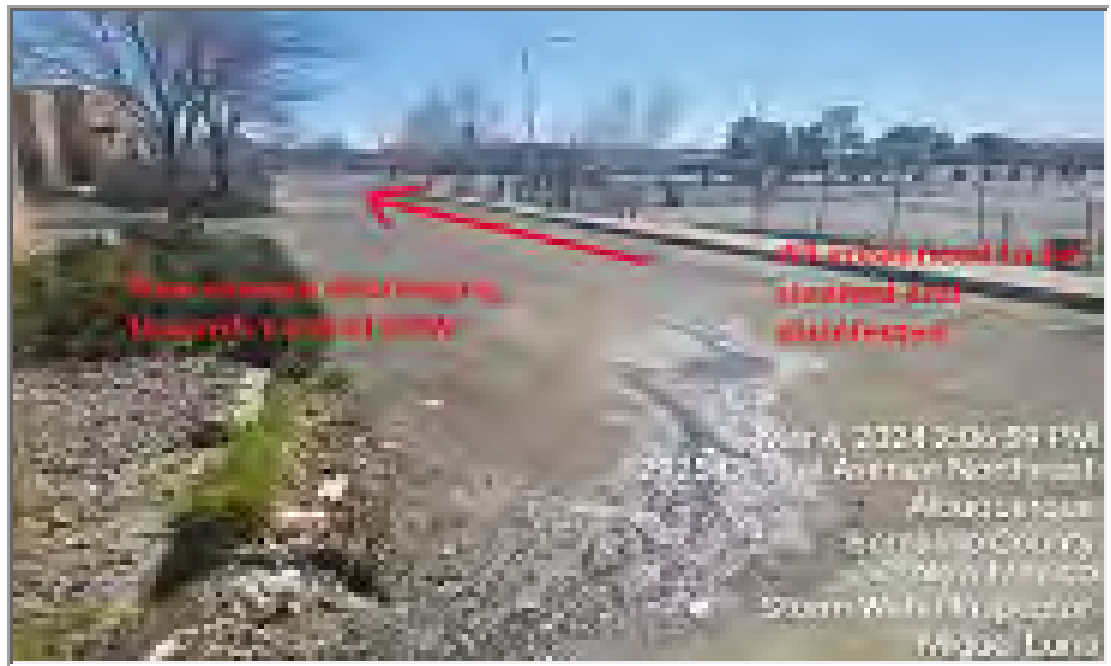
Address **634 ESPANOLA NE**

Field Observation THERE WAS WATER ALONG THE GUTTER

Initial Action NOBODY WAS HOME. LEFT EDUCATIONAL MATERIAL AT THIS ADDRESS

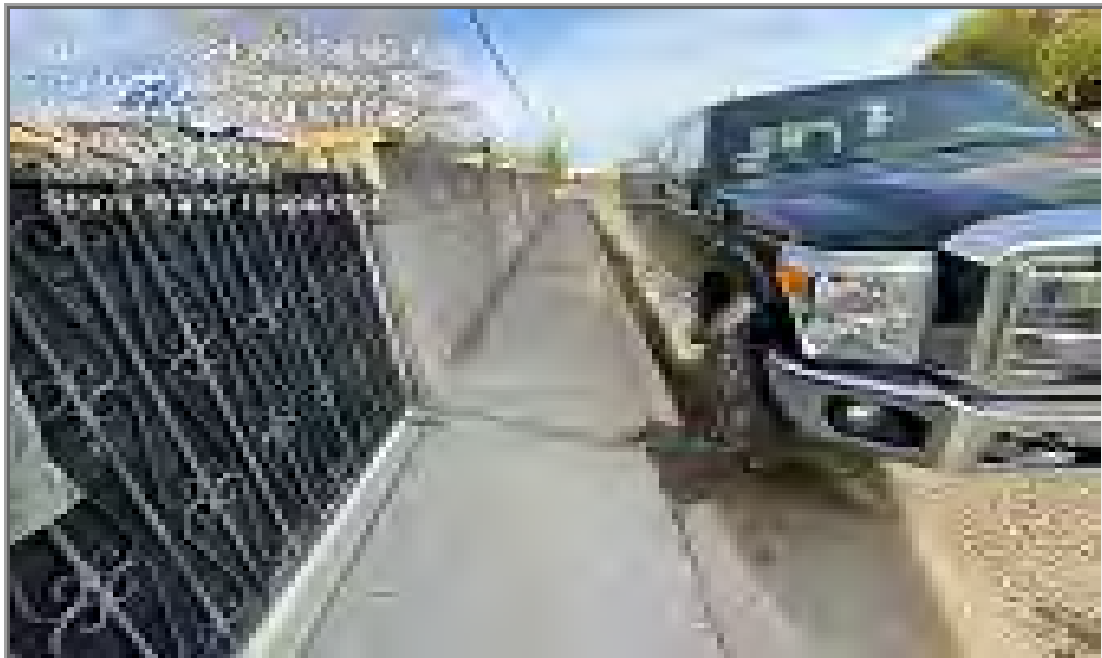
Address **2025 RIDGECREST SE**

Complaint SEWAGE IS LEAKING INTO THE STREET FROM THE BUSINESS.

Field Observation SEWAGE IS LEAKING INTO THE STREET FROM THE BUSINESS.

THEY DID FIX THE PROBLEM.
