## **FEASIBILITY STUDY**

## **RAIL YARDS' BLACKSMITH SHOP**

**CITY OF ALBUQUERQUE**

**CHERRY/SEE/REAMES ARCHITECTS, LLP**  
September 12, 2012

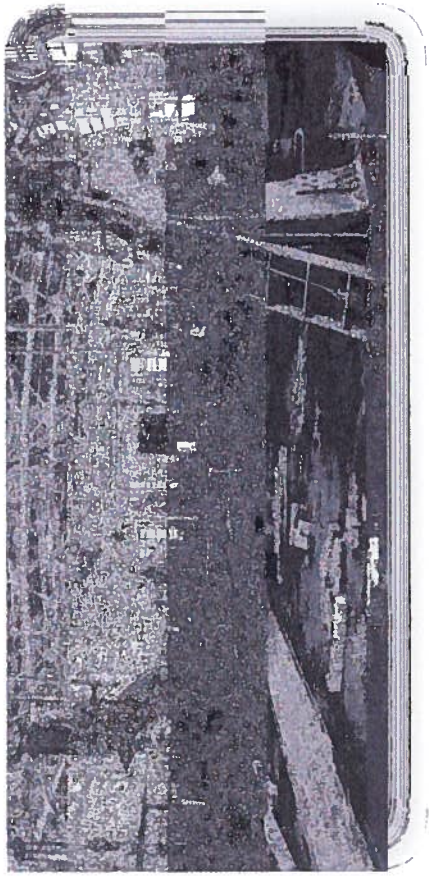
One of the original forges remains in place in the southeast corner of the building. This piece of equipment should be cleaned and displayed. Interpretive signs with photographs explaining the history and purpose of the building could be installed in this area. The central rails for moving locomotives into the building are also in place and run outside to the north. These rails should remain and serve as a focus to bring people into the building from the parking lot to the north.

*Left Top: Blacksmith Shop looking north*

*Left Bottom: Draw Bar and Hammer*

*Right: Existing Forge presently located in the southeast corner of the Blacksmith Shop*

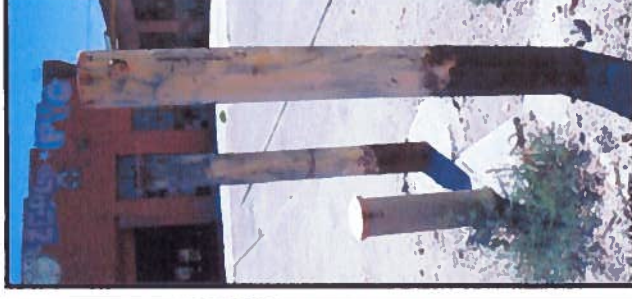
The previous uses of the Rail Yards and concern over remaining contaminants have resulted in over 14 studies and remediation work since 1991 and perhaps earlier. The vast majority of these specific sites are south of the major buildings. However, there are a few sites in the open area north of the Blacksmith Shop, referred to in the studies as Area A (also called Tract A). There had been battery storage to the north and immediately west of the Blacksmith Shop, and a sand blasting area about 300 feet north of the Blacksmith Shop. Soil borings, monitoring well installation, and remediation have taken place. Three monitoring wells (MW-6, MW-8, and MW-9) are in the area proposed for parking. It is anticipated that these wells could be capped with markers at grade level as are other monitoring wells on site, so as not to interfere with the parking layout.

*Monitoring Well North  
of Blacksmith Shop*

As part of the project that is the subject of this study, an environmental consultant should be hired to review the status of the Huang & Associates recommendations, and other appropriate studies to determine if any further remediation work is required within the project area prior to construction.

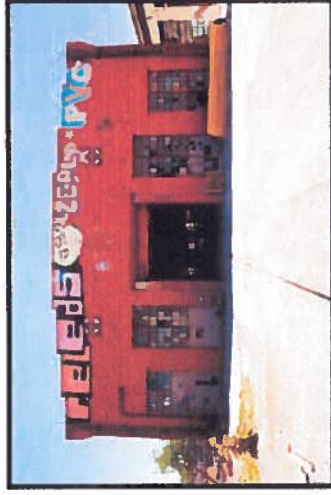
*North Elevation*

The condition of the building shell is remarkably good considering its age and years of neglect. The brick on the north façade has been graffitied and the parapet caps have been removed. The original central window has been removed on the north façade, and the circle has been filled in with brick. This feature is intact on the south facade.

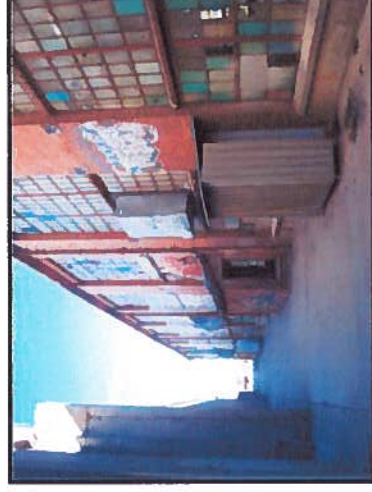
*West Elevation*

The northwest corner of the building has been damaged by the drain at that corner. Some brick on the west side has been damaged at the sill. Much of the brick throughout the building needs cleaning and repointing. The removal of the parapet caps on the north wall have left the brick cavity open to weather damage.

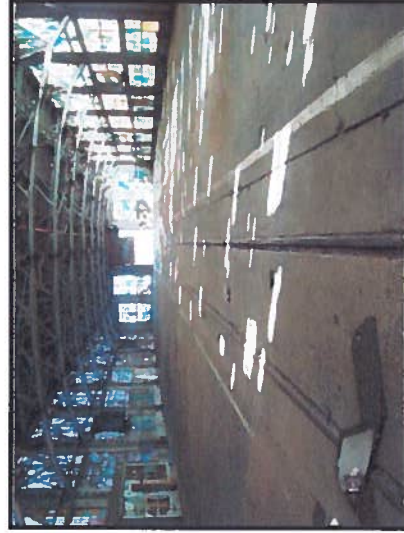
*Interior Looking South*

The interiors of the building are virtually unchanged from the original layout. The former office is damaged, but its original layout is clear. It allowed access to both the operating floor and the west passageway. The original railroad service tracks run north-south down the center of the building.

ADA and other code accommodations will be required for permanent occupancy. They will include the installation of toilets and drinking fountains. The floor at the railroad tracks must be leveled to the top surface of the tracks to avoid a trip hazard. Accommodations for other code issues are addressed in Part III: Code Analysis.
